# Massive landsliding in Narrabeen sandstones in the Watagan region

**ABSTRACT:** The Narrabeen Group is a thick sequence of bedded Triassic sandstones which occupies the stratigraphic interval between the Permian Coal Measures and the Hawkesbury Sandstone in the Sydney Basin. In the northern Sydney Basin it is laterally extensive, extending throughout the southern Hunter Valley from the Central Coast to beyond the Great Divide. In the Watagan region, a unique situation arises where a disconformity causes the Narrabeen group to be underlain directly by Permian upper marine sediments. The result is a dramatic occurrence of ancient massive landsliding, leading to steep sandstone slopes that break to an elevated detrital plane, of considerable lateral extent. This paper describes the unusual geomorphic features associated with the landslide mass and interprets a variety of individual mass-movement and rockfall mechanisms which have contributed to these impressive features in the various stages of its development.

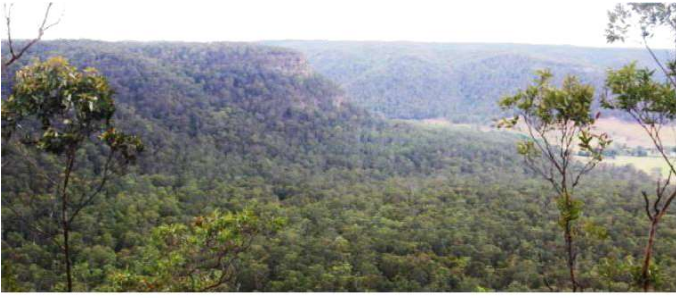
The outlined central landslide feature in Figure 2 shows a broad, long fan of slide debris that has run out in a southerly direction leaving a circular amphitheatre structure, rimmed by steep ridges with side slopes up to 45 degrees. The ridges are around 200m high on the western side (Fig. 3), but increase to around 400m high heading east. The ridge slopes

Figure 3. Overview of the slide from the western end of the upper ridge.

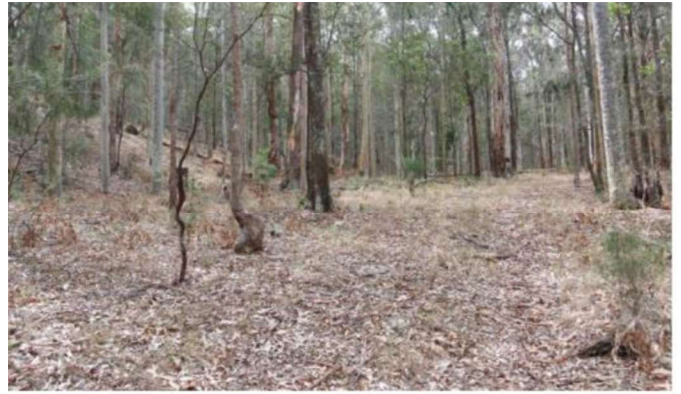
Figure 4. Set 1 lineaments in the slide fan, evident as a step down in the ground surface (left to right).

Perhaps the most difficult to explain feature at this location are the lineaments which criss-cross the massive slide surface. They seem too geometrically consistent to be simple radial drainage lines. The linear persistence may suggest they may be stress or structure related, but a regional rock mass structure or structural control seems unlikely. From the gross morphology of the slide feature itself, it could be proposed that the body of sliding material, as it moved downward and funnelled out of the circular valley it created, might have experienced some sort of lateral compression and then relaxation which caused the formation of a conjugate set of compressional/extensional strains. Alternatively, with the development of the incised drainage channels along the eastern and western margins of the slide, it is possible the colluvial mass has relaxed laterally into these drainage

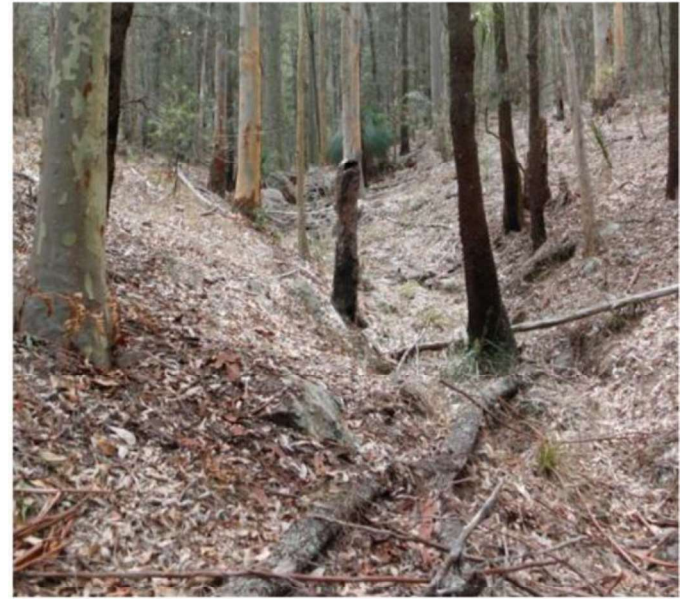
Figure 5. Set 2 lineaments in the slide fan, evident steeply incised gullies in the ground surface.

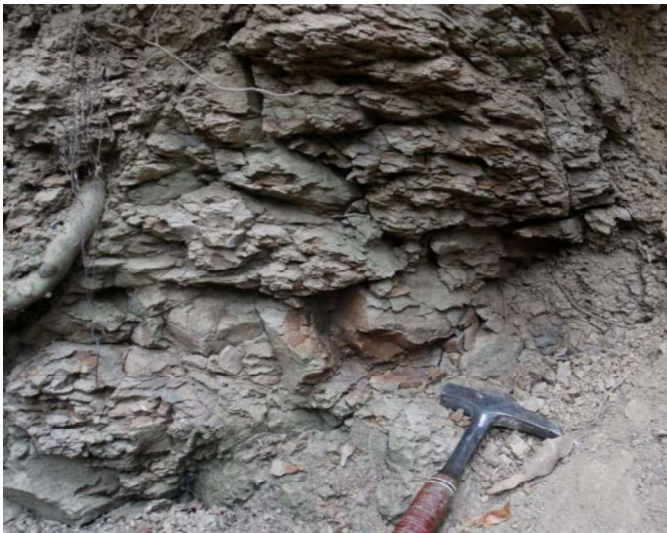
Figure 10 shows the siltstone bedrock exposure at the base of the slide, (red circle in Figure 1) in a deeply incised gully. It comprises a moderately weathered and intensely shattered siltstone material, pale brown, with a fissile nature and fine mica delineating bedding surfaces.

Figure 10. Intensely shattered siltstones at the base of the slide.

It is consistent with the Mulbring siltstone, as found exposed in other parts of the region, however, it could also be a fine grained unit corresponding to the Clifton sub-group (e.g. Dooralong shale), which may be present at this location. Regardless of its precise geological affiliation, it represents a weak foundation for the contrasting strong bedded sandstones which overlie it, and a likely host for the sliding that has occurred.

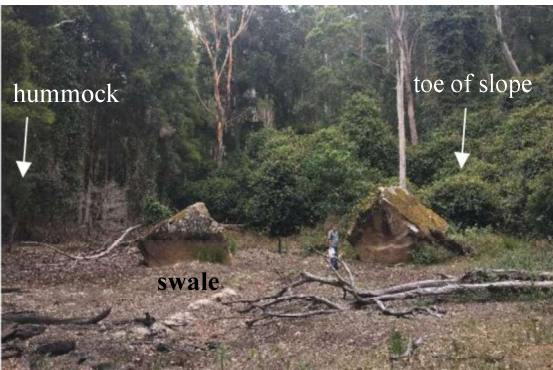
Figure 9 shows an example of a swale/graben at the toe of the ridge slope, with mudcracks observed in the base. Water level marks on the large rocks

clearly demonstrates these features hold water up to 1.5m or so deep at times.

Figure 9. Swale or graben at the toe of the ridge slope with several of the many mapped boulders.

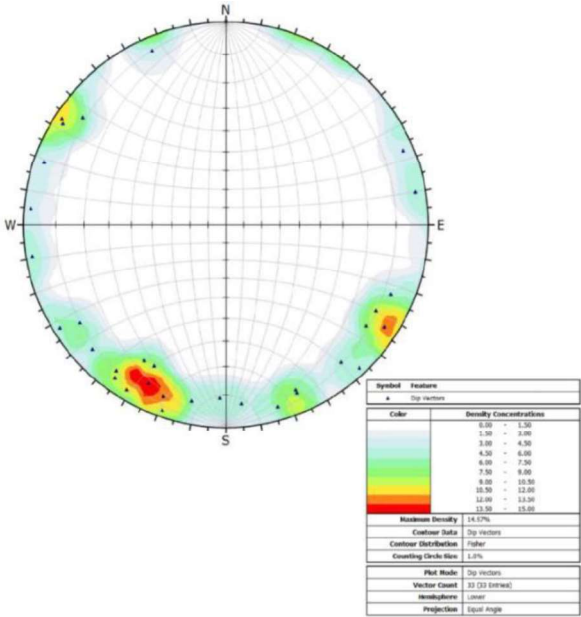
Figure 11 Bedding trends in the Narrabeen sandstones of the area, with a strong trend around 5° to 205°.

Figure 11 shows a stereo-net plot of 33 dip and dip direction values of the bedding surfaces that were measured within the outcropping sandstone units in the ridges above the slide. Despite some scatter, they show a peak concentration around 5° towards 205°. This general shallow south-southwesterly helps explain the prevalence of these landslides on the south facing slopes of the ridges, and the relative absence of similar large scale sliding on the north faces, such as area H, in Figure 2.
