# Geotechnical management of large scale slope deformations at the Teal Gold Project, WA

J.W. Watton

M.J. Fowler

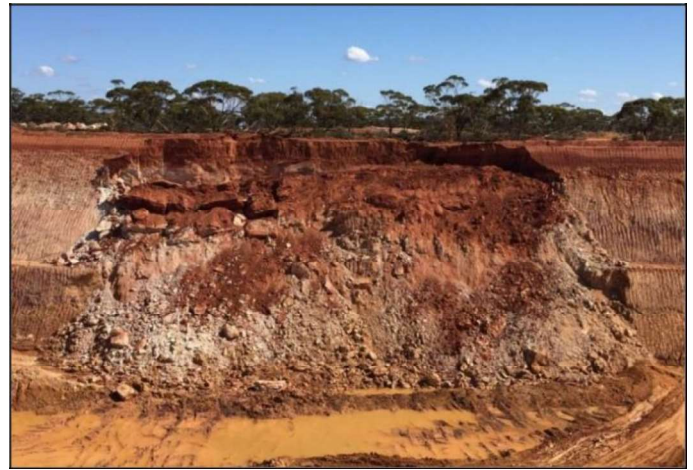
Photo 1. Observed instability along the western pit wall.

Significant slope instability was observed during mining. Approximately 75% of the eastern pit wall and 30% of the western pit wall deformed during mining as shown in Figure 2. Photo 1 shows an example of slope instability along the western pit wall. Photos 2, 4 and 5 show examples of instabilities along the eastern pit wall.

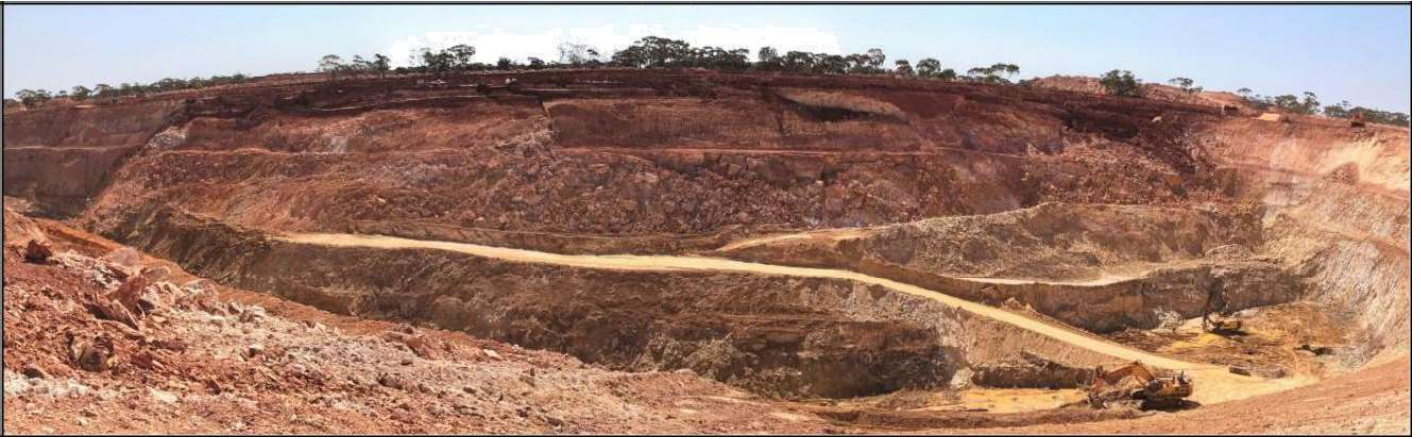
Photo 2. Eastern pit wall before slope unloading, showing the large scale instability and strategic buttressing material (midground).

Slope monitoring initially comprised of geotechnical inspections and prism monitoring. As the eastern pit wall buttressing material shown in Photo 2 was excavated, slope deformation rates increased significantly, reaching peak deformation rates of greater than 10 mm/hr.

Remedial slope modifications primarily comprised unloading of the crest and strategic toe buttressing of the eastern pit wall to reduce rates of deformation. Photos 2 and 3 show the eastern pit wall before and after unloading of the slope through the use of a cutback. Photos 4 and 5 show deformation observed along the eastern pit wall after the cutback was excavated.

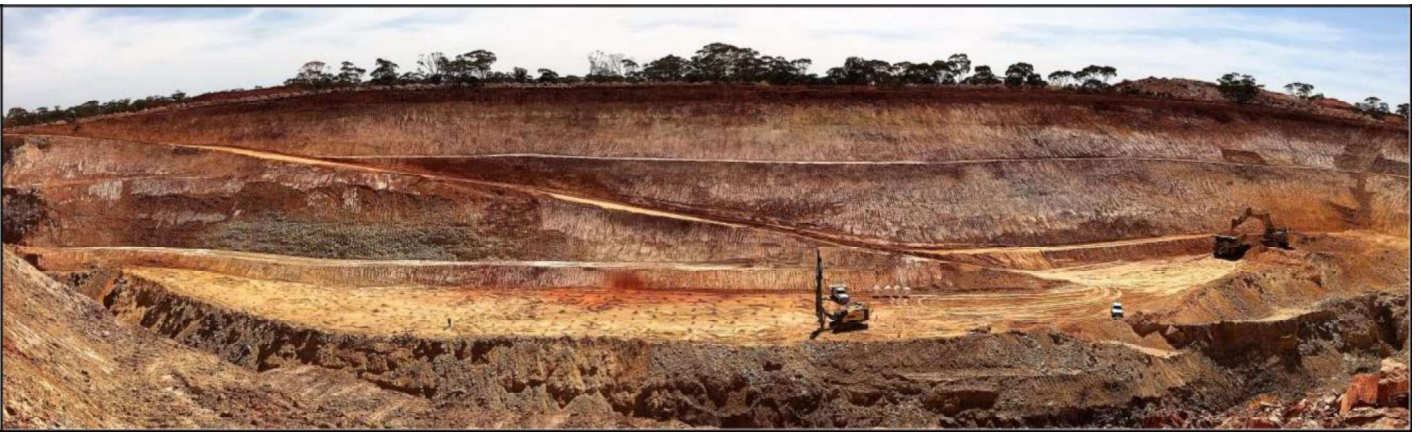
Photo 3. Eastern pit wall after slope unloading and approaching the completion of mining.

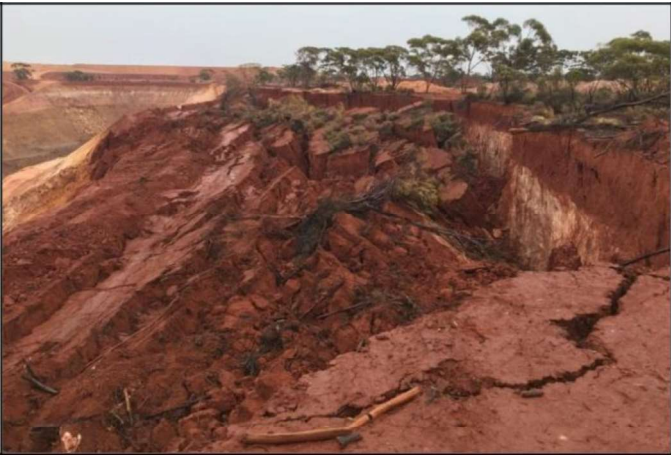
Photo 4. Head-scarp of the eastern pit wall instability at the completion of mining.

Deformation of the eastern pit wall continued until the completion of mining, with total displacements of over 10m and cracking observed up to 90m behind the crest of the eastern pit wall as shown in Photos 4 and 5.

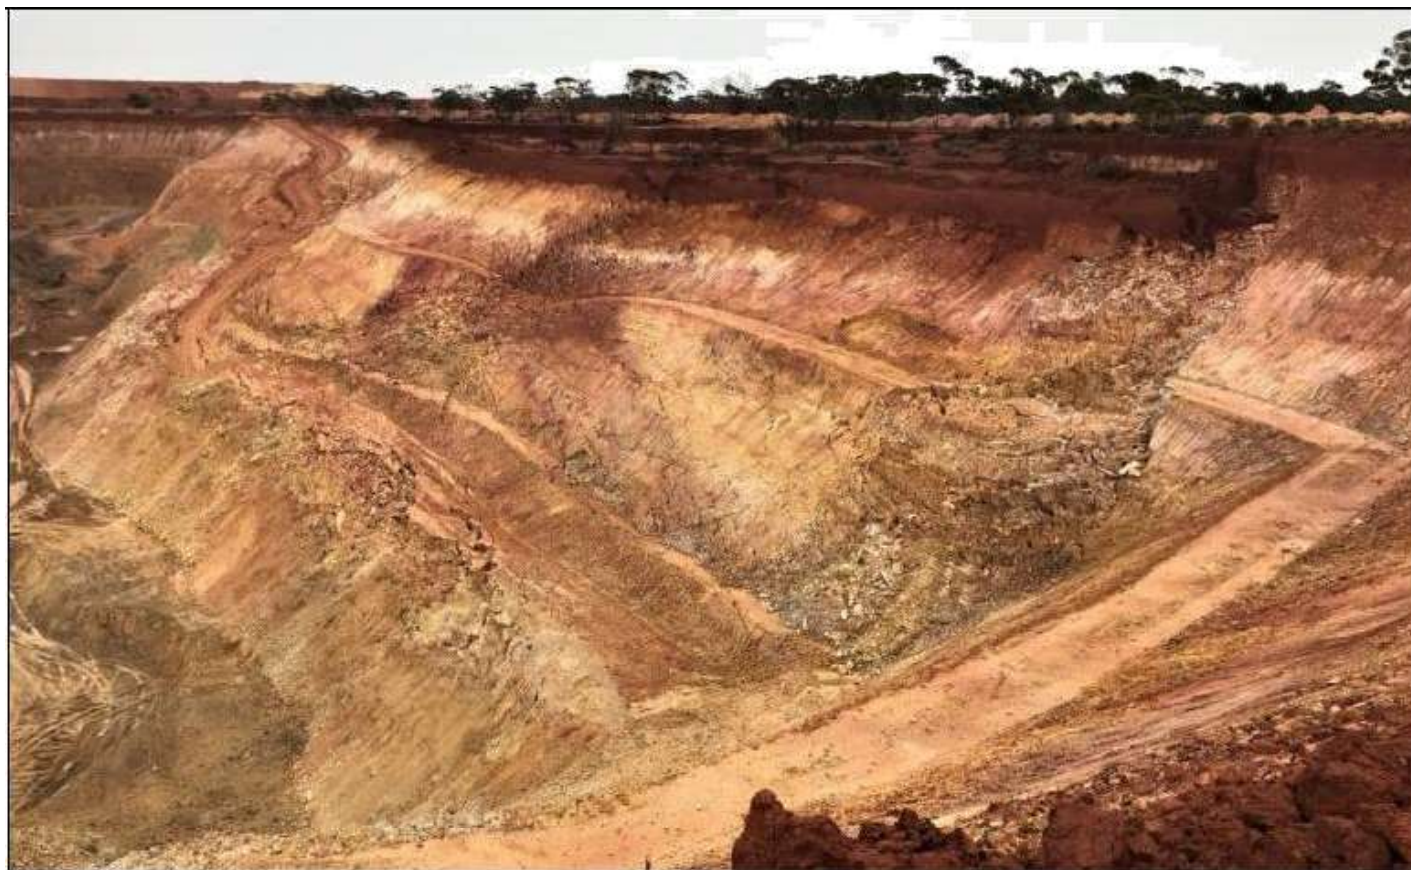
Photo 5. Eastern pit wall instability at the completion of mining. Table 2. Slope Angle Progression
