# Managing the risk between historic underground workings and an active open pit using geotextile and SMART markers

S. Nicoll, P. du Plessis & F. Pothitos  
*Newcrest Mining Limited, Melbourne, Australia*

**ABSTRACT:** Historic underground workings can be a source of unexpected collapse or subsidence of ground when being mined via open pit methods presenting a safety risk to personnel and an economic risk to achieving planned reserves or disruption to the mine plan. Processes for managing these risks in active open pit operations have been developed in many mine sites around the world, however an engineering and monitoring solution for bridging underground workings below permanent haulage ramps in open pit operations has not been well established.

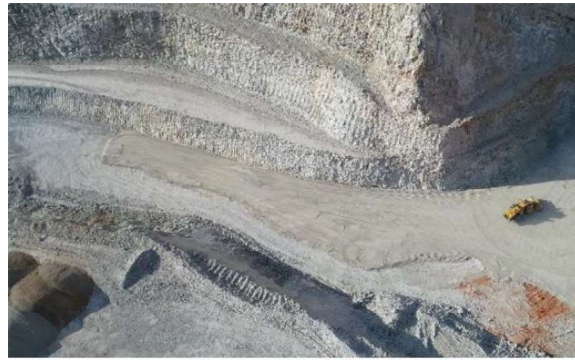
Figure 3. Aerial of the first layer of fill material being placed. Example of the aeolian sand backfill can be seen in the bottom right.

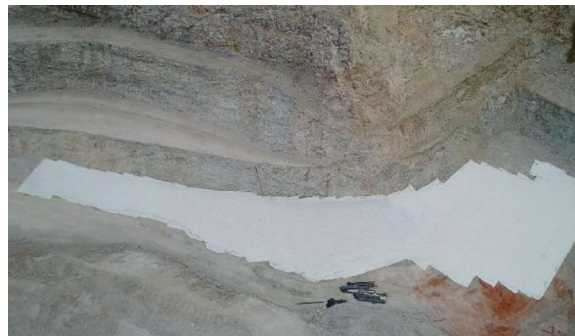
Figure 5. First layer of geofabric completed.
