# The performance of modular block walls reinforced with geogrid subject strong ground motions during the 2016 Kaikoura earthquake

**ABSTRACT:** The existing Dashwood Bridge on State Highway 1 over the railway line was a pinch point and quite dangerous with the high number of trucks using it. The bridge was built in 1932 in a continuous 4 span concrete beam, and no longer met the NZTA seismic standards. It was decided, due to the strategic route strategy risk, that a new structure was required with improved alignment across the railway. One of the main design considerations was the seismic load case (acceleration specified was 0.6g), because the structure is located only 12km from a large earthquake of  $M_w = 6.5$  which occurred on 21st August 2013 (17km depth, and 20km east of Seddon). The 70-week project was started in January 2014 and the Keystone TW3 walls were started at the end of June 2014 taking approximately 1 month to complete the two walls, one at each end of the culvert. The 2016 Kaikoura earthquake occurred at two minutes after midnight on 14th November 2016 in the north eastern part of the South Island of New Zealand, with magnitude  $M_w = 7.8$ . This resulted in

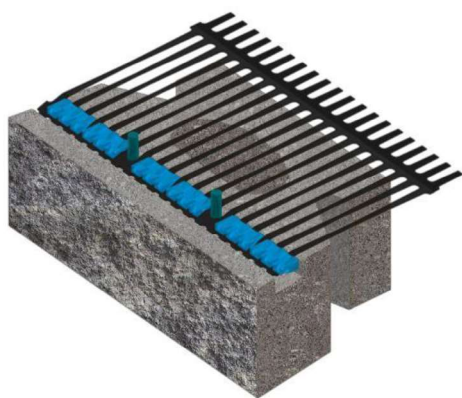
The Keystone TW3 Wall System comprises dry laid modular concrete blocks connected to Tensar uniaxial geogrids using a mechanical connector; the strength of the connection was an important consideration for design of this structure being located in a seismically active region, as mentioned above.

Figure 2. Keystone TW3 modular block retaining wall system

The wall sections were required to provide support for the slope sides at either end of the 54m long CSP Steel Culvert. The design incorporated a Keystone TW3 modular block face and used Tensar RE500 uniaxial geogrids for soil reinforcement.

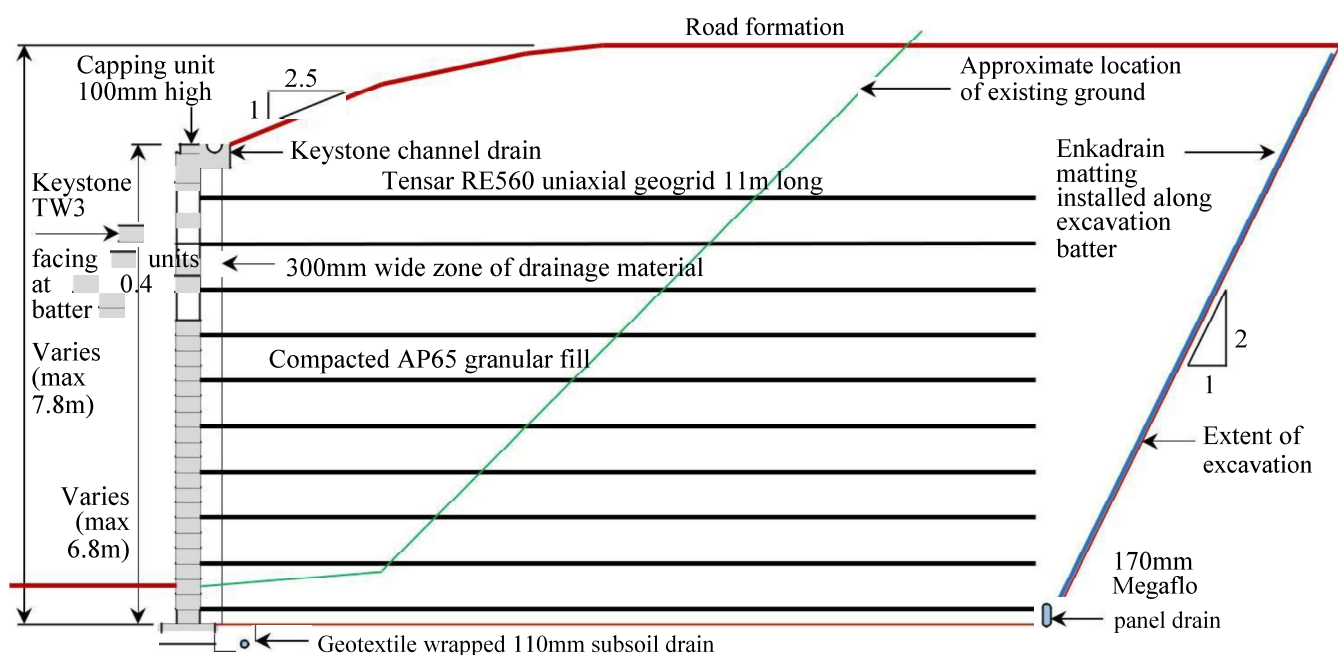
The final layout had a geogrid spacing of 0.6m (every 3rd block) and a reinforcement length of up to 11m to satisfy the stability requirements, see Figure 4.

Figure 4. Keystone TW3 Eastern Wall (based on Opus Drawing 3/35/36/7544/R1)

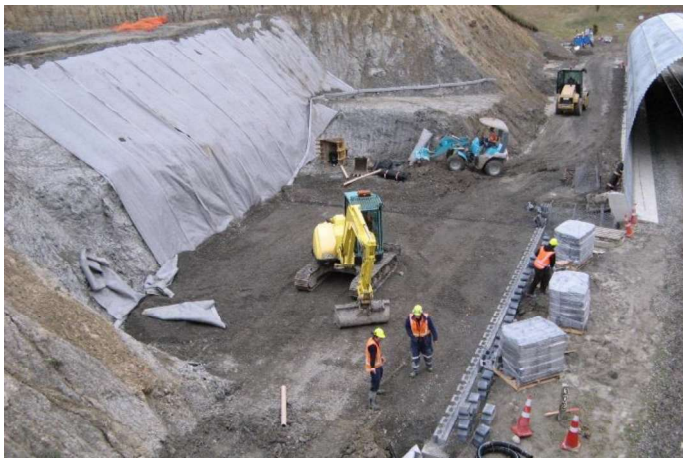
The overall project duration was 70 weeks starting in January 2014 and the Keystone TW3 walls were started at the end of June 2014 and took approximately 1 month to complete, see Figures 5 and 6.

Figure 5. Keystone TW3 east wall at Dashwood at early stage

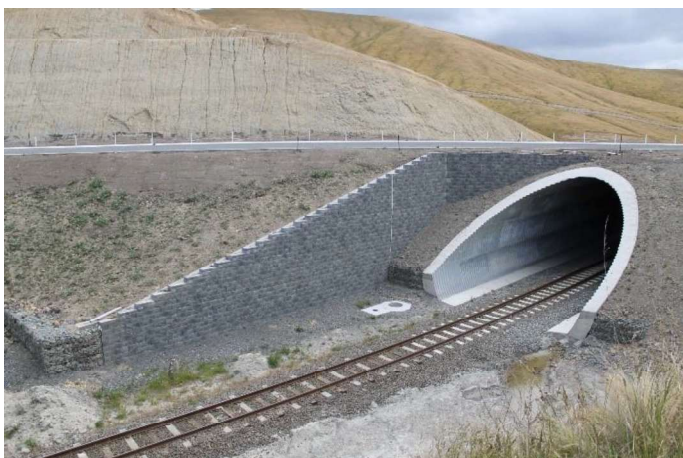
Figure 6. Keystone TW3 west wall at Dashwood completed

The image below in Figure 11 shows a similar view after the earthquake as the “before” photo in Figure 6.

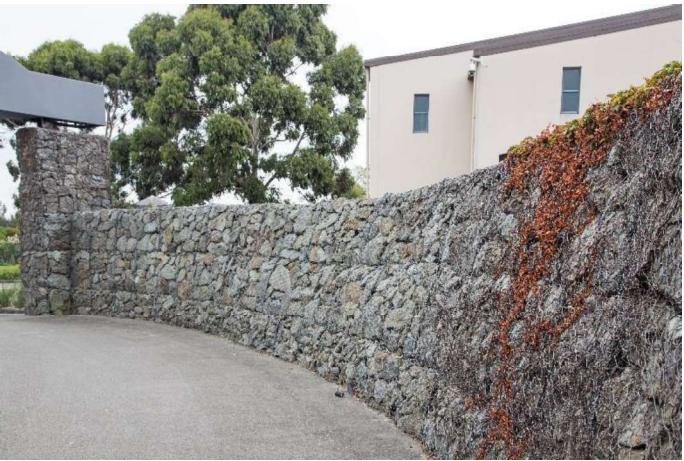
Figure 10. Gabion wall at winery south of Blenheim

A free-standing architectural gabion wall at a winery located 7km south of Blenheim Marlborough Girls College underwent permanent deformation from the earthquake, as shown in Figure 10.

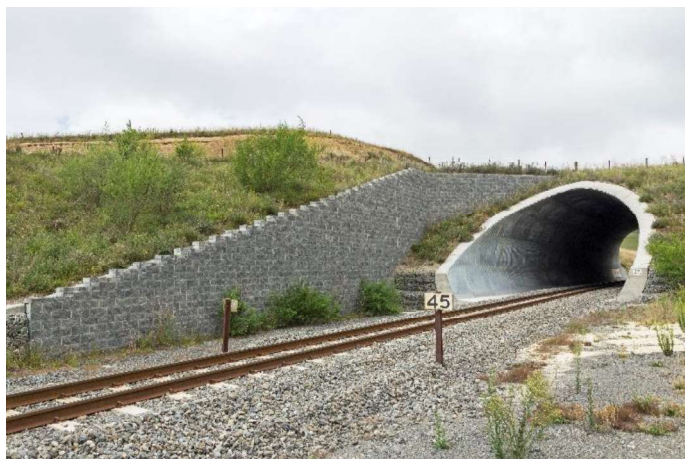
Figure 11. Keystone TW3 western wall in early 2018

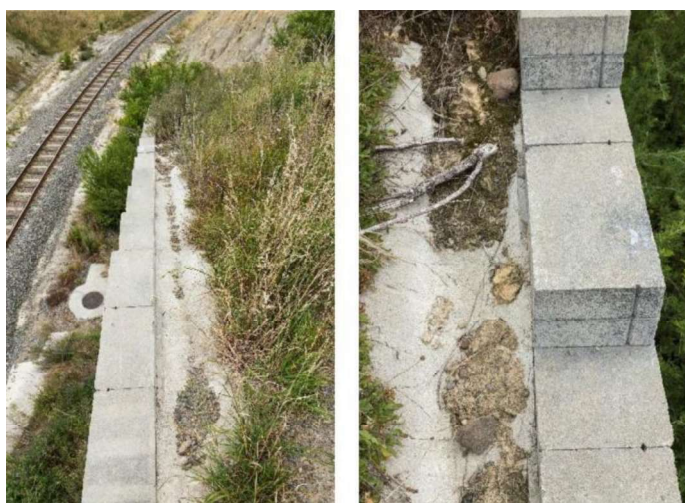
Figure 12. Views of swale drains

The inspection of the walls showed no sign of movement both vertically outwards and in horizontal alignment. The clearest evidence is shown by the images

in Figure 12 of the swale drains. There is no separation of the swale drain from the top of the wall and no observed cracks in the fill above the wall.
