# Challenges in geotechnical design for infrastructure projects

A. Clark & M. Dews  
*Aurecon, Brisbane, Australia*

**ABSTRACT:** Modern infrastructure projects present a number of key challenges for the geotechnical engineering professional. Major influences in terms of uncertainty and risk, commercial drivers and sustainability are explored in the context of two case studies in South East Queensland: a large scale linear highway development and the remediation of a small but critical crib wall.

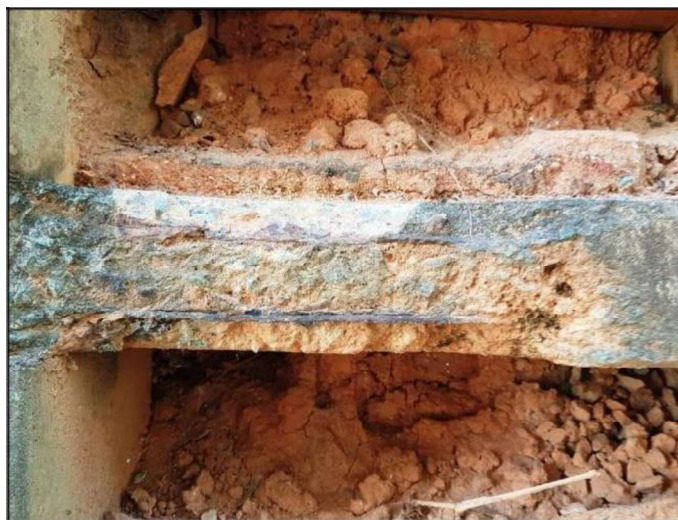
- Decay of the concrete crib wall units due to carbonation induced reinforcement corrosion and concrete spalling of precast elements.

Figure 2 demonstrates the corrosion induced spalling of the concrete crib wall units. This was a frequent occurrence.

Figure 2. Corrosion induced spalling of concrete crib wall units.

The characteristics observed during the condition assessment can be linked to similar traits as those identified in the collapse of a retaining wall at Harris Park Train Station, Sydney (Transport Sydney Trains, 2013), which was initiated by a rotational slump in a very wet compacted sand backfill. The Harris Park Station wall failed rapidly due to a complex combination of root causes. Similar defective traits between the two crib walls included:
