# Excavation directly beneath a heritage building with tight settlement limits, Sydney CBD

M.L. Teoh & J.C.W. Toh

**ABSTRACT:** The Wynyard Walk project was an extremely challenging design and construction project located in Sydney's Central Business District. Part of the project required excavation underneath a 12 storey heritage listed building with very little tolerance to movement, in order to deepen its existing basement by two levels. The excavation involved undermining of the building's existing shallow footings. The tight settlement criteria and geometric constraints of the site necessitated complete integration between structural and geotechnical design disciplines and the construction team, throughout the design and construction.

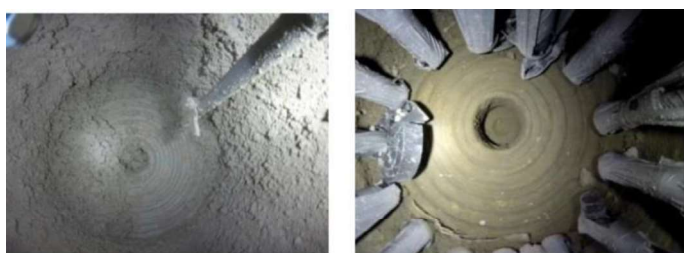
Figure 7: Photographs of pile base before and after being cleaned.

The excavation and drilling of the piles were undertaken using small excavators and a low head height piling drill rig due to tight site access and low head room in the basement. Each underpinning pile was cleaned to ensure that the base and side walls were free of spoil after they were drilled. This was important to the design to meet the tight project settlement criteria. A brush was attached to the end of the auger to clean the side walls. The spoil at the base of the piles was removed using a cleaning bucket as well as being vacuumed to ensure that as much spoil as practical was removed. Inspection was undertaken of every pile base and side wall using a high-resolution custom built downhole camera to verify the cleanliness of the base and the side wall of the pile. The cleanliness of the pile base was crucial as the flat jacks had travel limits. Spoil at the base might have required additional flat jacks travel which may have impacted the settlement control. Figure 7 shows photographs of the pile base before and after the base was cleaned.

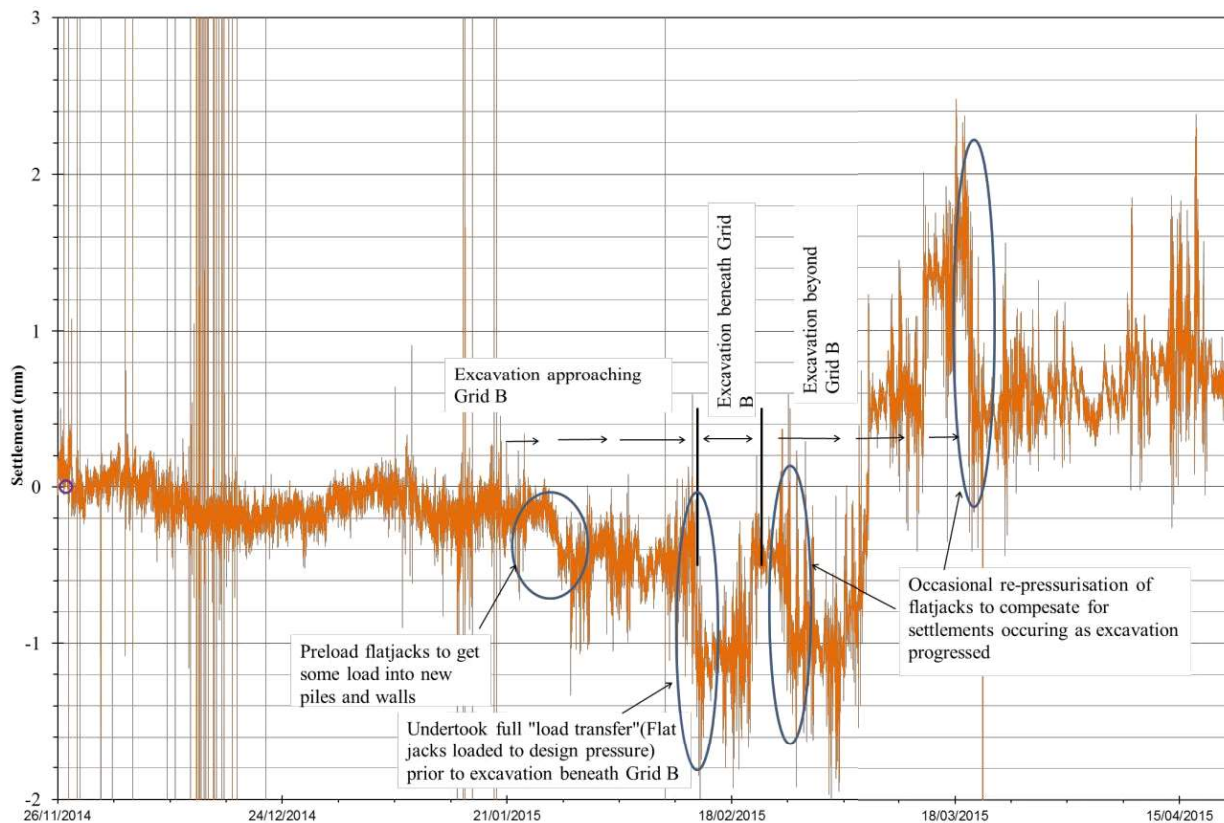
Figure 8: Settlement of the transfer wall at Grid B against time

Monitoring of the underpinning piles was undertaken in real time during excavation beneath Railway House. The adopted real time automated settlement monitoring was a high precision system with accuracy better than 0.5mm. Flat jack pressure was continually adjusted to compensate for new pile settlements as load came on during excavation. Figure 8 presents an example of the real-time settlement monitoring at one of the Railway Houses

(Grid B) during excavation. The real time settlement monitoring results were assessed in conjunction with the construction activities to allow the construction to respond to any movement that was observed. The settlement of the piles was controlled by adjusting the flat jack pressures as advised by the structural engineers.

The settlement data collected during construction essentially mimicked a series of full-scale pile load tests. The performance of the temporary and permanent piles and pad footings are summarised in Table 1.

The “worst case” design expectation was that the pile settlements could be up to 1% of diameter at a bearing pressure of 3.5MPa and 3% at a bearing pressure of 10MPa based on Pells et. al. values for Class III Sandstone. The range of measured settlement was more comparable with expectations for Class I/II Sandstone based on Pells et. al. (1998), i.e. settlements up to 1% of diameter for bearing pressures up to 10MPa.
