Reclamation of Pond F using the “sand raining technique” – A case history

B.I. Thomas & B. Aery
Aurecon Australasia

ABSTRACT: The increasing demand for hardstand area at East Arm Port in Darwin necessitated the reclamation of Pond F, a large tidal pond located to the rear of the berths. Reclamation was accomplished using a combination of innovative filling, ground improvement and traditional earthworks techniques. Sand was placed on saturated, compressible muds by the “sand raining technique” using a small cutter suction dredge to prevent mud waving and ASS generation. This was followed by accelerated consolidation using prefabricated vertical drains; a first for Darwin. Subsequent earthworks including an 18-month surcharge period ensured satisfactory delivery of the reclaimed pond to meet the projects time and cost objectives. Following removal of the sur-charge, the reclaimed area was developed into a block-paved refrigerated container or reefer terminal; its current and end use. This paper presents the innovative methodology adopted to overcome the geotechnical issues within the pond.

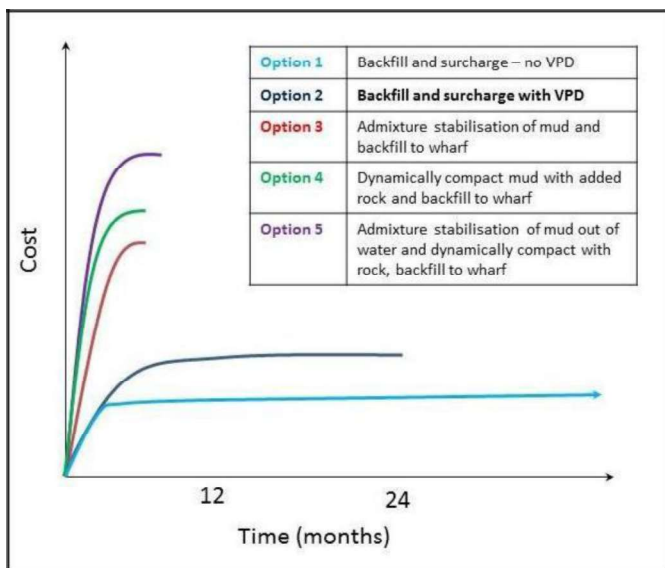
Figure 2. Schematic comparison of time versus cost for various options.

Figure 2 provides a schematic comparison of time versus cost for the five options. Whilst Option 1 is clearly the most cost effective compared to the other options, significant budget and program risks related to uncontrolled and geographically variable consolidation during and post surcharge make this option less than attractive, especially as program clarity was a requirement at the start of the project.

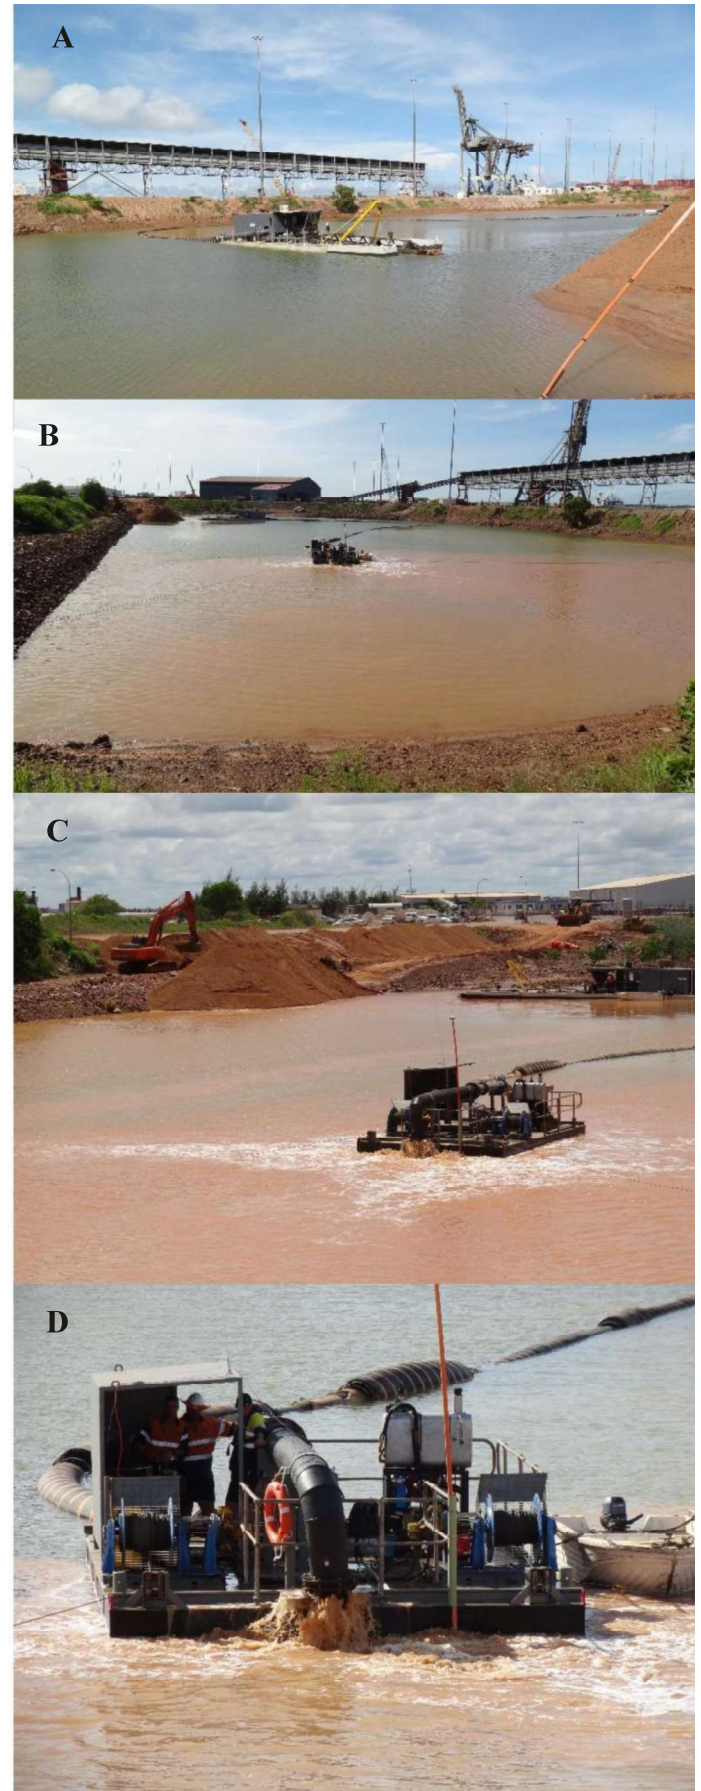
Figure 4 (A) Cutter suction dredge within the pond pumping sand to (B) a pontoon depositing material over soft soils. (C) Quarried sand was transported to site and carefully placed into the pond for dredging and transportation. (D) A closer view of the pontoon showing the diffuser spreading sand upon the soft muds

Firstly, to avoid mud-waving and / or exposure of the potential ASS muds to an oxidising environment, sand was evenly spread over the mud by means of a small cutter suction dredge (see Figure 4) placed within the pond itself. This novel and innovative “raining technique” served to cover and encapsulate the mud. Following removal of the dredge machine from the pond, sand could then be pushed into the pond and onto the sand to just above water level without disturbance to the material beneath. Finally, sand was placed using traditional earthworks techniques and built up to RL +2 m.

As the water within Pond F is tidal (typically 0.5 m above the levels of the surrounding harbour), the introduction of permeable sand simply displaces the water. Figure 4 shows the process of sand placing from a floating pontoon fed from a small cutter suction dredge.

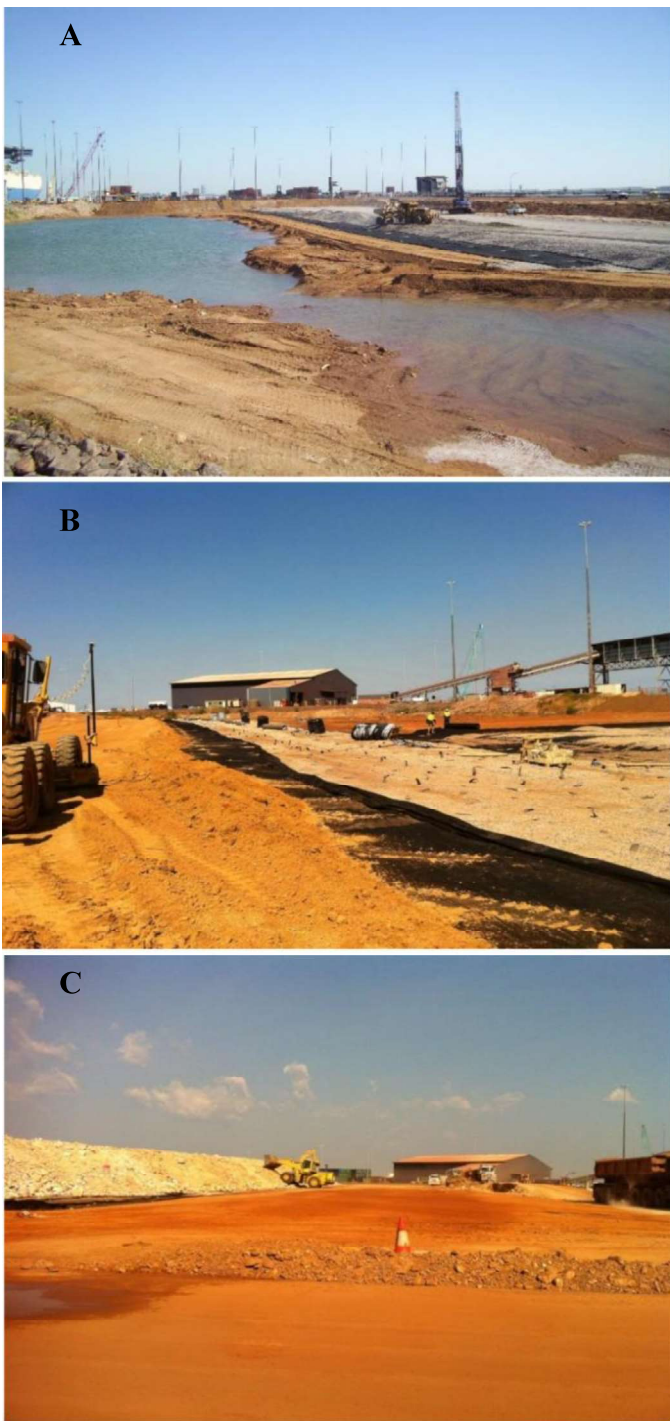
Figure 5: PVD Installation (A), ongoing earthworks (B) and placement of surcharge (C)

The coarse aggregate layer served not only as a drainage layer for the soon to be installed VPD's but also provided a robust trafficking layer for the PVD installation rig and other earthmoving equipment on the surface of the reclamation. Figure 5A shows the Stage 2 installation. Prefabricated vertical drains were installed by specialist subcontractors to depths of between 12.5 to 16 m below the level of surface of the drainage layer (RL +2.5m) in a 1.4 m triangular pattern. The PVD's were 100 mm wide, 3.4 mm thick

A second layer of separating geofabric was then placed on the drainage layer and earth filling commenced (Figure 5B). This was undertaken in the usual way with material trucked-in, placed and compacted in accordance with the earthworks specification for the project. Filling continued until a level of approximately RL +5.25 m was achieved (Figure 6).

During earth filling approximately 0.5 m of further settlement was recorded. A 4 m high rock surcharge was placed in two stages, with approximately two thirds placed before December 2012 and the final third in April 2013 (Figure 5C). The surcharge provided sufficient load to consolidate and improve the in situ compressible material to meet the end criteria at hand over time.

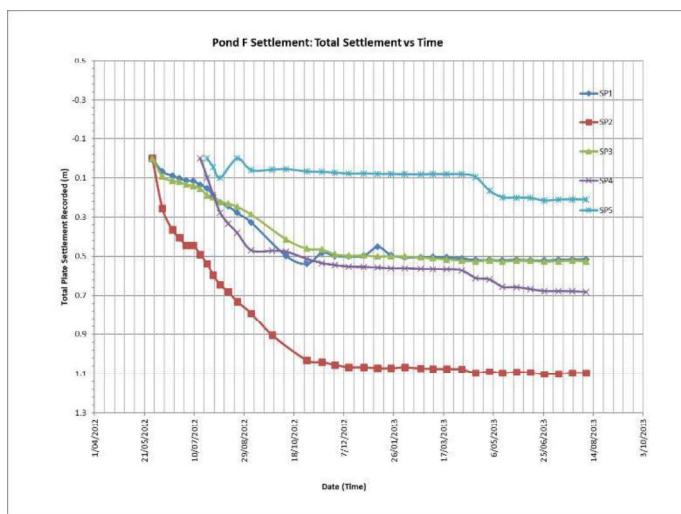
Figure 7. Settlement of fill with time

Figure 7 summarises the settlement readings taken between installation and April 2013. The plates positioned on the drainage layer have settled around

0.5 m, whereas SP2 which was positioned on the sand prior to the insertion of VPD's has settled over 1.0 m.

Settlement graphs in Figure 7 show that primary consolidation had practically ceased by April 2013. Based on Asaoka method (Asaoka 1978) the surcharge was removed during December 2013, much earlier than anticipated.
