Rock slope stability assessment at iron ore handling plant site in Western Australia

Srijib Chakrabarti

Coffey Geotechnics Pty Ltd, Perth, Australia

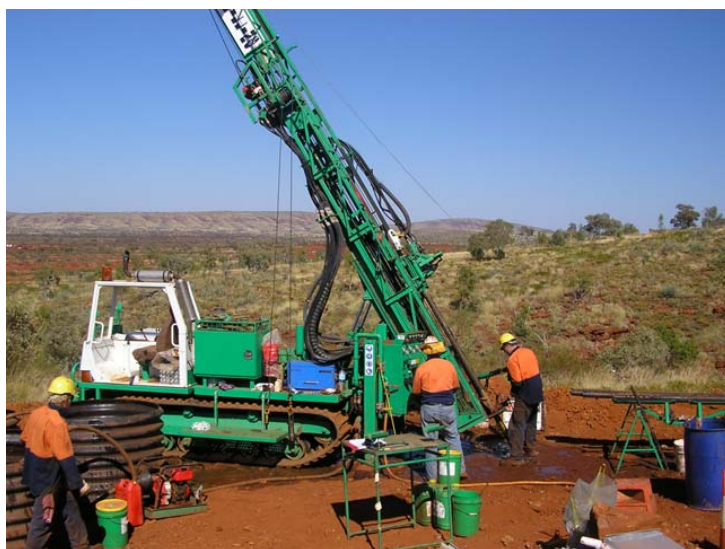
Figure 1 Primary crusher plant location

The layout of the final crusher plant site is illustrated in Figure 1. Also shown in Figure 1 is a photograph of the site taken during the drilling of three inclined boreholes BH13, BH14 and BH15 up to 25m depth. The site layout suggests that the depth of excavation within the crusher plant area would be up to 13m, and located between BH14 and BH15.

- BH13 ● Approximate Locations of Cored Boreholes
 A Proposed Cut Faces (A to D)

The primary objective of the slope assessment was to derive the maximum batter slope angle where mechanical slope support would not be required for permanent stability. Figure 1 shows the four slope locations analysed, which are referred to in this paper as Slopes A, B, C and D.

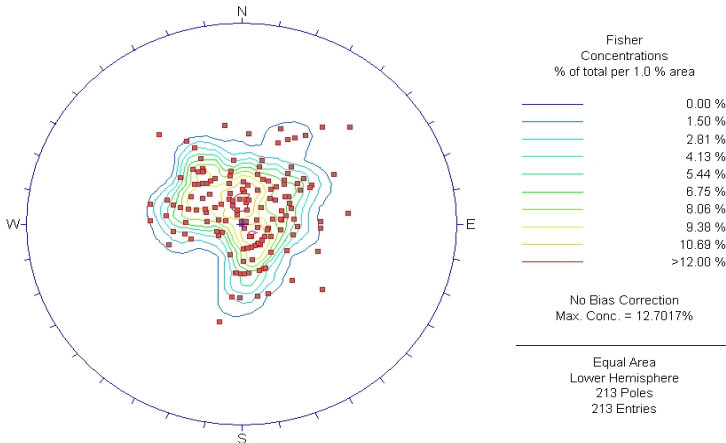
Figure 2 Contour of orientations of discontinuities

A stereographic pole plot of all rock joints and partings, measured in Boreholes BH14 and BH15 drilled at the crusher site together with those from Boreholes BH1 and BH2 drilled at the original crusher site, is illustrated in Figure 2 using DIPS software version 5.1. Three slope batters of 1V:1.2H, 1V:1.5H and 1V:2H were considered in the analysis of rock slopes.

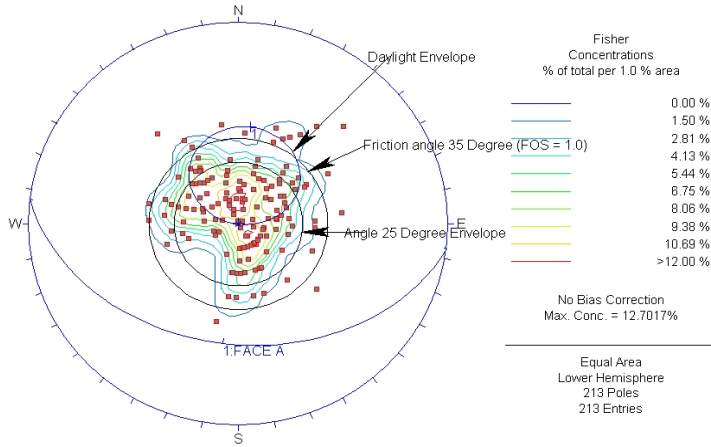
Figure 3 Cut face A (1V:1.2H): plane failure analysis

Based on the results of kinematic analyses, rock excavation with a slope batter of 1V:1.2H for slopes A to D will have a low to moderate likelihood of plane failure and a low likelihood of wedge failure occurring. Typical stereographic representations of these analyses for slope A are presented in Figure 3. The estimated FOS values for the measured discontinuities at Slopes A to D are presented in Table 2.

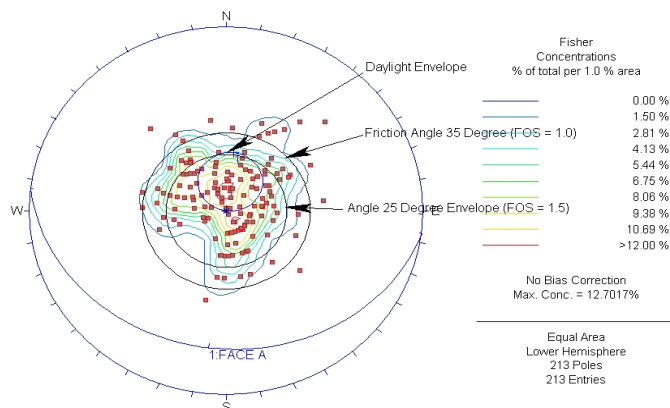
Figure 4 Cut face A (1V:2.0H): plane failure analysis

Typical stereographic representations of the kinematic analysis for Slopes A at a slope batter of 1V:2H is presented in Figure 4. The results of the kinematic analysis for Slopes A to D, based on

measured discontinuities from Boreholes BH1, BH2, BH14 and BH15, gave FOS greater than 1.5. The kinematic analyses further suggest that the likelihood of plane failure, toppling failure and wedge failure to occur in Slopes A to D is negligible.
