Emergency and final works for anchored residential retaining wall, Lyttelton, New Zealand

Cid Chenery
Golder Associates (NZ) Ltd, Christchurch, New Zealand

This paper describes initial design efforts; the emergency works put into place, wall design through construction to completion. It includes the design and construction issues for an anchored retaining wall using steel soldier piles and sleepers to achieve a rustic effect. Careful liaison with the Council and neighbouring property owners was required and the design and construction was integrated with the adjacent slopes to complete the works.

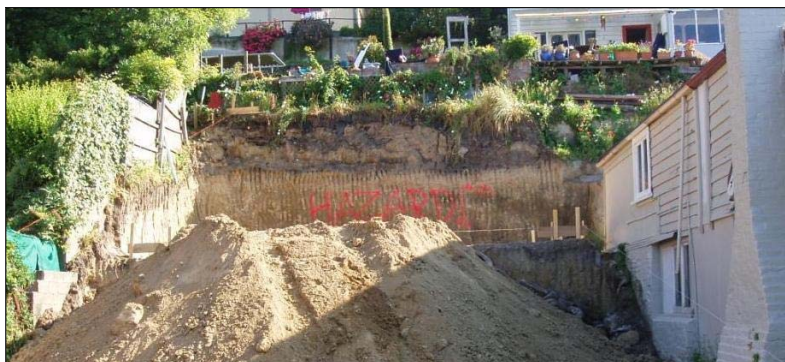
Figure 2: Excavation as at the end of December 2004

Our initial inspection in December 2004 revealed that site preparation had largely been completed, resulting in a 4 - 5m high unsupported excavation at the rear of the site (Figure 2). The unsupported cut was formed partly of in-situ loess, a buried top soil horizon and about 1.5 - 2 m of non-engineered fill which formed the surface layer. The consented design included a timber pole retaining wall to about mid slope height, and to batter the slope back above this level to its full height.

The steeply sloping nature of the slope above the excavated bank combined with the presence of non-engineered fill and buried top soil indicated that there was a significant potential for instability to occur particularly in the event of adverse rainfall conditions during construction. Any failure could also impact on the two adjoining properties immediately above this area.

We undertook initial investigative works and indicated to the client that we considered that the original timber pole retention system was not appropriate. A more substantial support system such as an anchored retaining wall, or a soil nail wall with shotcrete facing was recommended. The client considered the cost implications for these wall types, gained an attractive cost for a crib wall design and subsequently ended of involvement in the project in January 2005.

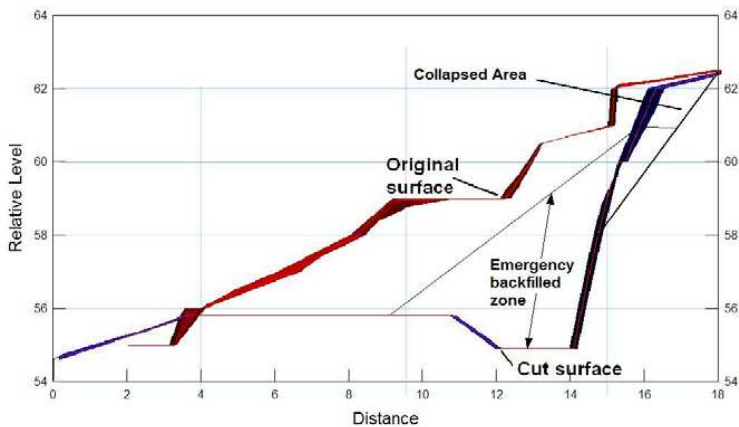
Figure 3: Comparison between original and unstable cut surface

The subsequent inspection revealed that the excavation for the 5m crib wall now had a sub-vertical face height of 7.5m (Figure 3). A collapse had occurred in the non-engineered material and this had extended to below the small deck of the residence immediately uphill. Council placed a stop notice on the works and we were directed to undertake remedial and final design works for the project.

It was decided to immediately place backfill against the slope to stabilise the area.

An underdrain consisting of a perforated pipe, 110 mm diameter pipe surrounded by free draining (20 - 40 mm) gravel, all wrapped within a geotextile fabric was placed prior to backfilling. This drain had to be directed toward the road via an excavated channel through the building platform to prevent ponding of waters at the base of the fill. A weathered volcanic rock was sourced from a local quarry as suitable backfill material.

Plastic sheeting was placed over the exposed slope to reduce erosion, water infiltration and subsequent further instability. A downpipe from the affected residence was also temporarily directed away from the site.

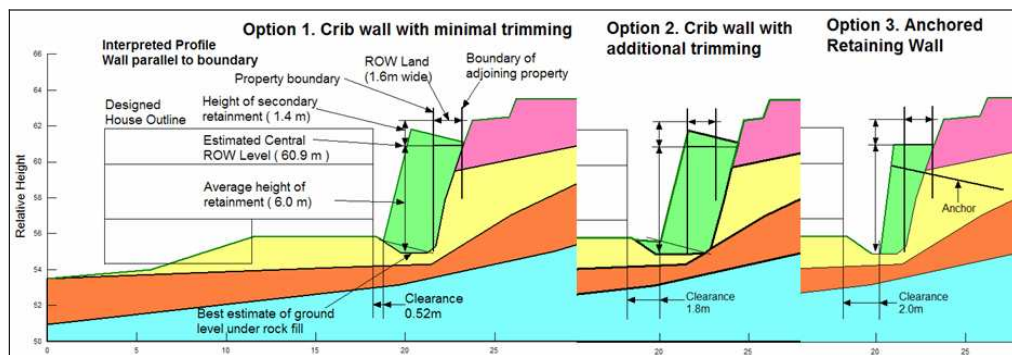
Figure 4: Three design options considered

The client wanted to persist with the wooden crib wall design. This wall was initially to be 5m high with small return wings. A two tier system to incorporate the ROW and support the 7.5m in height, with much larger return walls was now proposed. Three options were considered; two consisting of the crib wall design and one with an anchored wall design (Figure 4). The first option considered minimal further excavation (after clearing of emergency backfill), the second required further excavation (up to 100m³) and the anchored wall required less excavation than the first option. The first option gave about 0.5m clearance to the consented residence design, the second about 1.8m and the third up to 2m. We also considered that soldier pile installation would give some immediate mitigation affect against possible gross instability. The client opted for the anchored wall design.

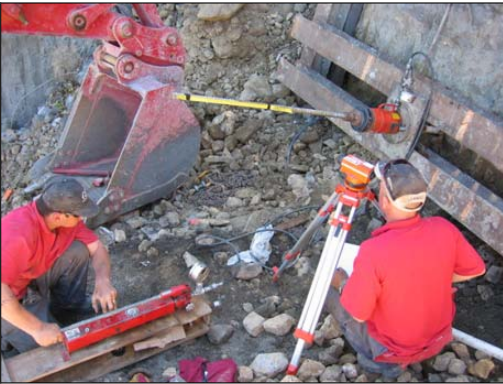
Figure 6: Testing Anchors

Designed anchors were galvanised 32mm diameter bar centralised and grouted within a 100mm diameter hole with a design working load of 192kN. Bar design included minimum 6m bond and 4m unbonded lengths with an assumed allowable adhesion of 10kPa; however the onus for the anchors' capacity was placed on the clients' subcontractor. The unbonded lengths averaged at 5m and were lined by PVC tubing with Denso tape to seal the ends prior to grouting the annulus (Figure 7). Each anchor was proof load tested to 133% working load and locked off at 50% working load (Figure 6).

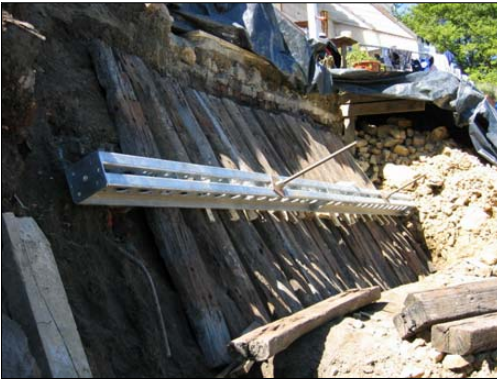
Figure 8: Temporary stability works

The design included both construction and inspection procedures, liaison with Council and numerous inspections of the affected upslope residence. Construction had to be staged such that the stability of the exposed slopes was not compromised as excavation of the emergency backfill was undertaken and the construction progressed. Temporary measures were undertaken to ensure that the area directly below the residence atop the excavation was not further affected by construction activities (Figure 8).

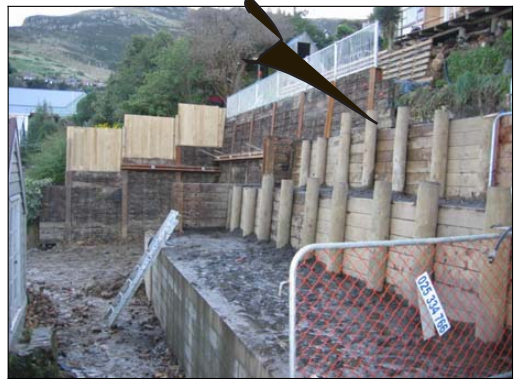
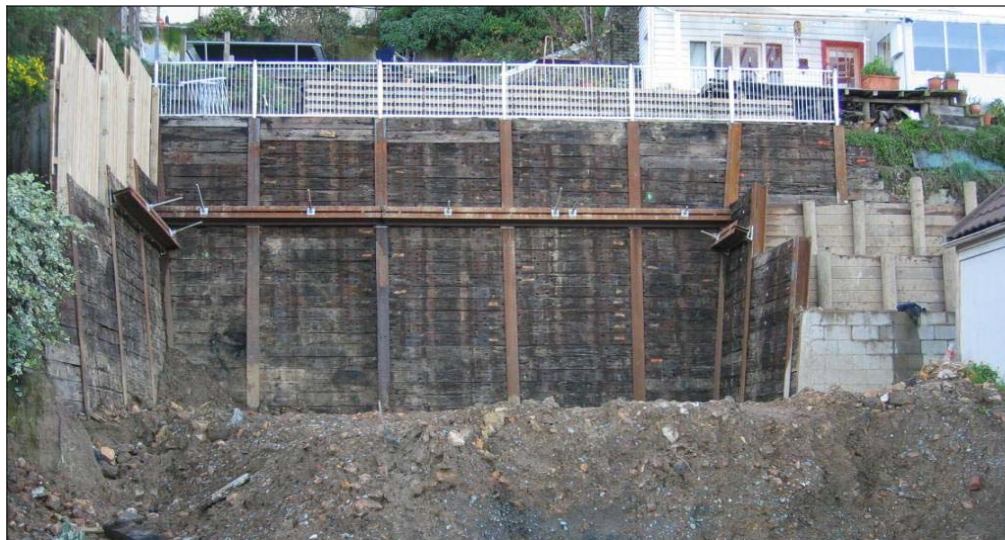
Figure 9: Completed wall from side

Figure 10: Completed works

Completion of the works incorporated the design, Council approval and construction of the neighbouring retaining walls into this wall (Figures 9 & 10). All Certification as required by Council were subsequently issued.
