# Geological analysis of a fault controlled landslide in brittle Carboniferous ignimbrites

Stephen Fityus

John Gibson

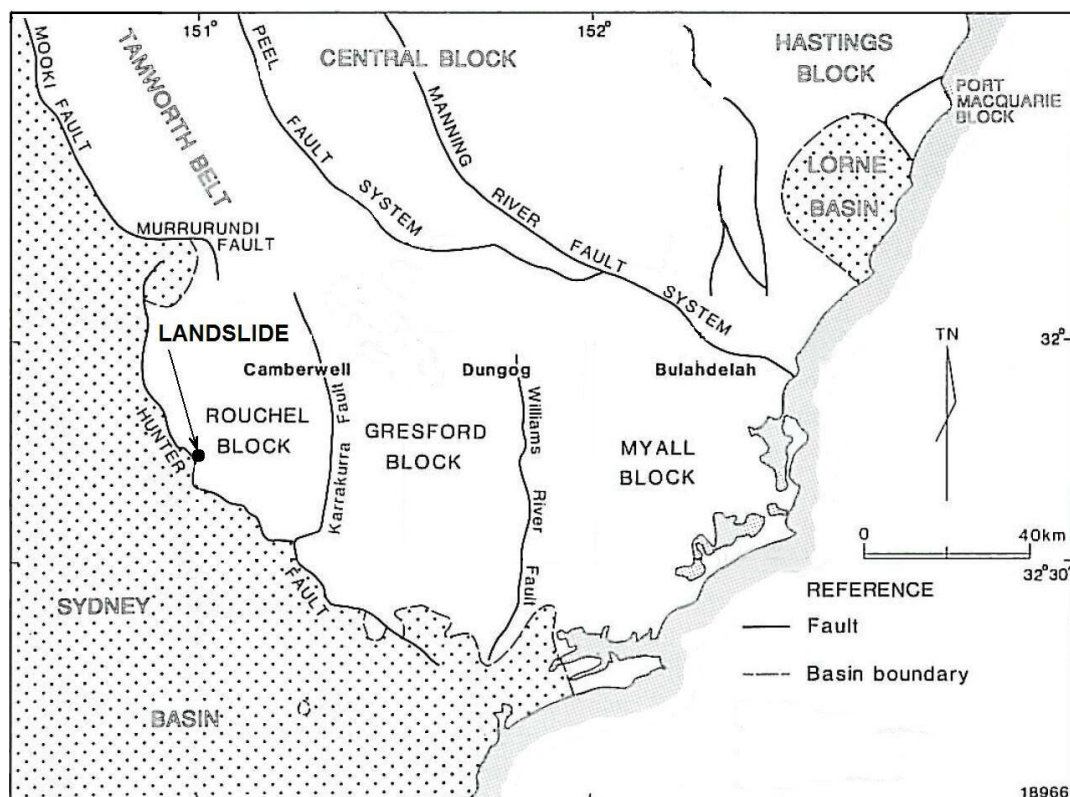
Figure 1: Geological setting of the Southern New England Fold Belt, showing major structural subdivisions and the location of the landslide studied here. (adapted from Roberts et al. 1990)

The landslide studied in this paper occurred in rocks of the Tamworth Trough (Collins 1991) or Tamworth Belt (Roberts et al. 1990) of the Southern New England Fold Belt (SNEFB) within the Hunter Valley. The extent of the Tamworth Belt is shown in Figure 1. Although this region has been subject to only sparse development to date it is hosting increasing numbers of developments, both large and small, as the region prospers. Projects such as the recently completed Karuah Bypass (Fityus et al 2005) and the proposed Bulahdelah Bypass and Tillegra Dam illustrate the increasing importance of a better understanding of the geological characteristics of the northern Hunter Valley.

Three major regions (referred to as blocks in Figure 1 from Roberts et al (1990), and as super-blocks in the present discussion) are recognised within the SNEFB. They are separated by two dominant north-south trending fault structures, the Williams River Fault to the east and the Kurraakarra fault to the west. These are the Myall super-block east of the Williams River fault; the Gresford super-block between the Williams River and Kurraakarra faults; and the Rouchel super-block west of the Kurraakarra fault.

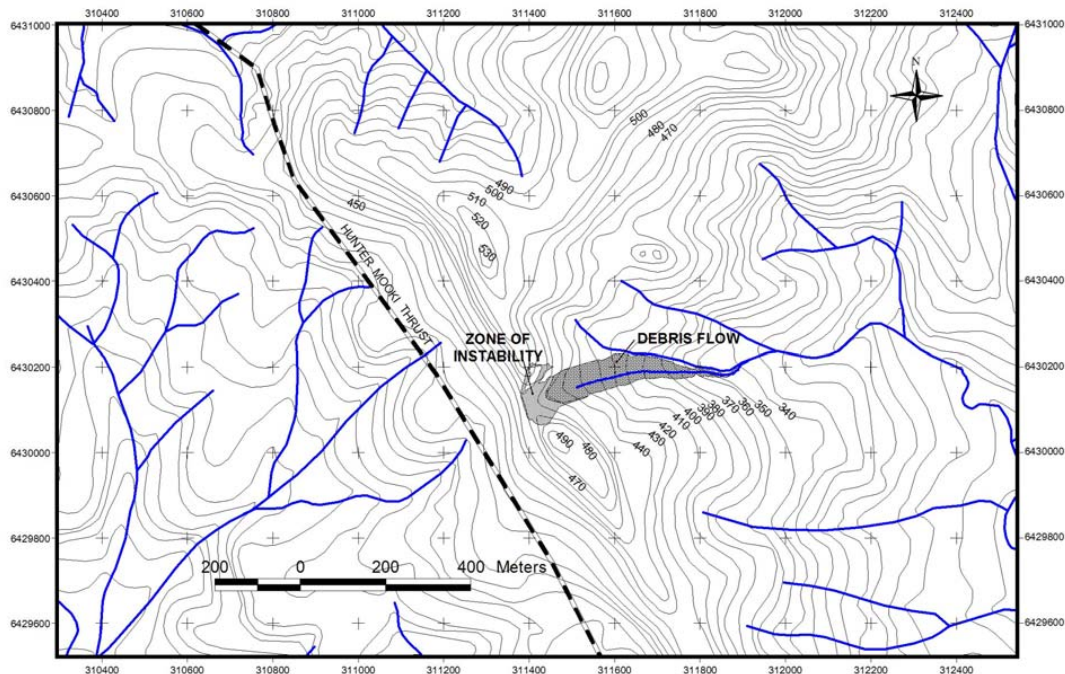
Figure 2: Map of the Muswellbrook rockslide

A map of the Muswellbrook slide and the surrounding features is presented in Figure 2. A description and discussion of its important characteristics follows.

As noted above, the slide is situated at the southern margin of the Rouchel super-block just east of its boundary with the Sydney Basin. According to the available geological models (GSNSW, 2003), the Hunter Mooki thrust lies 150m to the southwest of the slide as indicated in Figure 2. The geology in the wider area of the slide is mapped as the Native Dog Member of the Isismurra Formation. This unit is generally described as a massive, cliff forming, buff lithoidal dacitic ignimbrite overlain by purple, red and green lithoidal ignimbrites and tuffs with interbedded lithic sandstone and conglomerate (GSNSW, 2003). In the locality of the slide the lithology exclusively comprises a massive red-brown dacitic ignimbrite with a thickness in excess of 40m and no discernable bedding. It is heavily jointed with at least 4 principal joint sets as shown in Figure 3. Most of these cover a broad range of directions: some of these could readily be further resolved into 2 or 3 adjacent, overlapping sets. At least seven significant sets have been identified.

As is evident from Figure 2, there is a strong demarcation between topographic styles across the Hunter Mooki thrust, with the Whittingham Coal measures of the Sydney Basin (southwest) expressing a much milder topographic relief than the Native Dog Member of the SNEFB (northeast). The slide has developed on the north eastern side of a prominent, steep ridge of the Native Dog Member. Cliffs are weakly developed on the southwestern side of the ridge, which is considerably steeper (around 35°) than the northeastern side (around 25°).

The Muswellbrook rockslide, as shown in Figures 2 and 4, can be classified in accordance with Crudden and Varnes (1996) as a rock-topple/rock-slide with an associated debris flow. It involved the easterly collapse of a substantial volume of rock from the upper part of a steep northwest-southeast trending ridge at a locality some ten kilometres east of the town of Muswellbrook. The instability directly affected an area of around 95 m x 145 m, leading to a flow of rock debris with an estimated volume in excess of 100000 m<sup>3</sup>, that travelled around 425 m down a gully attaining a maximum width of around 75 m.

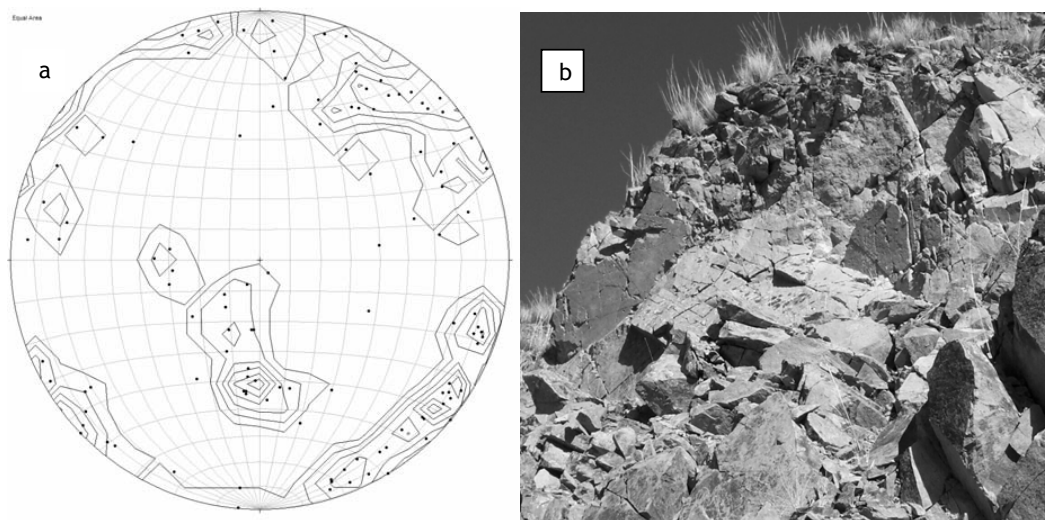
Figure 3 Rockmass Joints. a) poles of 117 measured joints.  
b) several sets of joints expressed in an exposure in the northern slide scarp.

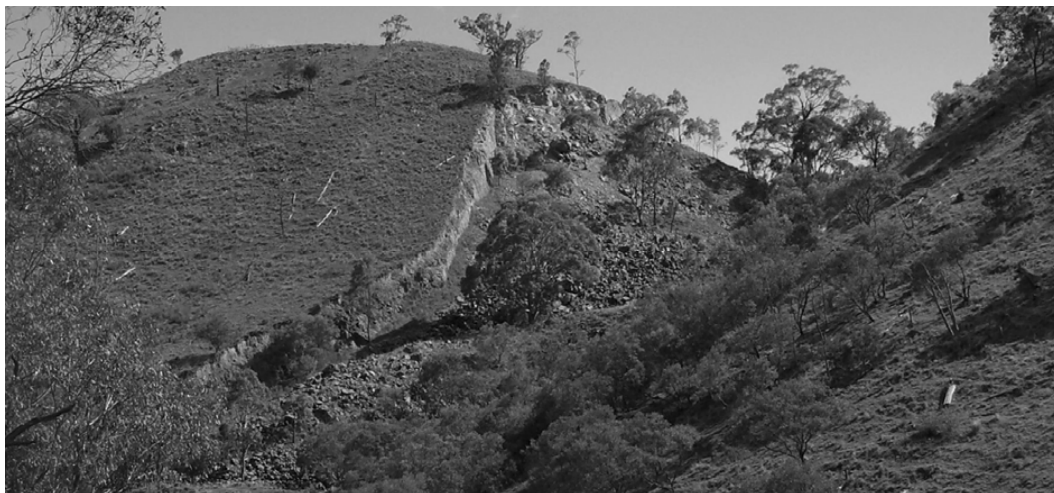
Figure 3: Photograph of the Muswellbrook slide showing rock scarp and upper debris slide.

The key to the instability in this situation was a significant fault that could be identified in the slide scarp on the northern side (the lower part of the two-part lineament on the left side of in Figure 3). The fault is present as a body of breccia several metres wide, made up of large angular ignimbrite cobbles in a matrix of fractured and pulverised rock rubble. The breccia, is well cemented and physically resistant, displaying some cementation by zeolites such as heulandite, stilbite and laumontite, but there is little interstitial clay. The breccia is thus highly porous and permeable with the capacity to serve both as a reservoir for groundwater and a conduit for groundwater to enter the highly fractured rock mass.

The slide produced scarps in relatively fresh rock along either side of the zone of instability, each totalling around 25 m in height. These side-scarps are a compendium of joint faces of different orientations, except for the northern side, which contains two distinct, geologically controlled linear faces, as shown in Figure 4. The rear of the slide within the saddle and above the steeper southwest-facing slope, forms only a low scarp.

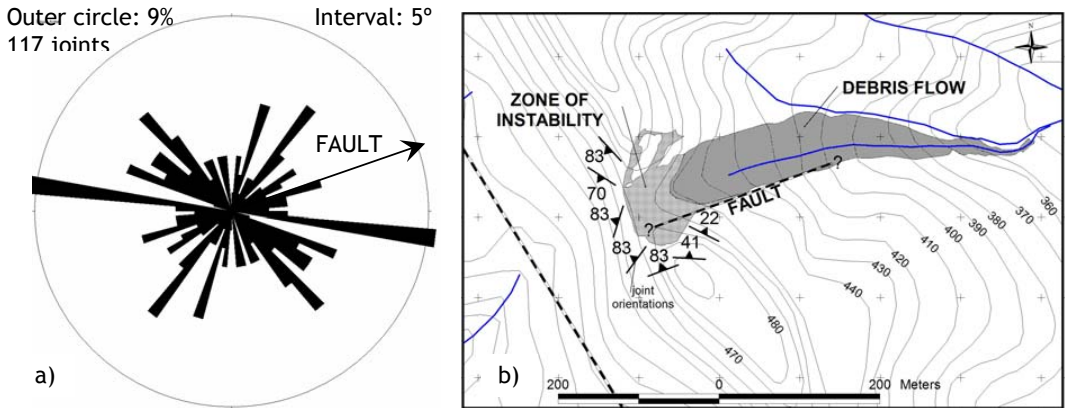
Figure 4: a) rose diagram of joint and fault strike directions;  
b) map of slide showing significant joint sets that combine with the fault to result in instability.
