# Lessons learnt on stability of a piled retaining wall in weak soils

Shaw-Shong Liew

G & P Geotechnics Sdn Bhd, Kuala Lumpur, Malaysia

This paper presents a case study on a distressed piled retaining structure of 7.5m high over soft soils. Due to the underlying weak materials, the retaining structure was designed to be supported by five rows of vertical driven precast concrete square piles. During backfilling of the constructed retaining wall, excessive lateral movement was observed. Investigation was conducted to reveal the probable causes of the wall distress. It was noticed that the normal stability assessment using slide method had over-estimated the safety margin of the piled wall. The vertical effective stresses for computing the sliding resistance at the bottom of the wall were over-estimated without considering the vertical support from the pile. An unrealistic safety factor was produced to justify the design. The lateral resistance of the vertical piles was not adequate to provide the lateral stability of the wall under the actual lateral earth pressure.

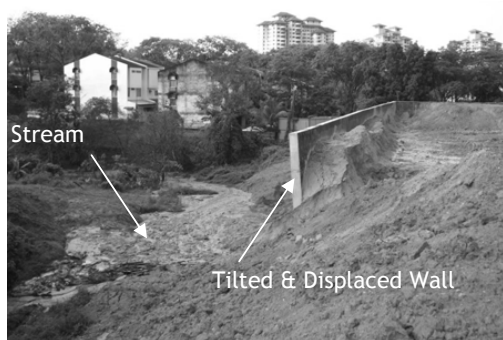
Site inspection was carried out immediately after the wall displacement and tilting were reported. During the site inspection, vertical flexural cracks were observed at the front and back of the displaced wall, particularly over the portion in close proximity to the return of the wall. Three (3) levels of weepholes had been installed in the retaining wall at RL42.5m, RL45.0m and RL47.50m. There was water staining from the weephole drains located at the mid height and bottom rows, revealing that groundwater level behind the retaining wall had previously risen above RL45m. The incident occurred after an intensive prolonged antecedent rainfall event. Figure 1 shows the overall site condition after the distress and the water staining at the weephole drains.

Figure 1: Overall Site Conditions and Water Staining at Weephole Drains

For the geotechnical wall stability assessment, three cases of groundwater levels at RL40.4m, RL42.5m and RL45m were modelled. The observed water staining at the second row of weephole drains suggested the most probable groundwater level was above RL45m at the time of wall distress. The following stability aspects have been performed with the achieved factor of safety (FOS) summarised in Table 1.
