# Launched Soil Nails - Successful Development within the New Zealand Market

A O' Sullivan<sup>1</sup>, G Quickfall<sup>1</sup>, I Kett<sup>1</sup>

## Abstract

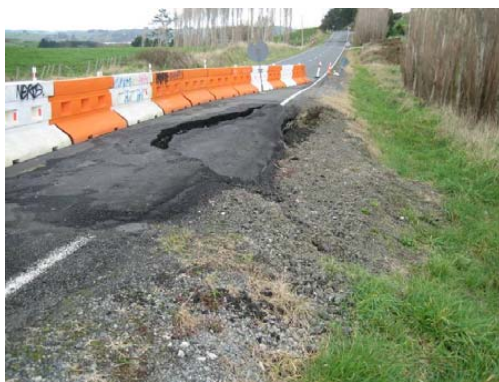
Since it was first constructed in the 1960s, a large number of sections along Wharehine Road have been subject to ongoing movement. Much to this is due to the complex underlying geology. The section under review here experienced a dramatic slump, of around 600mm following a storm event in mid 2006. Figure 1 below shows the extent of damage caused.

Figure 1: View of Wharehine Road showing collapse in Pavement

Following a request from the client to investigate the site and comment on the feasibility of an LSN based design to provide a cost-effective solution, some basic geotechnical investigation work was carried out to determine the typical soil profile and to establish the most likely failure mechanism. The investigation showed that the road fill material was underlain by a layer of very weak, completely weathered siltstone of the Northern Allochthon Group (locally referred to as Onerahi Chaos). Back analysis indicated that the likely soil parameters at the site for this type of material were  $c' = 0 \text{ kPa}$ ,  $\phi' = 19^\circ$ .

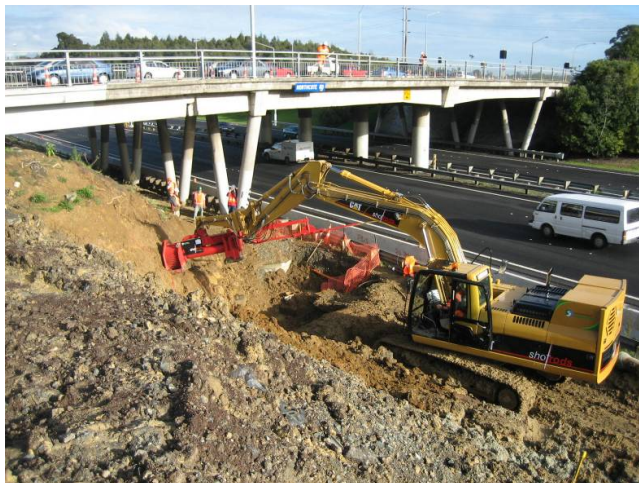
The section of bank to be reinforced was 10 m long and approximately 6m high, with the design based on 3 rows of LSNs, staggered at 1m centres. Surface erosion was to be prevented by designing a geotextile mat, which was to be placed along the slope following installation of the LSNs. Further reinforcing was supplied by providing a steel mesh which attached to the nails. Figure 3 below shows the LSN's being installed.

**Figure 3: Photo showing installation of LSNs into bridge embankment**

Had conventional nails been used, the installation would have taken approximately three weeks. The LSN based solution, only took one afternoon to install. The main difference in the time being that each bench could be cut immediately following installation of the previous row of LSNs.

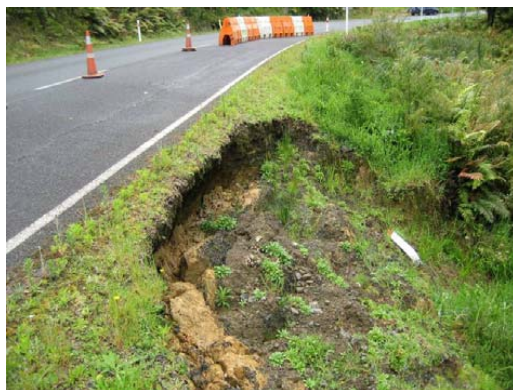
During the early part of 2006 cracks appeared in the pavement and minor settlement was noted over a length of 50m. Subsequently, following a severe storm event, a section of the embankment collapsed undermining a portion of the road.

**Figure 4: Photo showing failed portion of Murray Road**

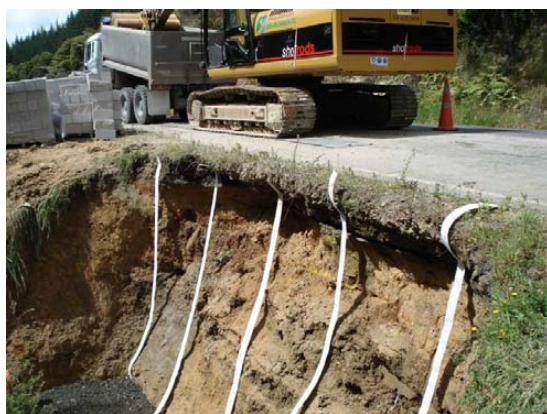
The observations made on site during construction matched the analysis carried out extremely well, with additional surcharge load from construction plant leading to the commencement of minor cracking at the surface (as predicted by the modelling). Thus the methodology used limited the extent of construction plant surcharge to >3m from the excavated face. The temporary excavation is shown in Figure 6.

Figure 6: Photo showing temporary excavation

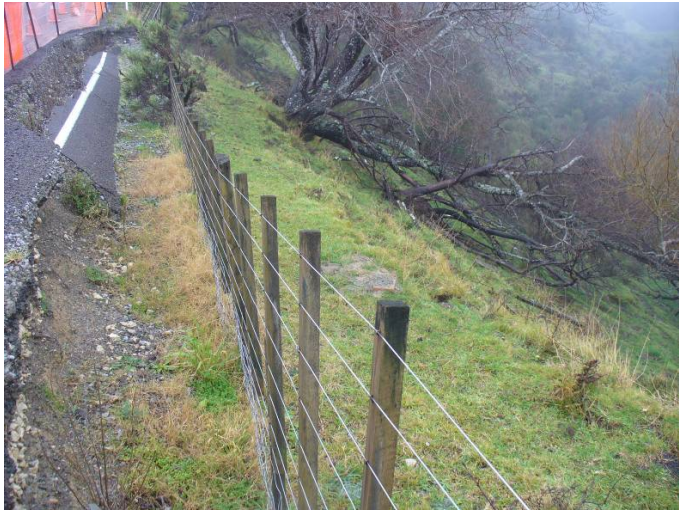
In early 2006 a slip occurred on a roading embankment on State Highway 2 just South of Gisborne on the East Coast of the New Zealand's North Island. The embankment had been constructed some 50 years ago using fill which would not meet today's standard for engineered embankment fill. The side slopes of the embankment were typically between 35 - 40° with no additional support measures present.

Figure 7: Slip on the eastern side of the road. Western side of road similar.

As a result of the substandard construction method, substantial water ingress allowed the embankment to become fully saturated during high rainfall events. This led to slip planes forming along the fill/underlying rock horizon on both sides of the embankment reducing usable pavement width significantly. A conforming gabion wall design was issued by the client for tender. A typical profile for this design is shown in Figure 8 below.
