Remedial measures for damaged slopes due to landslides in Chittagong Hill Tracts

Abu Siddique, Mehedi A. Ansary and M. Jahangir Alam

Keywords: landslide, remedial measure, slope stability

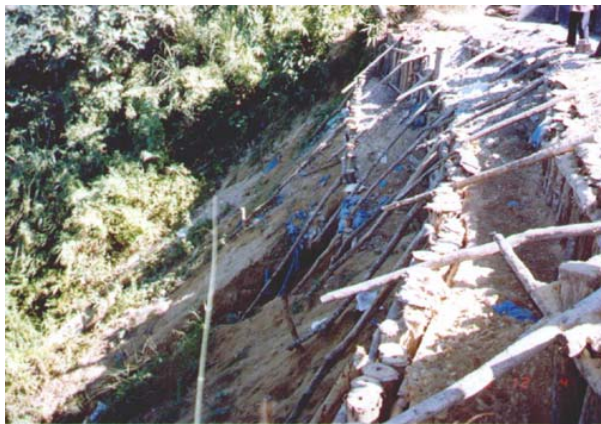
Figure 1 shows a typical section of existing land sliding slopes. The slopes of the sites became very steep due to considerable erosion of slope materials caused by heavy rainfall in this region. During the field visit, nature and extent of damage that had occurred at the two sites were assessed. Figure 2 shows a photograph of a section of one of the damaged slopes. The sections show considerable erosion of the existing slopes and some measures to protect the slopes using timber piling by the PWD (Public Works Department) Rangamati Division. It is noted that most of the damage occurred above RL 82 m (from PWD datum) in the three locations. No evidence of deep sliding was observed during site visit.

Figure 2: A photograph of damaged slope and temporary slope protection works by wooden piles
