A geomechanics view on heavy duty pavements

D.V. Toan

Beca Infrastructure Ltd, Auckland, New Zealand

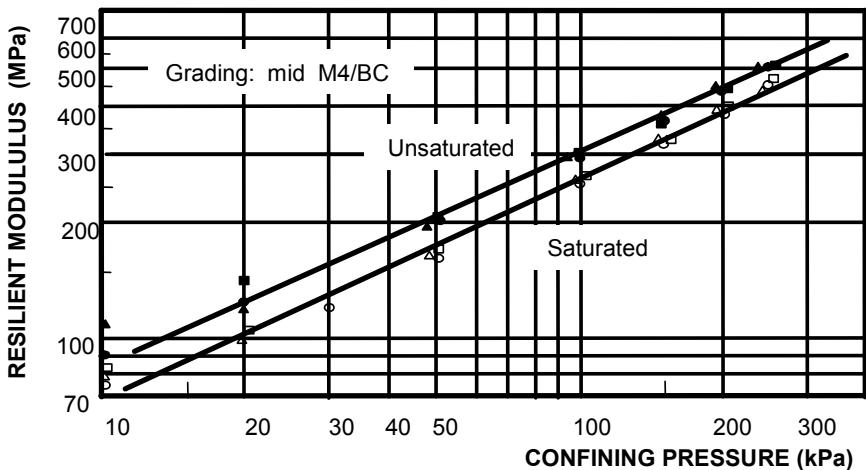
Figure 4: Resilient modulus vs confining pressure

A saturated basecourse was found to be less stiff than a drained one, by 30%- 50% (the resilient modulus halved under low confining pressure or under a chipseal). It was also found that the creep rate in the basecourse increased by a factor of 2 - 5 when saturated. These two effects combined to accelerate the accumulation of rut depth and shortening of the fatigue life loading to both cracking of the surfacing and causing shallow depressions along the wheel path.

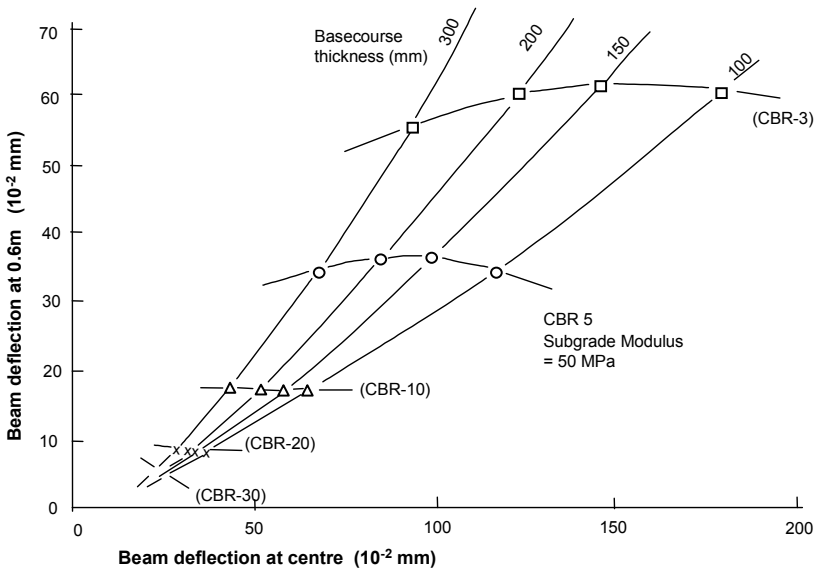
Figure 8: Beam deflections vs basecourse thickness & subgrade modulus

An intriguing finding I made was in one of the NZ National Roads Board research briefs into deflection bowl characteristics. Figure 8 shows beam deflections versus basecourse thicknesses and subgrade stiffnesses. The subgrade stiffness appears to be independent of the pavement structure, giving an effective tool to assess the stiffness of the subgrade more accurately than a large number of test pits and field tests. For the range of basecourse thicknesses there were the corresponding range of central deflections, however, at about 0.6m from the tyre, deflections remain relatively unchanged, reflecting the subgrade stiffness (refer to Figure 8).

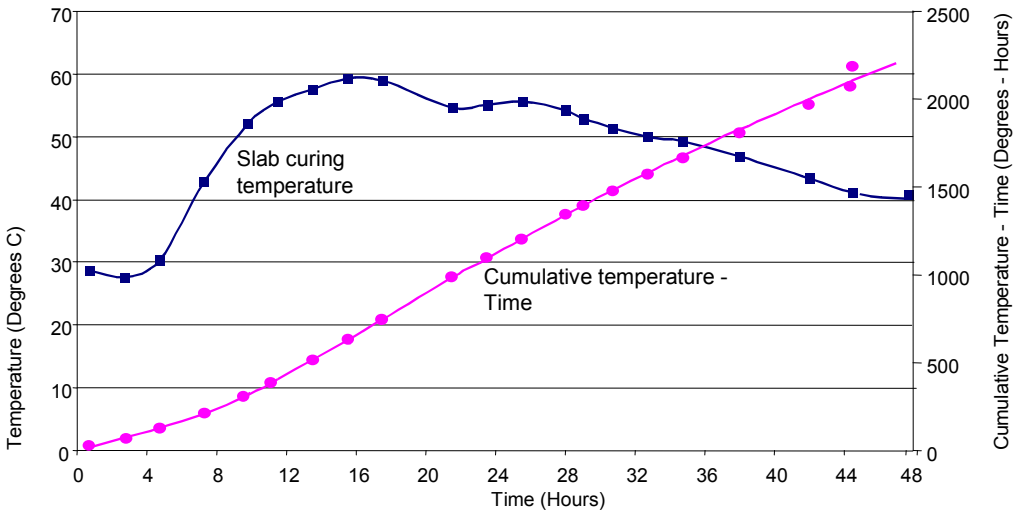
Figure 9: Concrete temperature - time

Figures 9 and 10 show the typical temperatures measured using digital thermo probes embedded in the concrete. The time-temperature graphs developed long ago proved quite correct. This allowed

us to shorten the curing period to 4 days, allowing the 400 tonne aircraft to land on the recently poured slabs (not without some trepidation from those involved!).

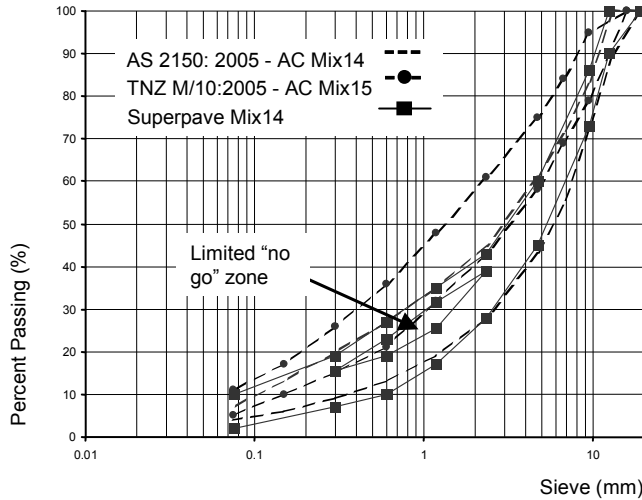
Figure 11: Comparison of asphalt Mix 14 - grading curve

Focus on friction surfaces on NZ roads is recent. Friction is not understood in detail. For example a chip seal may look coarse and highly frictional but in fact could be quite poor. If the exposed coarse aggregates become polished, however "rough" the surfacing looked, it would behave like a pavement made of fixed polished marbles. Good friction requires both good micro texture (the roughness felt by hand as a coarse sand paper) for velocities below 60 km/hr and good macrotecture (visible texture - for velocities above 60 km/hr). Macrotecture in AC is a function of the grading of the aggregates used in the mix. An improvement to the traditional TNZ mixes would be the use of Superpave mixes developed in the USA. Superpave mixes have a number of advantages, namely a better texture, a higher stiffness, easier to place and it costs less, as the mix requires less bitumen. (Refer to Figure 11 showing a comparison of a Superpave grading and a grading currently specified

by TNZ; it is noted that the Australian guide (ARRB Transport Research 2004) recommends gradings very similar to the Superpave without the “no-go” zone).

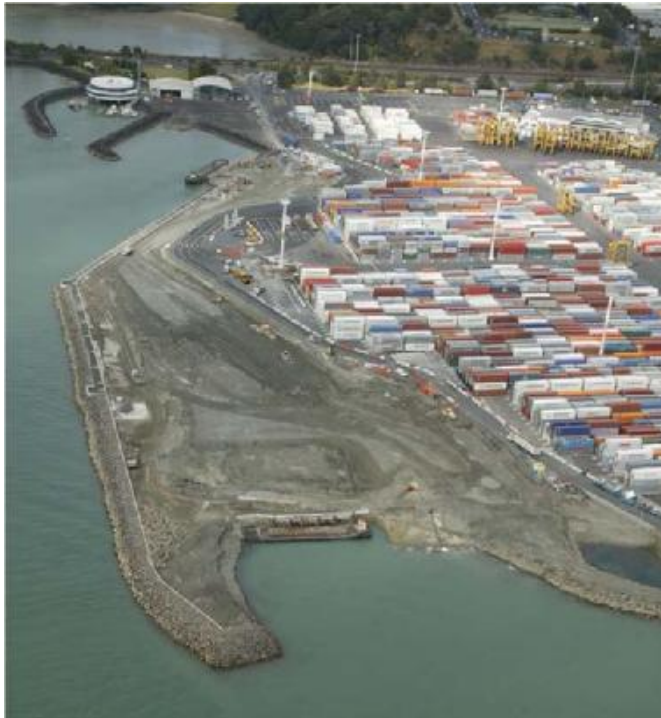
Figure 13: Fergusson Wharf reclamation

Mudcrete was first used for the reconstruction of the Whitbread Race stopover wharf in the Viaduct Basin and then the America’s Cup base wharves; this significantly reduced the lateral loads and hence the cost of the wharf walls. Mudcrete was also used for the duplication of the Upper Harbour Highway embankment for the second bridges; this allowed the fill slopes to be made steep to avoid the loss of the environmentally important mangrove stand. The site where Mudcrete has been recently placed is Fergusson Wharf extension in Auckland (Refer Figure 13).

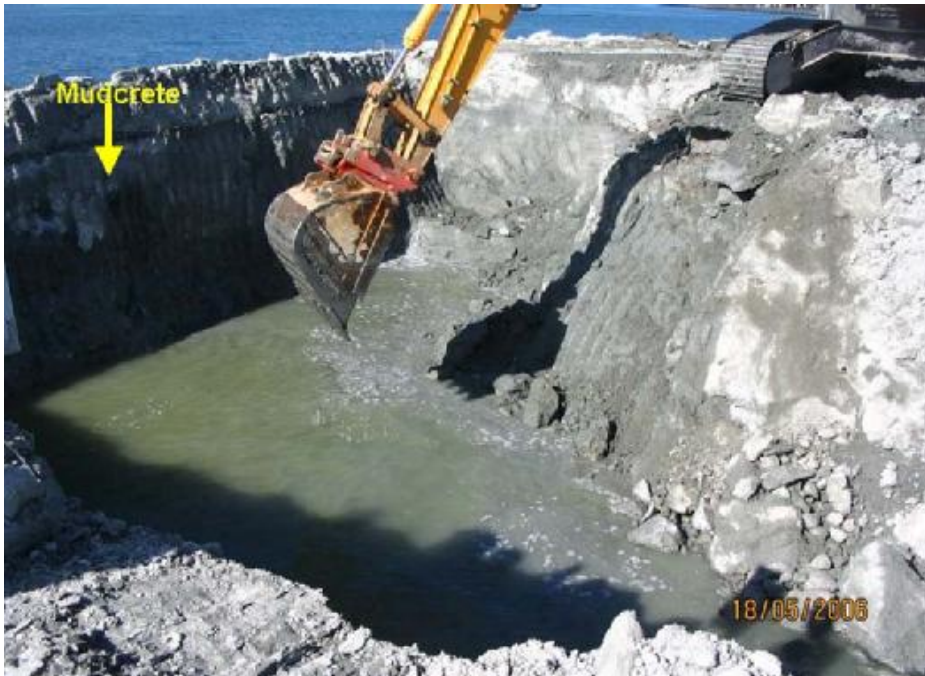
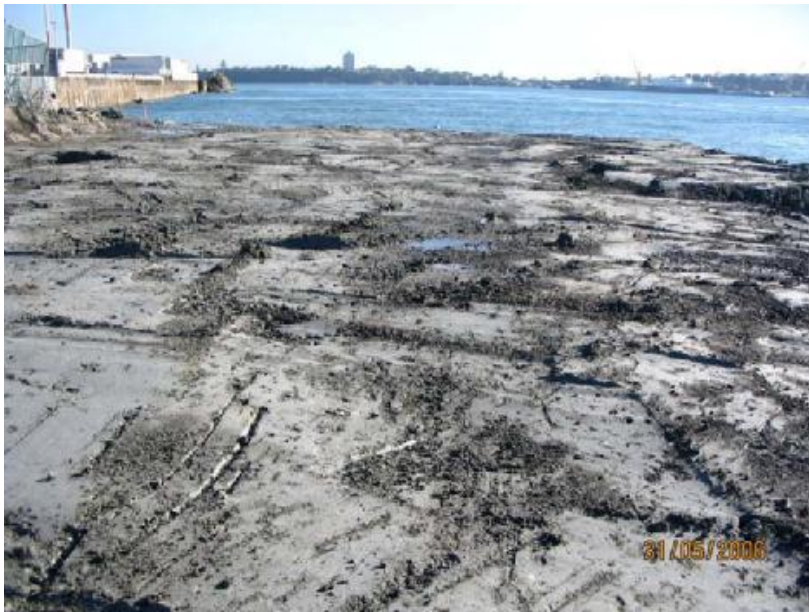
The low densities inherent in a cemented mud (without compaction) make Mudcrete “tender” or easy to crush in pavement construction turning it back to a mud. But with a small increase in cement percentage and sufficient time to cure, Mudcrete can yield CBRs well in excess of 10% for pavement support. (Figure 14 shows an example of a port pavement with axle loads of 120 tonnes on Mudcrete, and Figure 15 and Figure 16 depict Mudcrete in a cut face and as a pavement subgrade).

Figure 15: Trenching in mudcrete

Figure 16: Completed mudcrete subgrade

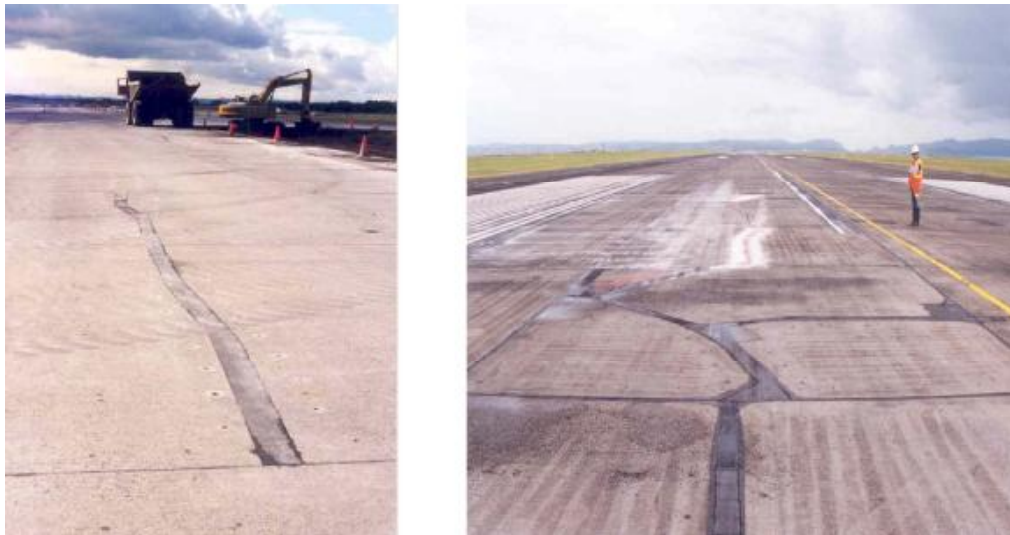
Figure 18: Fatigued slabs

30 years. Airport concrete pavement slabs tend to be un-reinforced. These slabs flex each time they are loaded by the 25 - 30 tonne wheels from jet aircraft with an all-up weight of around 400 tonnes for the Boeing B-747. Failure in fatigue ensues, with first, longitudinal cracking, then spalling, with dire consequences in terms of debris that could be sucked into the jet engines. Once one slab cracks, damage rapidly extends longitudinally from slab to slab. 2 - 3 years after the onset of initial cracking, the slabs tend to break into quarters or smaller pieces with much increased FOD (Foreign Object Damage - Refer to Figure 18).

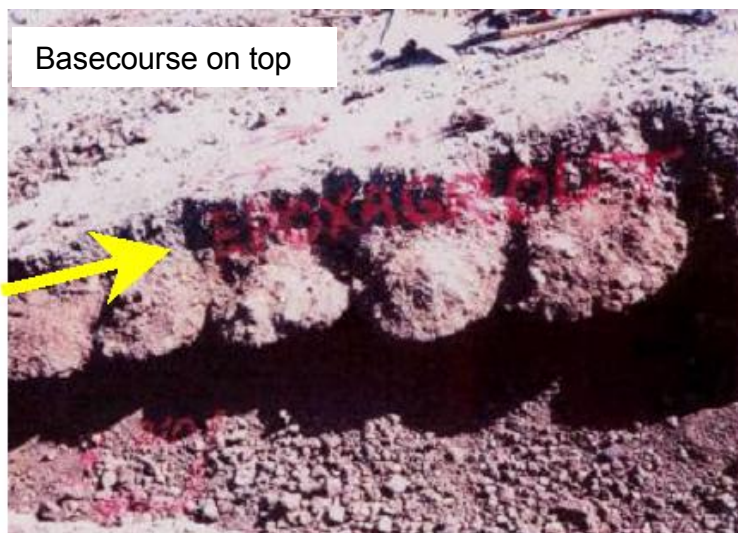
Figure 22: Epoxy underslab injection technique
(courtesy of Tom Watford, Auckland International Airport)

Semi-contiguous cemented bulbs
(NB. Concrete removed)

To achieve this we need to find a suitable product that penetrates damp or wet aggregates (the basecourse under the runway slab); sets to a high strength (like a roller compacted concrete); in a shape that forms a “beam”. If the epoxy were too free flowing it would have gone to the bottom of the basecourse and spread out in a thin flat layer. If it were too viscous it would have risen and spread under the slab to form a thin plate of epoxy. With patient testing, we achieved a series of roundish bulbs that “held hands” to form a “beam” (see photos on Figures 21 and 22).
