The paper was published in the proceedings of the 11th Australia New Zealand Conference on Geomechanics and was edited by Prof. Guillermo Narsilio, Prof. Arul Arulrajah and Prof. Jayantha Kodikara. The conference was held in Melbourne, Australia, 15-18 July 2012.

Geotechnical Engineering for Condor Tower

D. P. Stewart¹, FIEAust.

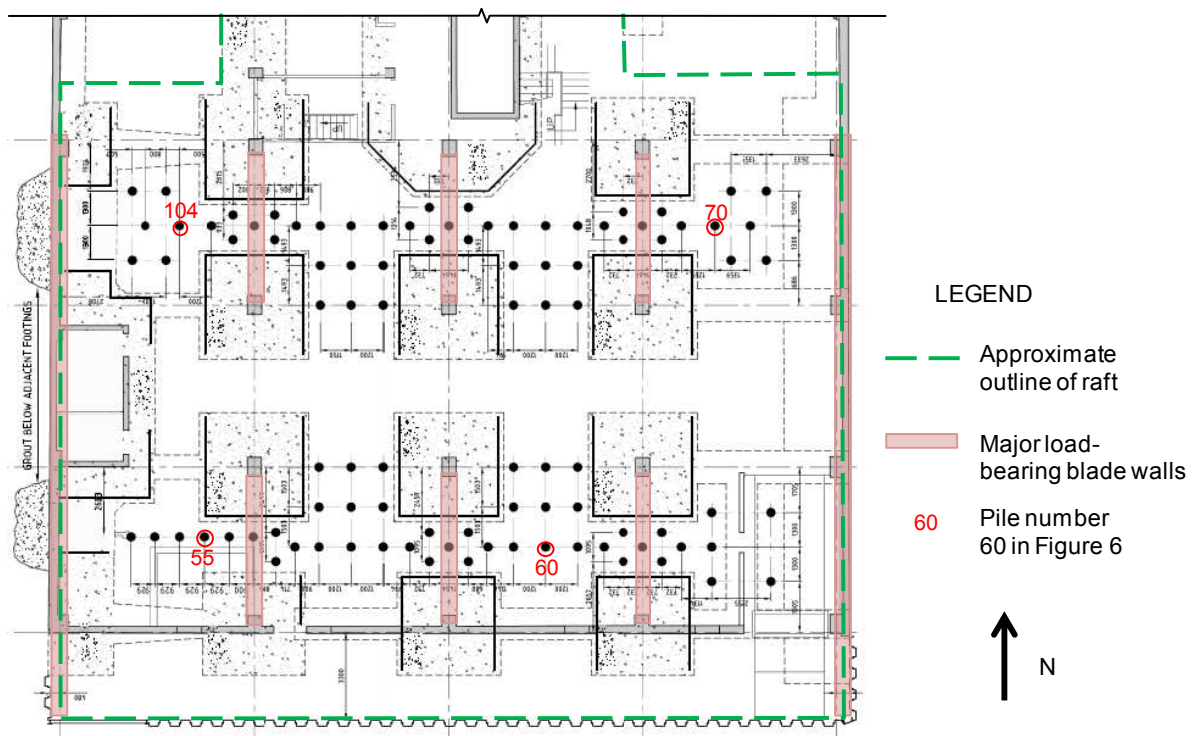
Figure 4. Micro-piles below new piled raft

Piles were installed using a specialist micro-piling rig held in position by jacking against the underlying and overlying floor slabs. The positions of the piles were selected to span across areas where several heavily loaded new blade walls would be constructed (Figure 4). To finalise the foundation design, a piling trial was carried out in advance of the production piling. Four piles, two 7 m long and two 10 m long, were subjected to static load testing. The piles were installed in two separate locations, so as to assess the variability in pile response across the site, given the variable ground conditions. Strain gauges were attached to the reinforcement cage to assess the split between base and shaft resistance. The results of the testing were valuable in providing confirmation of shaft and end bearing resistance and pile head stiffness and in assessing the practicability of the pile installation method. The results of load testing on the 10 m long trial piles are shown in Figure 5. Analysis of the load test data using various approaches indicated the parameters summarised in Table 1. Following assessment of the test pile results, 12 m long piles were specified for construction. About 90 reinforced grout-injected continuous flight auger piles of 300 mm diameter and 12 m length below underside of raft (13.2 m below piling platform) were installed.

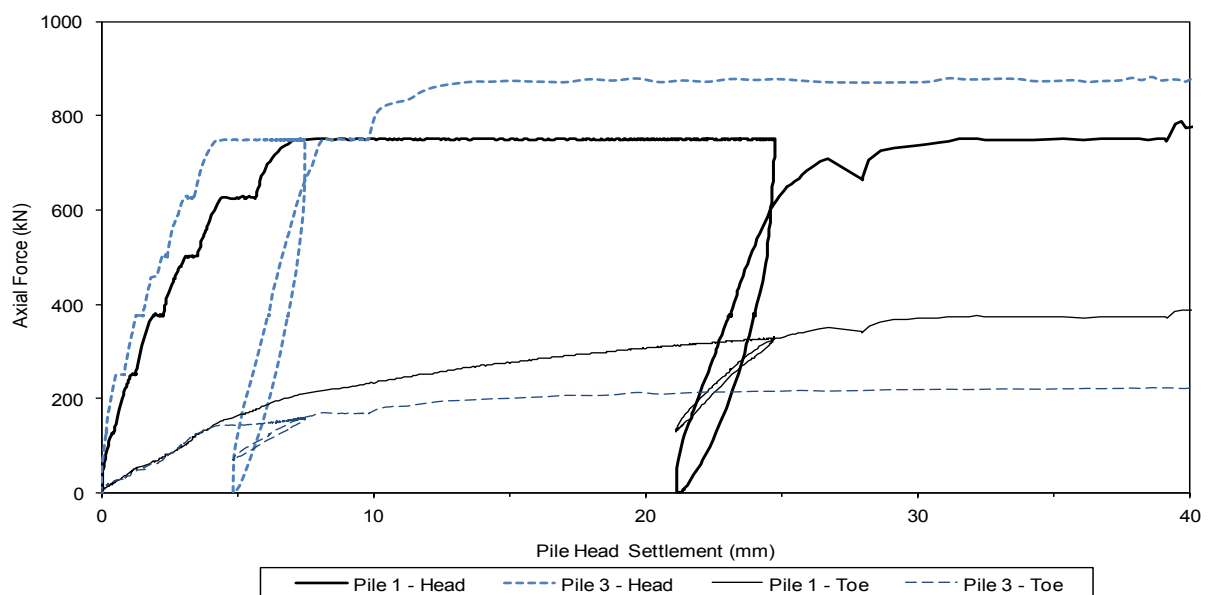
Figure 5. Pile load test results on 10 m long trial piles

No.	Area	Length (m)	Load at 10% defl. (kN)	Average $f_{s,ult}$ (kPa)	Average q_c over shaft length (MPa)	Mean q_c near pile toe (MPa)	Ratio $q_{c,ave}/f_{s,ult}$	Initial pile head stiffness (kN/mm)
1	South	10	750	50	7.5	4	150	300
2	South	7	430	40	7	2	175	150
3	North	10	870	77	7.9	2.2	103	300
4	North	7	675	78	8	2.5	103	300

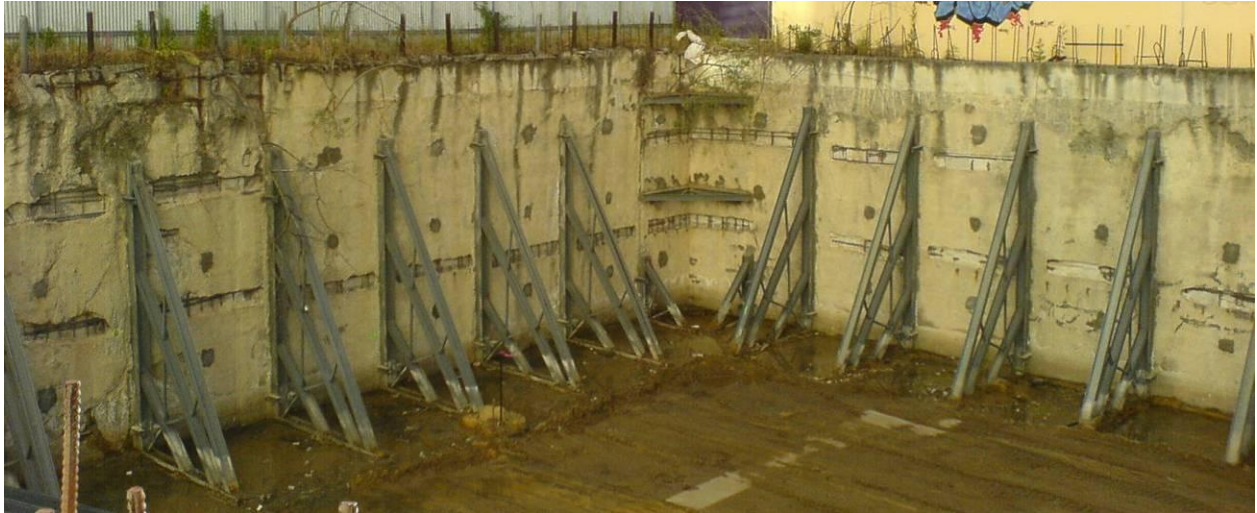
Figure 7. Steel struts supporting diaphragm walls; photograph taken after initial site cleanup

The Hay Street building was constructed within an abandoned open excavation supported by propped diaphragm walls, after abandonment of a previous development nearly 20 years earlier. The props were angled steel struts supported on strip footings founded within the base of the excavation and with tie beams running across the excavation base (Figure 7). Temporary ground anchors supporting the walls had been de-stressed after preloading the struts by jacking. The presence of the struts and footings complicated the development of the site because of the need to either maintain the struts in place while the new structure was built, or to provide additional support to the diaphragm walls before removing the struts. The initial development proposal was to extend the excavation a full basement level deeper to accommodate four basement levels. This initially seemed attractive since the old diaphragm walls extended relatively deep. However, it was found that the walls had inadequate bending strength to enable a deeper excavation to be supported. Following assessment of various options, a half-basement level deepening was designed over only the southern part of the site.
