# Uplift load testing of grooved tension piles in Waitemata Group Rock for the Manukau Rail Link

D. M. Oosterbeek<sup>1</sup>, BE(Civil), MIPENZ, CPEng

The results of static load testing in uplift of two preliminary test piles undertaken for the Manukau Rail Link project are presented. The test piles were 600mm in diameter with socket lengths of 3m within Waitemata Group Rock. Grooving of the rock socket was undertaken to provide a rough interface. Each test pile was loaded under maintained static conditions against a reaction frame supported by four screw piles to resist the test loads. Multiple load cycles were used within the predicted working stress range of the contract piles to test the performance of the piles under cyclic loading prior to imposing maintained static load increments to failure. Measurements of pile deformation were taken throughout the tests using strain gauges at the pile head. The results were analysed to determine ultimate shaft friction within the Waitemata Group Rock.

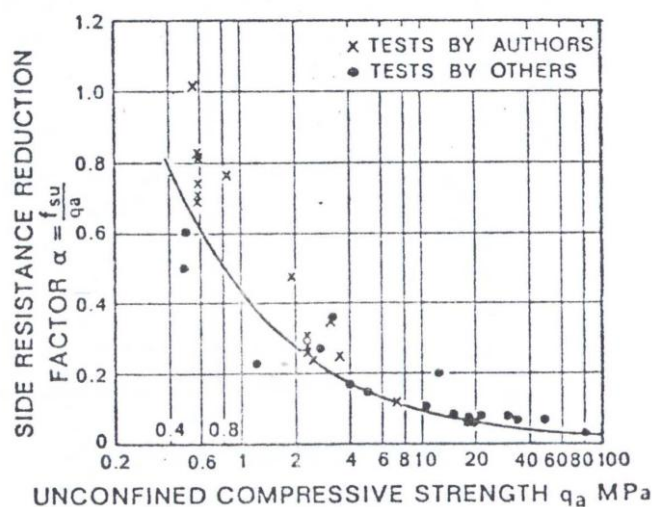
Figure 1: Side resistance reduction factor reflecting variation of rock strength (after Williams et al, 1980)

The unit ultimate shaft friction available at the pile/rock interface was assessed using the relationship proposed by A.F.Williams et al (1980) and shown in Figure 1. This relationship is based on testing to failure of test piles with a range of diameters within weak sedimentary rock and relates the unit ultimate shaft resistance to unconfined compressive strength. This was considered an appropriate relationship for this project based on similarity of rock type and strength. From this relationship a unit ultimate shaft friction of 430 kPa was assessed based on a lower bound unconfined compressive strength of 1 MPa. For the assessed Ultimate Limit State (ULS) tensile load of 2,100 kN and Serviceability Limit State (SLS) tensile load of 1,580 kN, a socket length of 9.2m was adopted for the contract piles (giving an average working shear stress of about 90 kPa at the pile/rock interface).

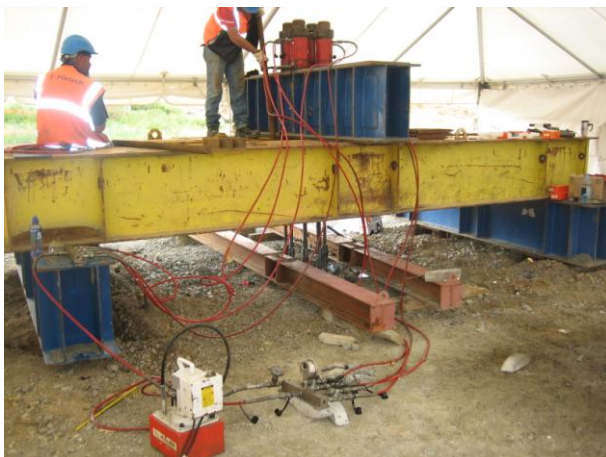
Figure 2: Pile test setup

The setup for each of the pile tests was designed and assembled by Piletech, and involved the use of steel I-beams to form a reaction frame and four steel screw piles supporting the frame at each end of the beams-on-ground. The screw piles functioned as reaction piles to resist the compressive load applied to the reaction frame by a hydraulic jack applying tension (uplift) to the pile. The setup is shown in Figures 2 and 3.

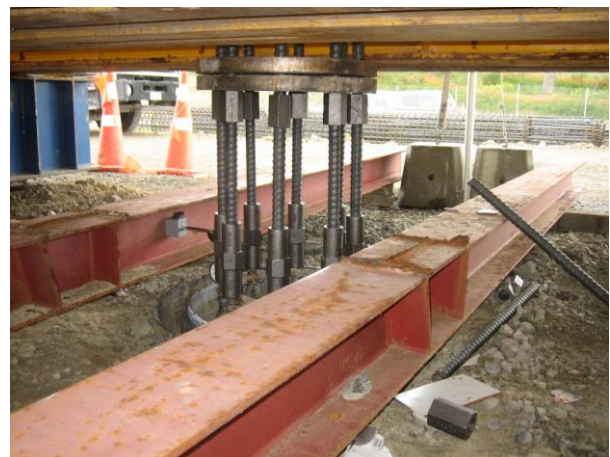
Figure 3: Connection detail

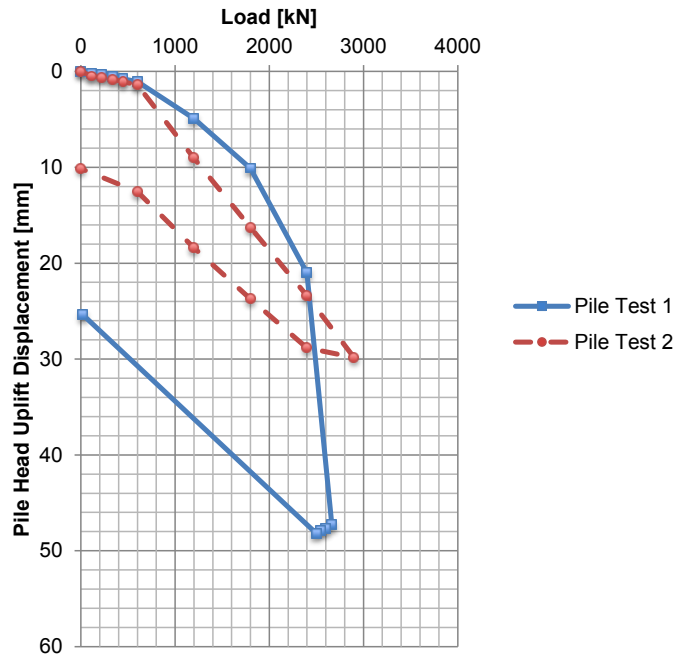
Figure 4: Pile test load-displacement curves

The load-displacement curve for Test Pile 1 indicates that the rock socket reached 'geotechnical' ultimate failure at approximately 2500 kN. For a 3m rock socket this equates to a unit ultimate shaft friction of approximately 440 kPa. Test Pile 2 reached a maximum test load of 2900 kN with significantly less displacement, and no indication of failure is observed in the load-displacement curve. The results are presented in Figure 4.

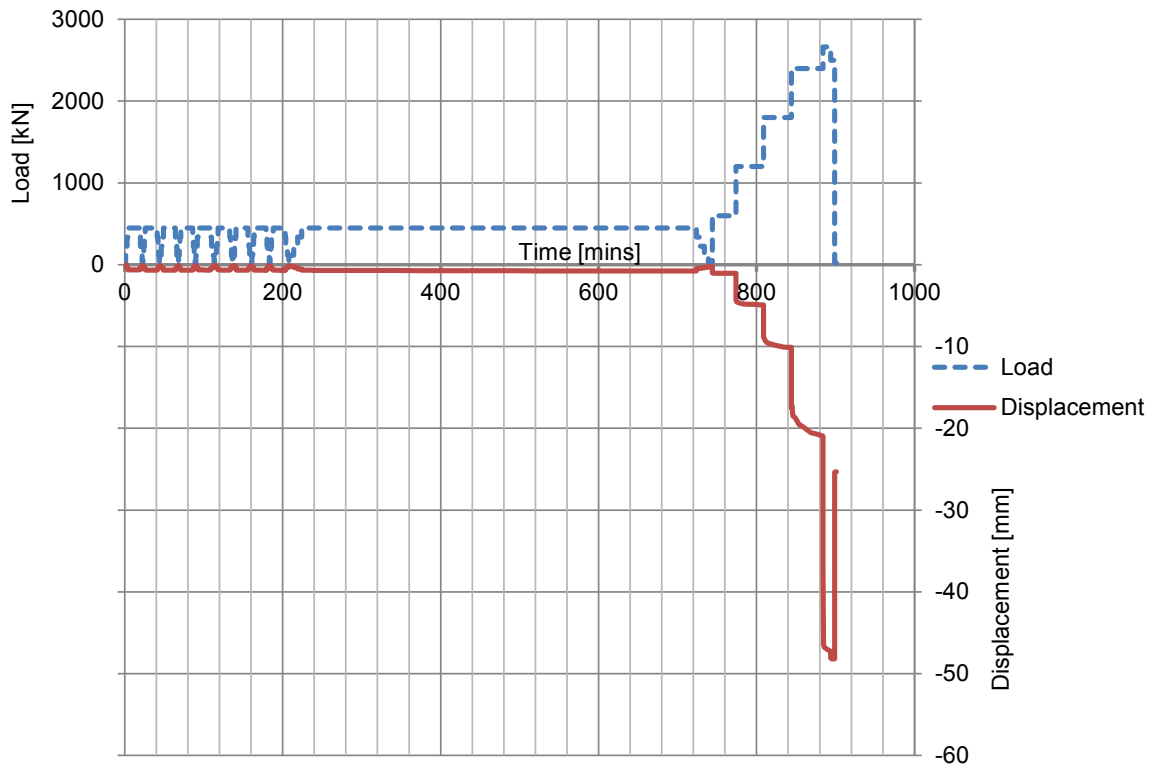
Figure 5: Load and displacement versus time for Test Pile 1

Figure 5 presents the load and displacement curves plotted against time for Test Pile 1. It can be observed that creep was negligible during load holding periods within the working load cycles, the degree of displacement was essentially identical for each load cycle to the working load, and displacement effectively returned to zero after each load cycle.

Also of note is that as the test load was increased beyond the working load of the pile, the degree of creep for each load holding period increased until the pile was unable to resist further tensile loads (endeavours to increase the test load resulted in large displacements).
