The paper was published in the proceedings of the 11th Australia New Zealand Conference on Geomechanics and was edited by Prof. Guillermo Narsilio, Prof. Arul Arulrajah and Prof. Jayantha Kodikara. The conference was held in Melbourne, Australia, 15-18 July 2012.

Controls on slope failures at the Te Toto Amphitheatre, New Zealand

C. Ritchie¹, and MA. Brideau²

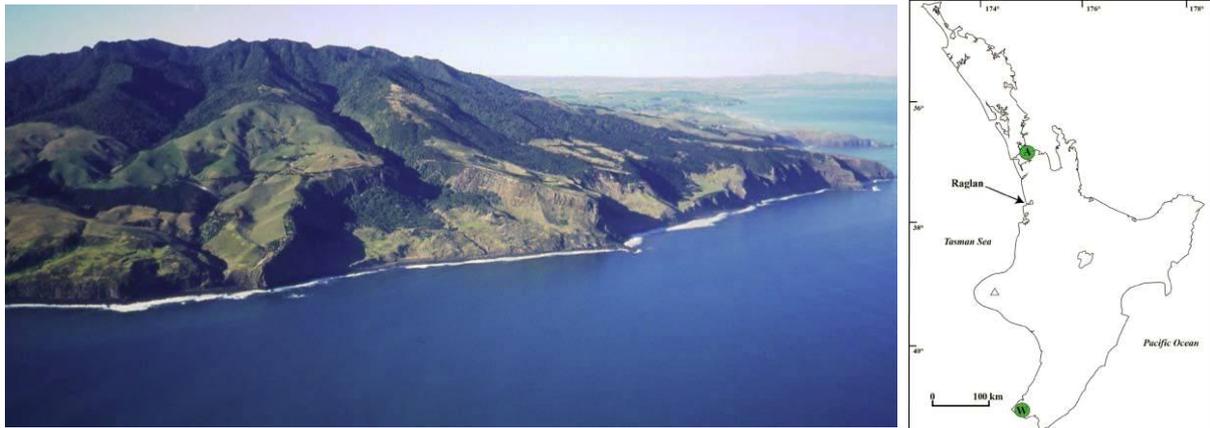
Figure 1. Aerial photograph of the Te Toto Amphitheatre and map locating Raglan within the North Island of New Zealand.

The Te Toto Amphitheatre lies on the north-western slope of Mount Karioi near Raglan, New Zealand (Figure 1). This region of West Coast New Zealand is characterised by surf beaches, estuarine harbours, and scattered Pliocene - Quaternary aged monogenetic volcanic fields (Ngatutura, Alexandra, Okete, South Auckland) (Briggs and McDonough, 1990). The amphitheatre has a distinctive horseshoe shape, with steep sided walls and a hummocky, boulder filled central valley. This represents the geomorphic expression of an ancient slope failure, with the majority of material thought to be deposited offshore (Edbrooke, 2005). Similar features of a smaller scale are seen further along the coast line, with Woody Head and Spray Bay directly to the south (Figure 1). The Te Toto stream runs through the middle of the amphitheatre from the upper slopes of Karioi, draining out to sea at the coast. The amphitheatre runs for 1.2km north south, and 1km from the coast to the top of the amphitheatre. The geology consists of interbedded basaltic lava flows, coarse grained pyroclastics and volcanic sediments of the Alexandra group volcanics. Seismic records held in the GNS Science database suggest that there is low seismicity in the area.

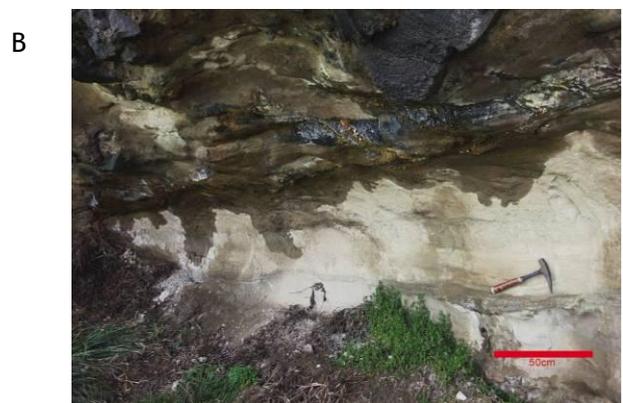
Figure 4. A) Histogram of Persistence, B) Seepage

Three geotechnical units were identified in the field, the Flow, Pyroclastics, and Volcanic sediment units. The most aerially extensive unit was the Flow unit, consisting of unweathered to slightly weathered basaltic lava flows. The Pyroclastics unit consisted of a clast supported volcanic breccia, this had an irregular erosive and intrusive contact with the Flow unit, reaching a maximum of 6 metres in thickness. The Volcanic sediment unit is observed as a continuous unit, up to 2 metres thick of fine grained sediment. It has a low angle dip of 10-15° and contacts below the Flow and Pyroclastics units. These are displayed on Figure 2, with their respective GSI estimates. The contacts between the Flow unit and the volcanic sediment and Pyroclastics irregular and undulating and are positioned roughly 10m above the valley floor. Point load test values (Figure 3) suggest that Flow had the highest material strength while Volcanic sediment the lowest. The Pyroclastics unit displayed an over estimated strength from point load tests due to only the clasts being tested, Schmidt hammer was found to be appropriate for estimating the intact material strength for this unit. Seepage was observed at a number of sites, particularly at the contact between the Pyroclastics and Volcanic sediment (Figure 4).

A kinematic analysis was performed considering toppling, planar sliding and wedge failure for two different regions of the Te Toto Amphitheatre. The analysis was performed using discontinuity data measured in the field (Table 1 and Figure 4), these are the combined discontinuities for all geotechnical units. Two structural regions were considered, the first representing a coastal cliff slope, the second an average hill slope. These slopes have a dip direction of 310° , the midpoint between the Northern and Southern wall orientations. Assumed effective friction angles between $30^\circ - 35^\circ$ are shown on each stereographic projection. These friction angles were estimated from roughness values from the discontinuity set most likely to influence the particular failure. Four main discontinuity sets were observed, three high angle and one low angle bedding influenced set.
