The paper was published in the proceedings of the 11th Australia New Zealand Conference on Geomechanics and was edited by Prof. Guillermo Narsilio, Prof. Arul Arulrajah and Prof. Jayantha Kodikara. The conference was held in Melbourne, Australia, 15-18 July 2012.

Lateral Spreading Measurements from the 2010 Darfield and 2011 Christchurch Earthquakes

K. Robinson¹, M. Cubrinovski¹, B. A. Bradley¹

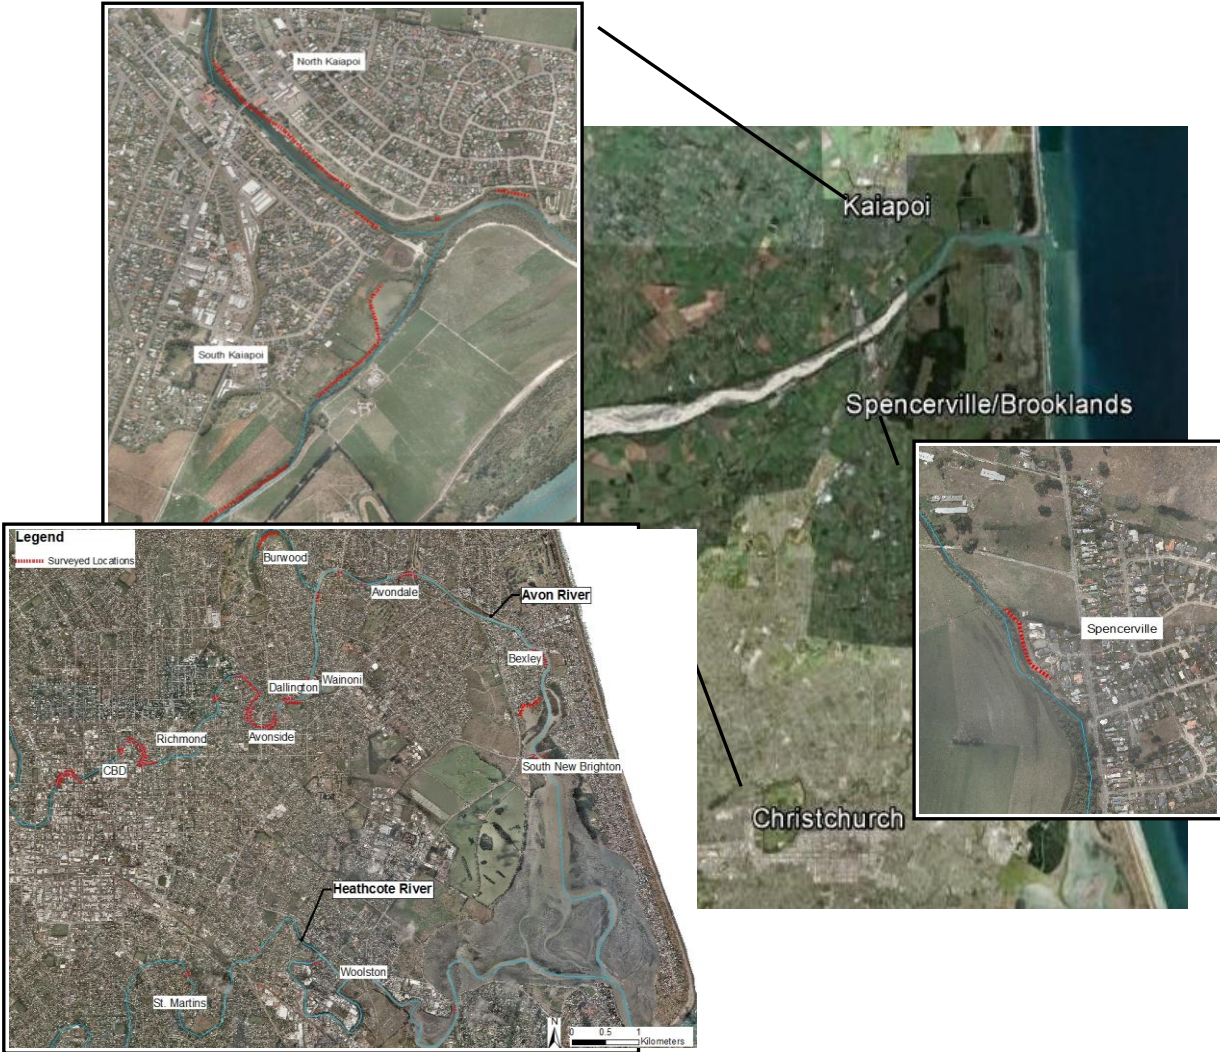
Figure 1. Location map of areas surveyed during field investigations of lateral spreading

Details of the ground surveying method employed can be found in Robinson et al. (2010). A list of locations surveyed and corresponding range of maximum lateral displacement for the 2010 and 2011 events is tabulated in Table 1. The approximate locations of these areas are shown in Figure 1.

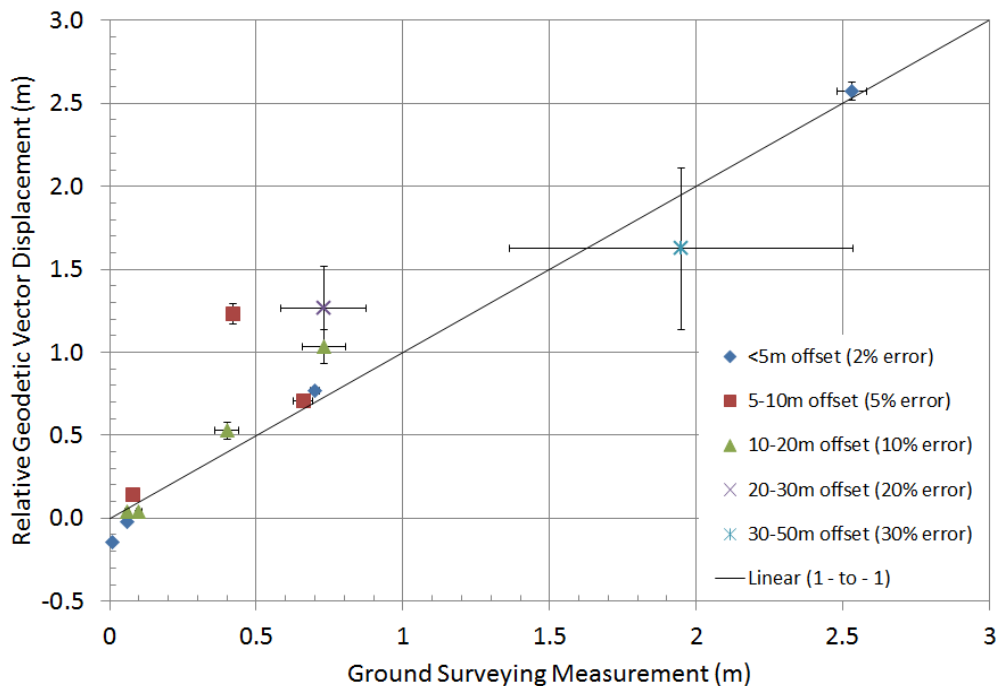
Figure 2. Comparison of relative lateral spreading displacements using the method of ground surveying and geodetic surveying

Figure 2 shows the results of our comparison in South Kaiapoi and is broken down by vector offset (perpendicular distance between vector location and field measurement). Each offset category has been assigned an estimated error associated with the comparison. This is to account for the variability in observed displacements within a specific area, despite being at equal distances from the waterway. In general, the field measurements matched reasonably well with the geodetic data with a majority of the vector data falling within 30% of the corresponding field value. We note that discrepancies between the two datasets are inevitable given the complex nature of lateral spreading and the highly variable field conditions. However, the general agreement between the two data sets serves to validate the simplified method of ground surveying and our results obtained using this technique.

The comparison considered pairs or groups of geodetic vectors located in a generally parallel alignment to a transect. The angle difference between transect and vector azimuths were computed in order to calculate the vector component in the direction of the transect. Using the groups or pairs of geodetic data, the difference in displacements from the geodetic data were compared with the differences in measured displacements from the transect field data at the equivalent distance from the waterway. This was accomplished by setting the furthest geodetic data point equal to the transect measurement at that distance and subtracting or adding that difference to all vector data points considered in the alignment.

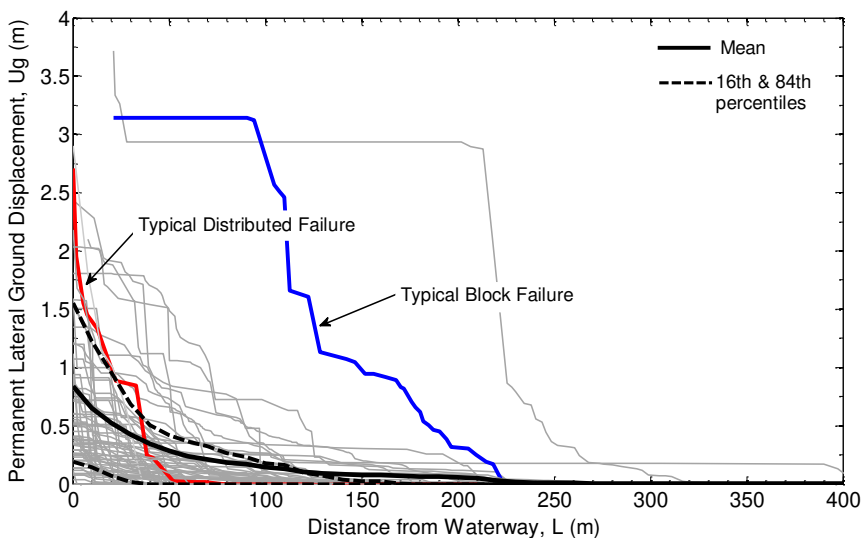
The 2011 lateral spreading field investigation conducted ground surveying at approximately 71 locations with the majority located along the Avon River in Christchurch. Figure 4 shows the results of measurements with respect to distance from the waterway. Again, the block-failure mode can be seen in Figure 4 on the two upper-bound transects that were surveyed along Courtenay Stream (South Kaiapoi). The remainder of transects generally exhibited distributed pattern of lateral spreading. Note that a total of 5 of the 71 transects (including the two transects in South Kaiapoi) were surveyed after the 13 June 2011 Earthquake (Mw 6.0) and hence, the spreading at these locations were likely influenced by the 22 February and 13 June events.

Figure 4. Results of field measurements of lateral spreading following 22 Feb 2011 earthquake

Figure 4 shows a similar range of maximum lateral displacements as in the September event. With the exception of the South Kaiapoi block-failure transects, the results show the majority of lateral spreading generally occurred within the first 100 to 150 metres of the bank.

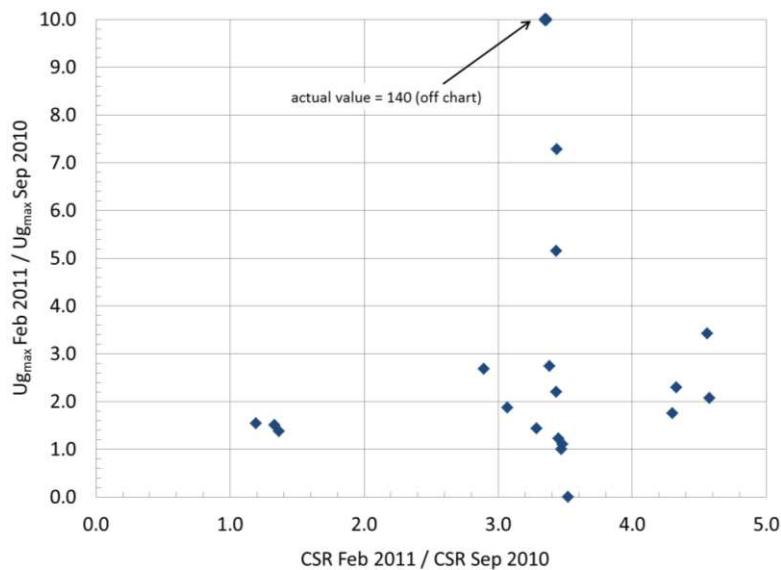
Figure 6. Maximum lateral displacement ratios versus CSR ratios from resurveyed locations

The plot shows a positive correlation between observed maximum displacement and CSR with some data showing an exponential increase in $U_{g_{max}}$. We note that the September 2010 accelerations were much less variable among the 17 resurveyed locations than in the February 2011 event (due to the greater R_{rup} distance in the September event). The consistency in CSR from September makes it more difficult to distinguish an exact relationship between $U_{g_{max}}$ and CSR; however, it is clear that there is some influence on increasing CSR on increasing maximum displacements.

Ignoring all other factors, we considered the sole effect of increased accelerations on the observed maximum displacements. The cyclic stress ratio (CSR) was calculated in accordance with Youd and Idriss (2001) at each "repeat" location (excluding the 5 post-June measurements) assuming a ground water level at the surface and using computed PGA values for each transect location. The observed maximum ground displacement ($U_{g,max}$) ratios were plotted against CSR ratios for these 17 locations, as shown in Figure 6.
