# Quality Control and Performance Monitoring of Ground Improvement using Continuous Flight Auger (CFA) Columns

This paper discusses the quality control methods used in the construction of unreinforced concrete columns, installed by CFA technique as part of the ground improvement for a reinforced earth ramp 8 m high that carries a passenger railway line. The successful delivery of the foundation works was assured through monitoring and testing. Real-time automated monitoring of installation parameters (including penetration rate, drill resistance and concrete consumption) during column installation took place to calibrate toe levels. Three test columns, each close to a geotechnical test, were constructed and cored down their centre, using a conventional rock core drilling technique, for column strength and base condition assessments. Each test column and selected production columns were scheduled for low-strain impact echo integrity testing (PIT). The performance verification of the ramp by means of vertical and lateral movement monitoring is also presented in the paper.

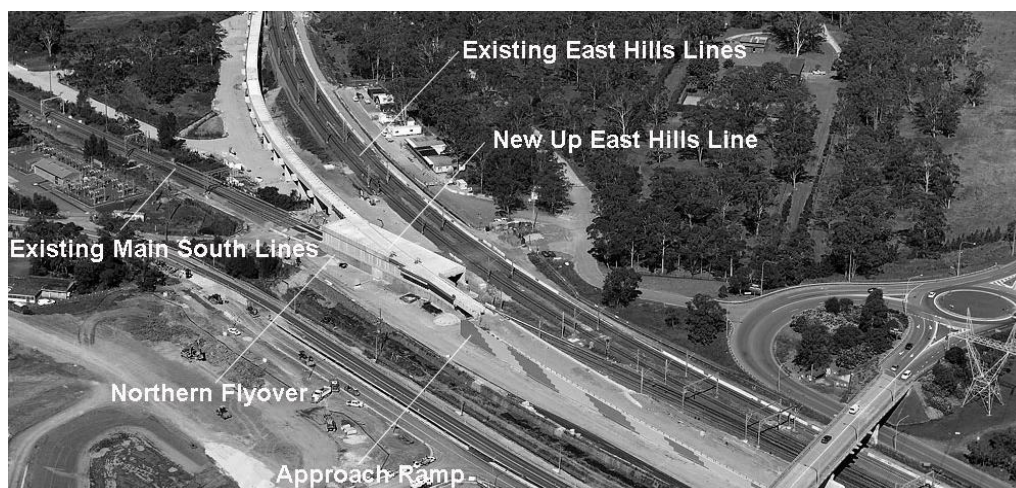
Figure 1. Approach ramp to Northern Flyover as at 3 December 2011

The northern flyover, around 65 m long and 13.5 m wide, is based on the portal frame concept and being constructed by GJA as part of the GTI. The flyover is connected to an approach ramp up to 7.6 m high. The ramp is 12.25 m wide, is retained by Reinforced Earth™ retaining walls up to 190 m long, and will take the new Up East Hill Line (UEHL) on to the flyover over the MSL (see Figure 1).

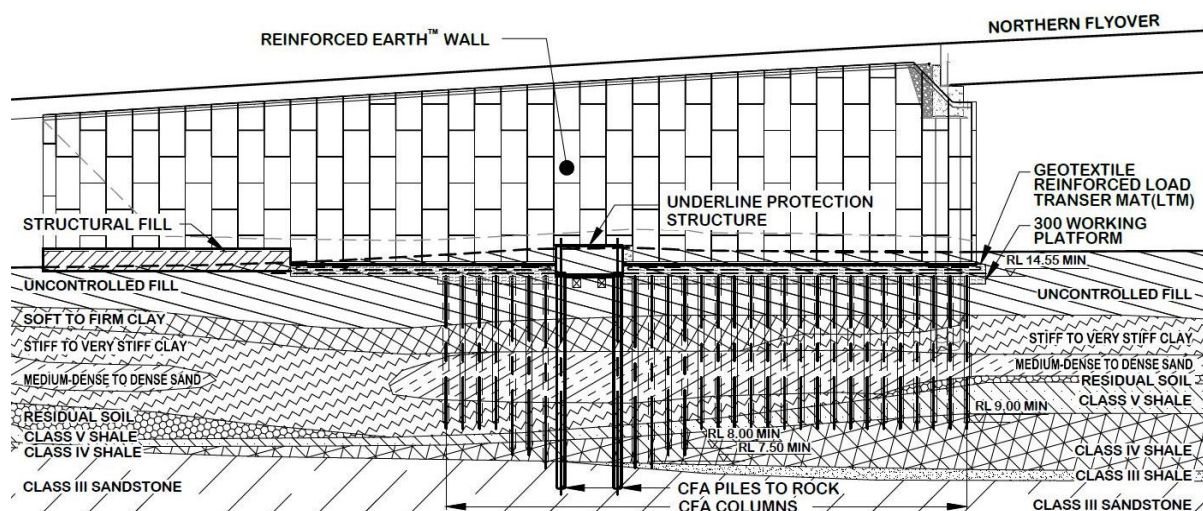
Figure 2. Typical subsurface profile and ground improvement beneath approach ramp

The specified characteristic compressive strength for the CFA columns 0.45 m in diameter was 10 MPa at seven days and 15 MPa at 28 days. The CFA columns were installed from 5.5 m to 7 m deep, at a spacing of 1.8 m centre, staggered in a square pattern. The lateral extent of the CFA columns beneath the ramp was 41 m. An underline crossing (protected by a bridge structure supported on CFA piles to rock) traverses through the ground improvement area. To smooth out the settlement profile for the ramp construction next to the crossing, the length of the CFA columns within 5 m of either side of the crossing were designed to increase gradually from 5.6 m to 7 m. The LTM was extended a further 9 m beyond the CFA column application area to achieve a smooth settlement gradient to the untreated ground. The footprint of the CFA columns matches the ramp footprint such that the wall facing panels will align directly above the outside row of the CFA columns. Figure 2 shows the typical subsurface profile and the extent of the ground improvement beneath the ramp. Figure 3 shows the typical CFA column arrangement.

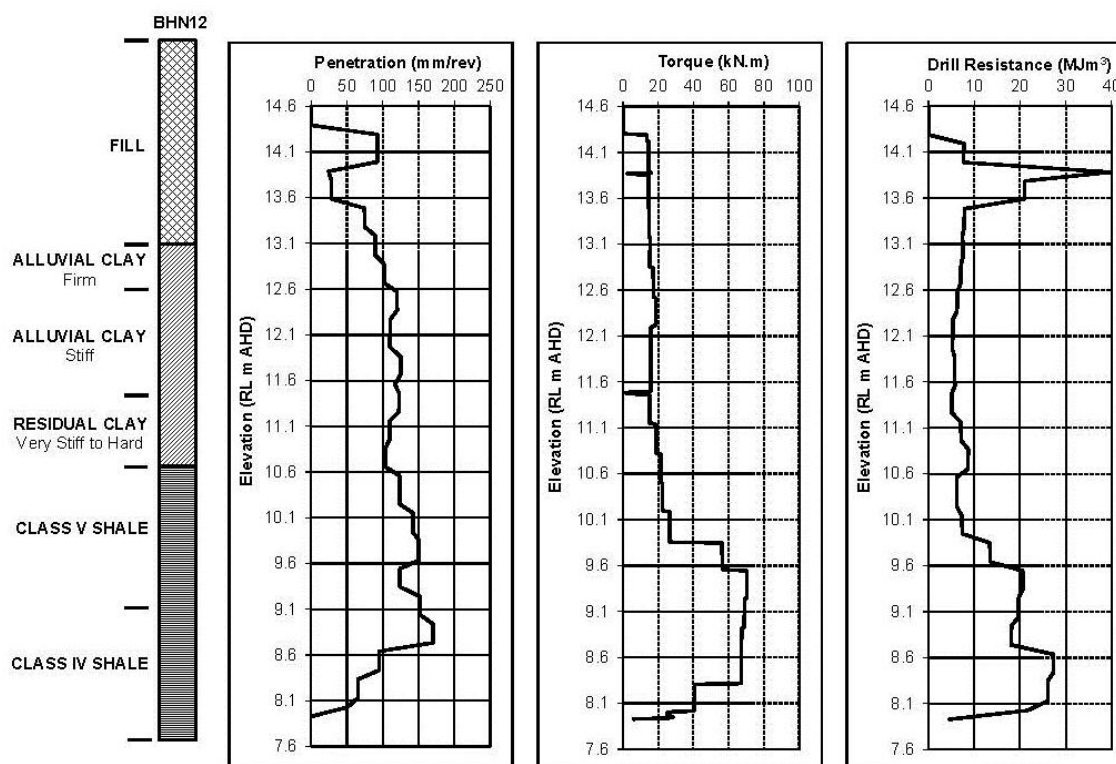
Figure 4. Real-time monitoring of installation parameters for test column T1

Three test columns were installed within the ramp footprint, with each test column positioned close to either a nearby borehole or cone penetration testing. Automated real-time monitoring of installation parameters (i.e. the auger-tip depth, auger penetration, rotation and withdrawal rates, drill resistance, incremental concrete volume and injection pressure) was used during the installation of the test columns to confirm column toe levels (refer to Figure 4). Verified through the automated monitoring, the production columns (160 columns, totalling 962 m) were installed in the same manner, with similar concrete volume and to the same standards and similar founding levels as the test columns, to ensure the production columns will perform as well as the test columns.

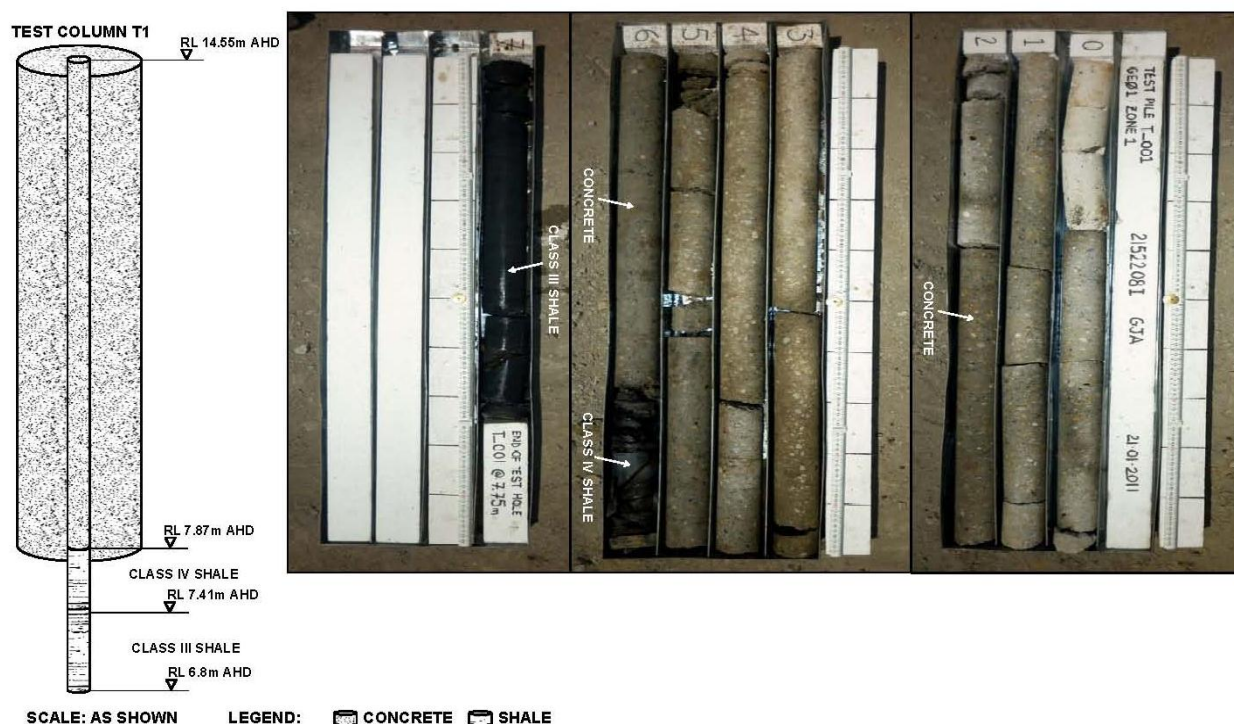
Figure 5. Coring test column T1

A conventional site investigation coring technique was applied to core through each of the test columns into the underlying founding stratum to verify the conditions of the column base and to obtain core samples of the concrete for strength proving tests. The as-built bases of the test columns were between RL 7.75 m AHD and RL 7.25 m AHD, about 6.7 m to 7.3 m long. The coring verified the 'clean' bases of the test columns, in flush contact with weathered rock, classified as either Class IV Shale or Class III Sandstone in reference to the rock classification developed by Pells et al. in 1978 (see Figures 5 and 6). The cored samples of the concrete forming the test columns were tested for compressive strength tests. The test results showed the concrete has average characteristic strengths of 13 MPa and 21.3 MPa for seven days and 28 days, respectively, exceeding the specified minimum characteristic strength requirements.

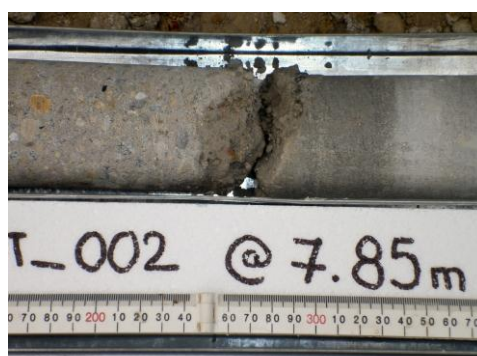
Figure 6. Flush contact between concrete and rock at base of test column T2

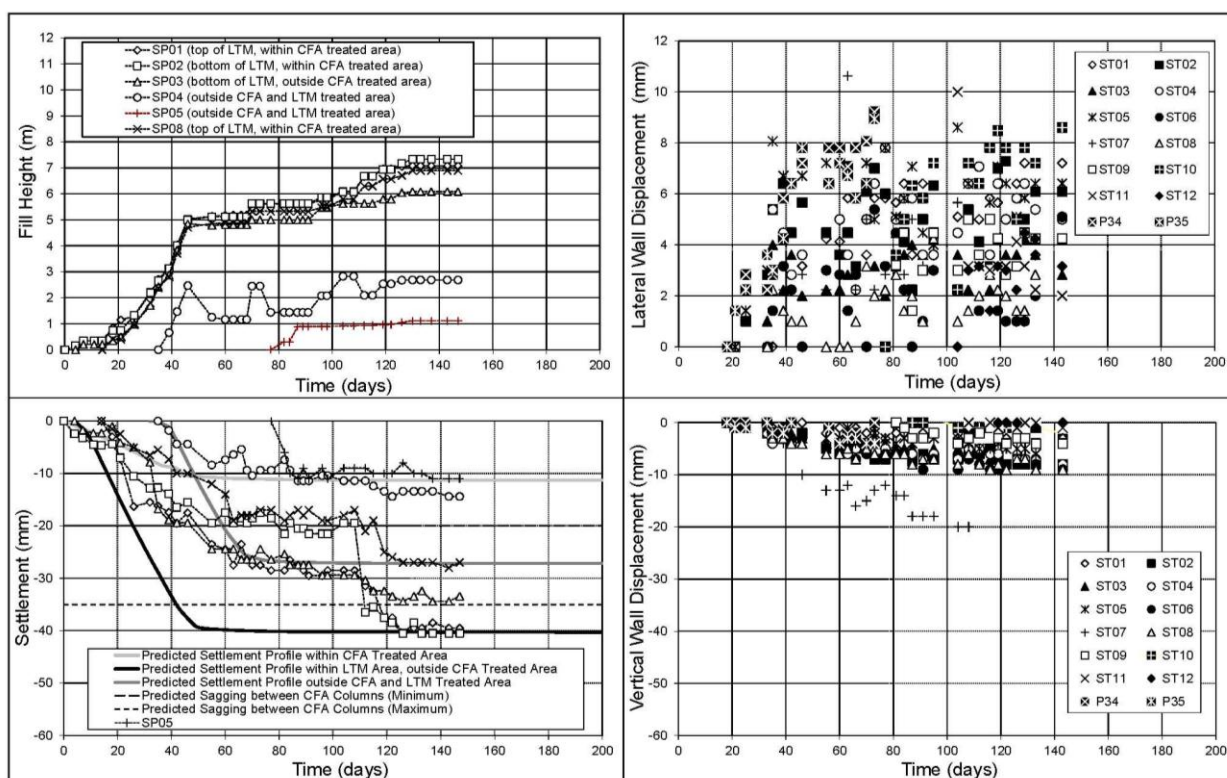
Figure 7. Settlement and lateral movement monitoring

The measured movements, shown in Figure 7, were calibrated against the predictions from the finite element numerical modelling. The comparison of ground movements has shown the following:

- The numerical analyses inferred that the ground inclusions using the CFA columns could constraint settlements to the order of 10 mm. The survey targets on the retaining wall panels founded immediately on CFA columns generally recorded

settlements of this order of magnitude. The small vertical movements enforce the fundamental role of the CFA columns in reducing the deformability of the ramp.

- The settlements recorded by SP01 and SP08 positioned on top of the LTM within the CFA column treated area appeared to be of a similar order of magnitude (i.e. about 30 mm to 40 mm) to those recorded by SP02 positioned at the base of the LTM, also within the CFA column treated area. This infers that within the CFA column treated area, the ground between the CFA columns at the top of the LTM settles concurrently with the ground at the base of the LTM, by a similar order of magnitude, when the loading from the approach ramp is imposed.

- The measured ground sagging between the CFA columns at SP01, SP02 and SP08 is of a similar order of magnitude to that predicted. The monitoring showed that the ground between the CFA columns settles by around 30 mm to 40 mm. The numerical analyses predicted vertical deformations of up to 35 mm for the ground between the CFA columns. The ground sagging enforces the arching effect in the reinforced LTM towards the CFA columns.

- Interestingly, the magnitude of settlements recorded by SP03 positioned at the base of the LTM but outside the CFA column treated area is also of a similar order (i.e. about 35 mm) to that recorded by SP01, SP02 and SP08 positioned between the CFA columns. This suggests that within the 'transition' zone where the LTM is extended over a lateral distance of 9m but with no CFA columns, the ground is also expected to behave similarly with regard to settlement characteristics (when subjected to a similar load). The predicted settlements within the 'transition' zone were 40 mm.

- SP04 and SP05, located outside the CFA column and LTM treated areas, recorded settlements of up to 15 mm. ST07 on the wall panel that is not supported by CFA columns, beyond the ground improvement area, recorded settlements of around 20 mm. The numerical analyses calculated settlements of up to 25 mm.

- Survey targets at top of the flyover viaduct abutment piles P34 and P35 recorded settlements of less than 5 mm since the piles are founded on rock. The measured settlements are consistent with those predicted.

- Lateral deformations of around 10 mm were recorded by ST01 to ST12, P34 and P35. The measured lateral deformations were considered reasonable.
- Groundwater level monitoring in BHN12 recorded negligible fluctuations.
