The paper was published in the proceedings of the 11th Australia New Zealand Conference on Geomechanics and was edited by Prof. Guillermo Narsilio, Prof. Arul Arulrajah and Prof. Jayantha Kodikara. The conference was held in Melbourne, Australia, 15-18 July 2012.

Settlement and load sharing behaviour of a piled raft subjected to strong seismic motion

K. Yamashita¹, T. Hashiba² and H. Ito³

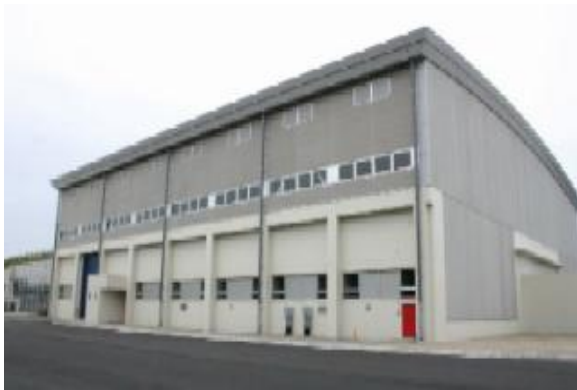
Figure 1. Hadron experimental hall

The hadron experimental hall is located at J-PARC (Japan Proton Accelerator Research Complex) in Ibaraki Prefecture (Figure 1). The J-PARC is a joint project between KEK (High Energy Accelerator Research Organization) and JAEA (Japan Atomic Energy Agency) to study material and life science, hadron and particle physics using high-intensity and high-energy proton beam. Figure 2 shows a schematic view of the building and the foundation with a soil profile. The experimental hall, 19 m in height above the ground surface, is a steel reinforced concrete structure. The subsoil consists of loose to dense sand with SPT *N*-values of 7 to 40 to a depth of 6 m from the ground surface, underlain by diluvial dense sand-and-gravel with SPT *N*-values of 60 or higher and medium to dense sand with

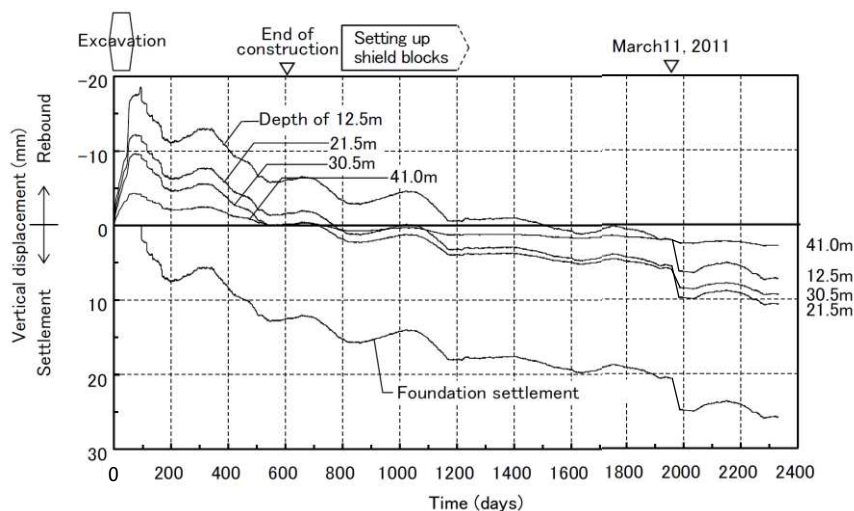
Figure 4. Measured vertical ground displacements

Figure 4 shows the measured vertical ground displacements relative to the reference point. The ground displacement at the depth of 12.5 m was approximately equal to “foundation settlement” if it was initialized just before the casting of the foundation mats. The foundation settlement near the center of the hall was 12.4 mm at the end of construction. Thereafter, the settlement increased due to the setting up of the shielding blocks and reached 20.7 mm just before the 2011 Tohoku Pacific Earthquake. Figure 5 shows the measured axial loads of the piles. As for pile P1, the measured pile-head load increased considerably after the end of construction due to the setting up of the shielding blocks. Figure 6 shows the measured contact pressures and pore-water pressure beneath the raft. The contact pressures increased gradually after the end of construction and the pore-water pressures were almost constant.

Figure 12 shows the profiles of the measured vertical ground displacements just before and after the earthquake, where the measured displacements were initialized just before the casting of the foundation mats. The foundation settlement increased 4.1 mm to 24.8 mm 28 days after the earthquake. It can be seen that the increments in the ground displacements occurred mostly by the compression of the silty soil between depths of 23 and 41m. The compression of the silty soil seemed to be caused by the vertical cyclic loading due to the inertial force acting on the building. Thereafter, the vertical ground displacements were stable and the foundation settlement reached 25.2 mm one year after the earthquake as shown in Fig. 4.

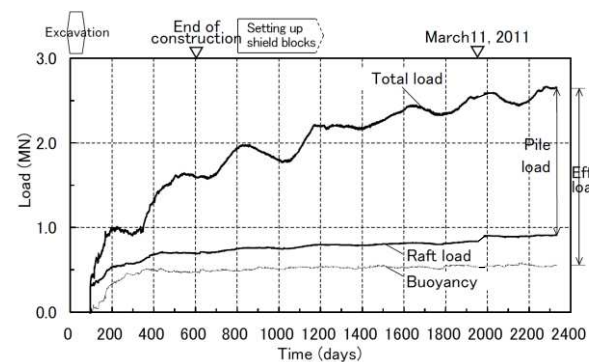
(a) Load sharing between raft and pile

(b) Ratio of load carried by pile

Figure 7. Load sharing between raft and piles on tributary area of pile P1

Figure 7(a) shows the time-dependent load sharing among the piles, the soil and the buoyancy in the tributary area of pile P1. Figure 7(b) shows the ratio of the load carried by the pile to the effective load versus time together with that to the total load versus time. Here, the total load was the sum of the measured pile-head load and the raft load, which was derived from the mean value of the measured contact pressures, and the effective load was the total load minus the buoyancy. Figures 8(a) and 8(b) show those in the tributary area of pile P2. The ratios of the load carried by the piles to the effective load in the tributary area were estimated to be 0.85 on pile P1 and 0.67 on pile P2 just before the earthquake. At that time, the ratios of the load carried by the piles to the total load were estimated to be 0.67 on pile P1 and 0.45 on pile P2.

The ratio of the load carried by the piles to the effective load in the tributary area of pile P1 decreased only slightly to 0.82 and that of pile P2 decreased slightly to 0.57 28 days after the earthquake. In one year after the earthquake, the ratios of the pile load to the effective load were quite stable. Meanwhile, the ratios of the pile load to the total load decreased only slightly to 0.65 on pile P1 and 0.43 on pile P2 28 days after the earthquake.

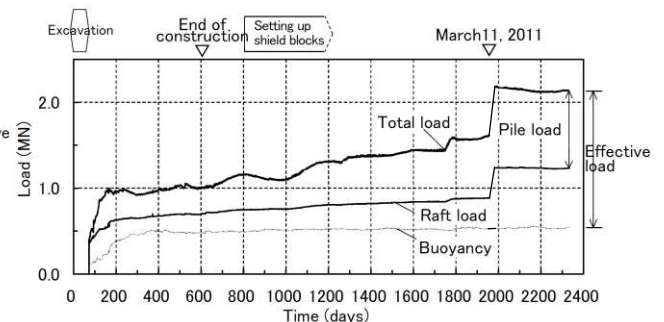
(a) Load sharing between raft and pile

(b) Ratio of load carried by pile

Figure 8. Load sharing between raft and piles on tributary area of pile P2

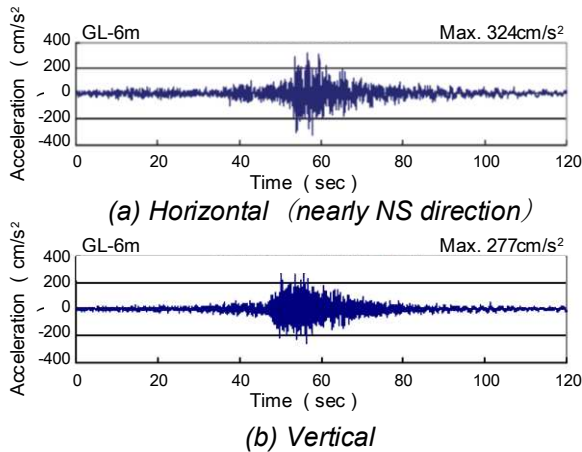
Figure 9. Time histories of accelerations at Tokai (Hashimura et al. 2011)

The 2011 Tohoku Pacific Earthquake struck the East Japan on March 11, 2011. Hashimura et al. (2011) has reported about the response characteristics of the five-story base-isolated building located 0.9 km south from the hadron experimental hall. Figure 9 shows the time histories of accelerations

observed at a depth of 6 m below the ground surface near the building. The peak horizontal and vertical ground accelerations of the earthquake were 3.24 m/s^2 and 2.77 m/s^2 , respectively. Figure 10 shows the response spectra with a 5% damping ratio of the horizontal acceleration of the ground and that of the basement. It can be seen that the predominant period of the horizontal ground acceleration was 0.22 s.

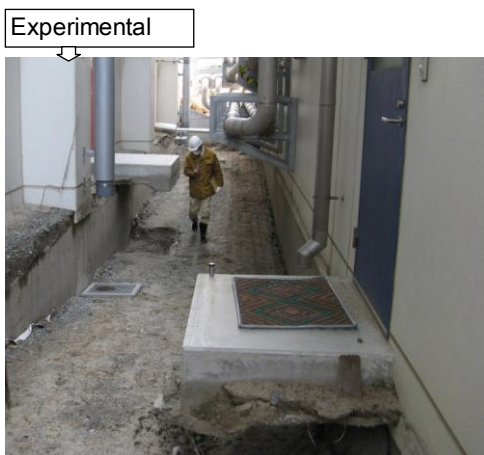
Figure 11. Ground subsidence around the building

Figure 11 shows the ground subsidence along the northeast side of the experimental hall near the north corner. The ground subsidence reached a maximum of 1.2 m, which was presumed to be caused by compaction of the back-filled sand due to the strong horizontal and vertical ground motion. Although the monitoring system was suspended immediately after the earthquake because of power outage, the system was restored 28 days after the earthquake.

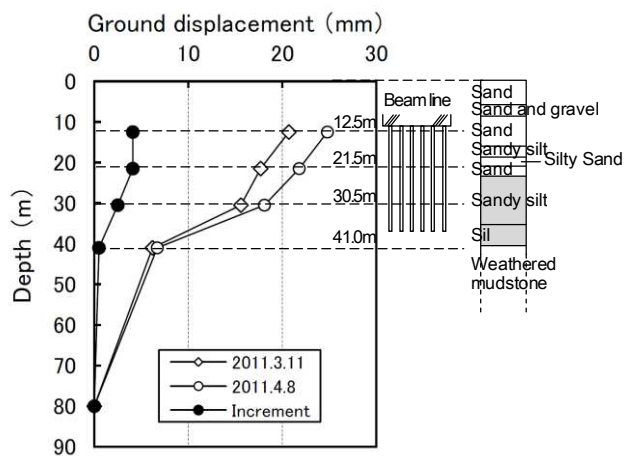
Figure 12. Profiles of vertical ground displacements
