Monitoring the Effect of Massive Sandstone Roof in a Longwall Operation at West Cliff Colliery, New South Wales

SUMMARY Results of monitoring the first longwall at West Cliff Colliery are presented. The monitoring programme had the express aim of establishing the stability of the gate roadways and the intervening pillars, overlain by a massive sandstone roof, as input data for future longwall operations at the colliery. The parameters monitored included (i) pillar load close to the face (ii) convergence in gate and main roadways (iii) convergence in other roadways located around the longwall (iv) load on face support chocks (v) stress in other pillars ahead of the longwall face. The results of these investigations showed that the size of the pillars is adequate and the convergence of the roadways is within acceptable limits. Excessive loading occurred on four-way roadway intersections and in future these will be eliminated. Results of observations also show that roof behaviour in the goaf is greatly influenced by the joint system in the sandstone, leading to asymmetrical failure of the goaf behind the face.

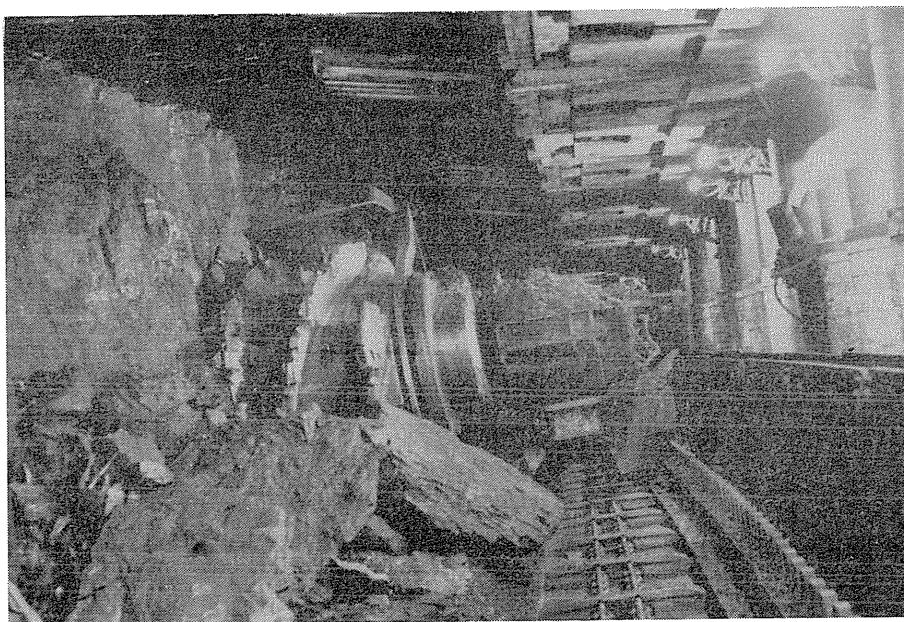
Figure 3 Longwall face installations

Mathematical modelling using the boundary element method was undertaken to define the size of the gate roadway pillars. Based upon a three-heading panel layout and operational experience the size of the chain pillars was selected to be 35m x 55m and 20m x 80m (Figure 2). On the basis of mathematical and physical model studies, underground geological data analysis and observations in other mines working in the region, a 900 tonne four-leg chock-shield support system was selected. A 1250 tonne/hour conveyor system and 350 kW shearer-loader formed the backbone of the longwall operation. The face support equipment is the largest ever manufactured in the world for this purpose. Figure 3 shows the face installation.

Each of the 89 chock-shield longwall face supports (Figure 3) was equipped with two pressure gauges, enabling the hydraulic pressures in the rear leg pair and front leg pair to be measured separately. Pressure was also monitored using pressure transducers and the information conveyed to the surface by telephone cable. Computer processing of this information presented some early problems.

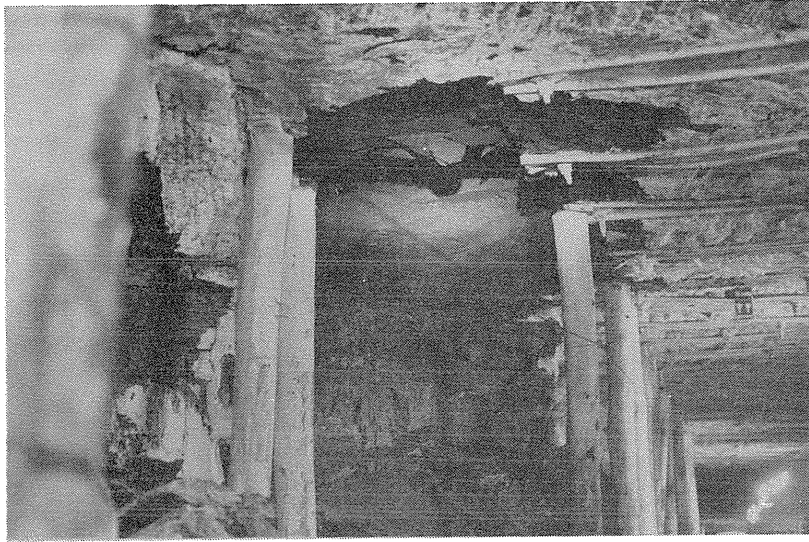
Figure 9 Conditions of roadway in B heading, 471 Panel, in sandstone area showing effect of high pressures

Observation of both the main gate and tail gate showed that the presence of jointing played a dominant role in the behaviour of the gate roadways. The main joint system, which made an angle of 30° to the face (Figure 2), protected the main gate. No floor heave occurred in the main gate ahead of the face. This joint system also controlled goaf behaviour such that the main gate road remained open behind the face, sometimes up to 20m but more usually 10-15m when mining under sandstone roof. The tail gate on the other hand experienced heavy loading conditions (Figure 9). Excessive floor heave

occurred at the tail gate end of the face resulting at times in collapse of the tail gate end. Floor heave was seen up to 15m (usually 6-8m) ahead of the face in the tail gate roadway.
