The paper was published in the proceedings of the 7th International Symposium on Geotechnical Safety and Risk (ISGSR 2019) and was edited by Jianye Ching, Dian-Qing Li and Jie Zhang. The conference was held in Taipei, Taiwan 11-13 December 2019.

Upgrading Existing Levees' Seismic Resiliency with Pressed-in Double Sheet Pile Walls

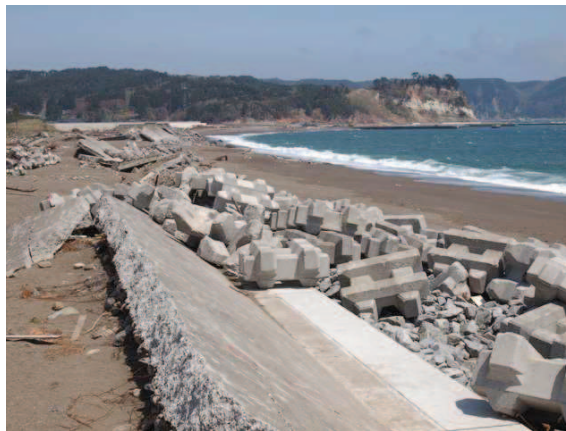
Figure 1. Heavily damaged coastal levee of Noda, Iwate Prefecture (Tohoku Regional Bureau, Japan Ministry of Land, Infrastructure, Transport and Tourism)

A magnitude 9.0 earthquake occurred on March 11, 2011 that caused severe damage to many coastal structures in northeastern Japan. The survey report (ASCE 2013) compiled by the experts from the American Society of Civil Engineers categorizes failure modes of coastal structures observed after the Great East Japan Earthquake and Tsunami. Another major factor contributing to the damage is liquefaction of the foundation soil. Figure 1 shows a heavily damaged coastal levee in Noda in Iwate Prefecture caused by the earthquake and tsunami.

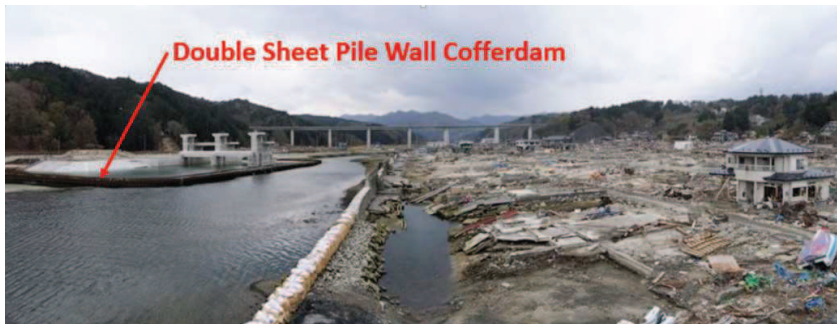
Figure 2. Tsunami-survived double sheet pile cofferdam in Yamada Town, Iwate Prefecture, Japan (Japan Press-in Association, both Figures 2 and 3)

A temporary double sheet pile cofferdam survived the tsunami in the coastal town of Yamada in Iwate Prefecture. See Figure 2 for the cofferdam and the ruined residential and commercial district next to it. The sheet pile cofferdam was still standing upright with only partial damage in spite of the 9m high tsunami overtopping, keeping its original functions as shown in Figure 3.

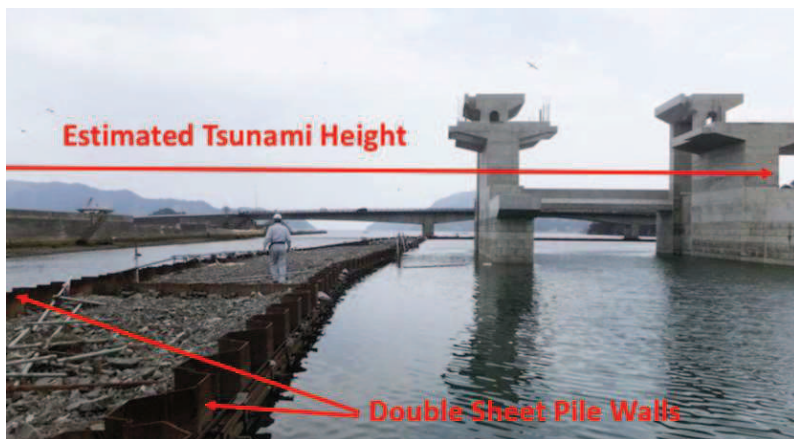
Figure 3. Almost intact double sheet pile wall cofferdam after 9m-high tsunami overtopping

The primary reason for the structure's ability to maintain a high level of resiliency against the strong vertical and lateral forces was that the sheet piles were driven into a non-liquefiable soil layer and the double sheet pile walls were connected to each other with inner bulkhead walls and tie-rods (Otsushi et al. 2015). Since then, the earthen levees' retrofitting with double sheet pile walls has been studied with numerical modeling and physical experiments by various university, government, and corporate researchers primarily in Japan.

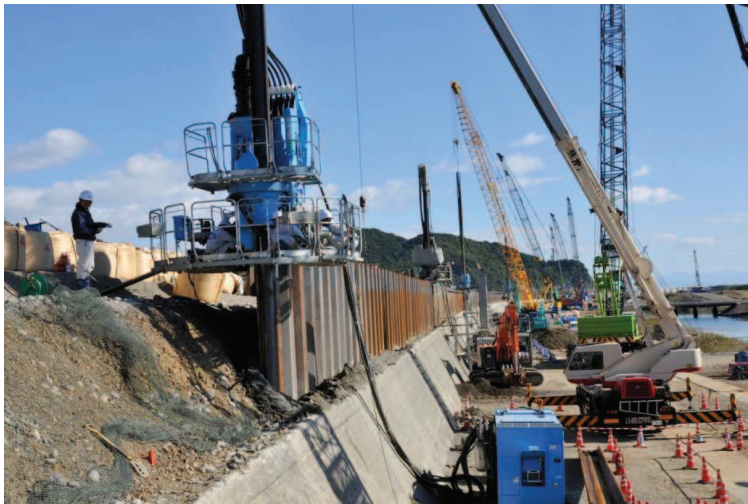
Figure 6. Press-in work of sheet piles into the existing levee at multiple sections

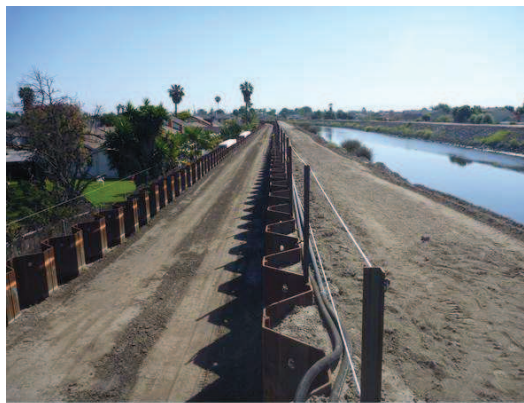
Figure 9. Completed double sheet pile walls

adequacy (Fayad et al. 2015). The sheet piles were pressed in due to the proximity to the nearby homes and concern about the levee’s potential liquefaction by vibratory pile driving (Takuma 2017). See Figure 9 for the installed double sheet pile walls prior to the DSCM column work.
