Qualitative analysis by local ground water level observations and seepage analysis of underseepage during flood at the Kita river

ABSTRACT: At the Kita River, which flows through Kyushu, Japan, there have been three major floods between 2016 and 2018 that significantly exceeded the height of the ground level. Each time, large-scale sand boils due to underseepage have been confirmed at around 13.0 km on the left bank. The base ground has a very thick permeable layer of gravel. Also, a sand layer (thickness of about 2m) has been distributed near the surface of the ground. Given this, the following mechanism may be in operation. While river water has penetrated into the permeable layer, it has been pressurized by the presence of the sand layer near the surface. It is assumed that the pressurized water has broken up the sand layer locally, causing an outflow at high velocity, which has ejected a large amount of sand. After the 2016 flood, an impervious sheet pile wall had been installed. While the effectiveness of the wall was confirmed in some places. But in other hands, there were some places where seepage and boils still occurred at floods after installing the wall. Ground water le

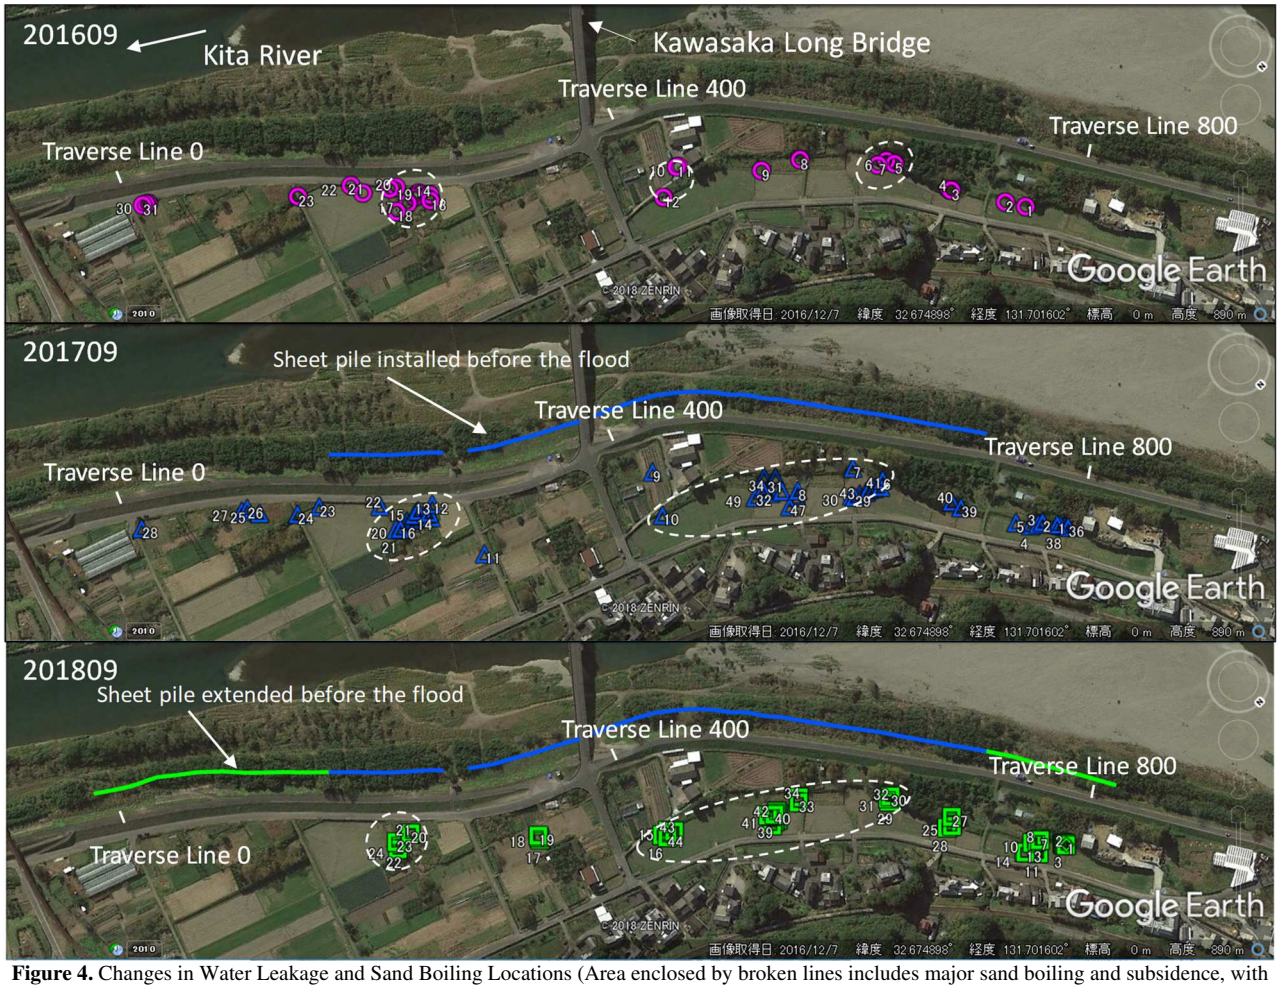
Figure 4. Changes in Water Leakage and Sand Boiling Locations (Area enclosed by broken lines includes major sand boiling and subsidence, with minor water leakage and sand boiling in other areas) from 2016 to 2018 and Range of Measures using Steel Sheet Piles[1]

Fig. 4. shows the transition in seepage and sand boiling locations due to these floods. Compared to 2016, the number of leakage points from the 2017 and 2018 floods increased to around 400-600 side lines[1].

Two factors can be considered for such a change. One is the difference in the highest flood water levels. It is possible that the leakage locations around 400-600 side lines occur due to higher water levels. The second factor is the effect of impervious sheet piles. After the 2016 flood, the installation of impervious sheet piles commences as a means of mitigating the impact on embankments of seepage and sand boiling. Residents near the leakage points have suggested that the reduced water leakage is a testament to the installation of the impervious sheet piles. This can also be considered the case due to the fact that traces of water leakage were only found near the borders of the range where impervious sheet pile was laid and where the July 2018 flooding has slightly exceeded the ground level, which was thought to be the effect of installing the impervious sheet piles.

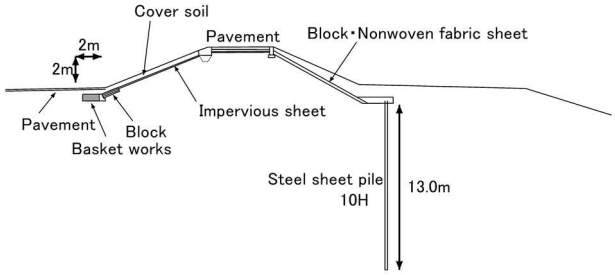
Figure 7. Embankment structure

The embankments in this area had reinforcements for overtopping, like pavement at the top and impervious sheet at landside slope which are unusual in Japan. As mentioned above, impervious sheet piles have been installed and extended in this area since 2016. The result has been the embankment structure shown in Fig. 7.

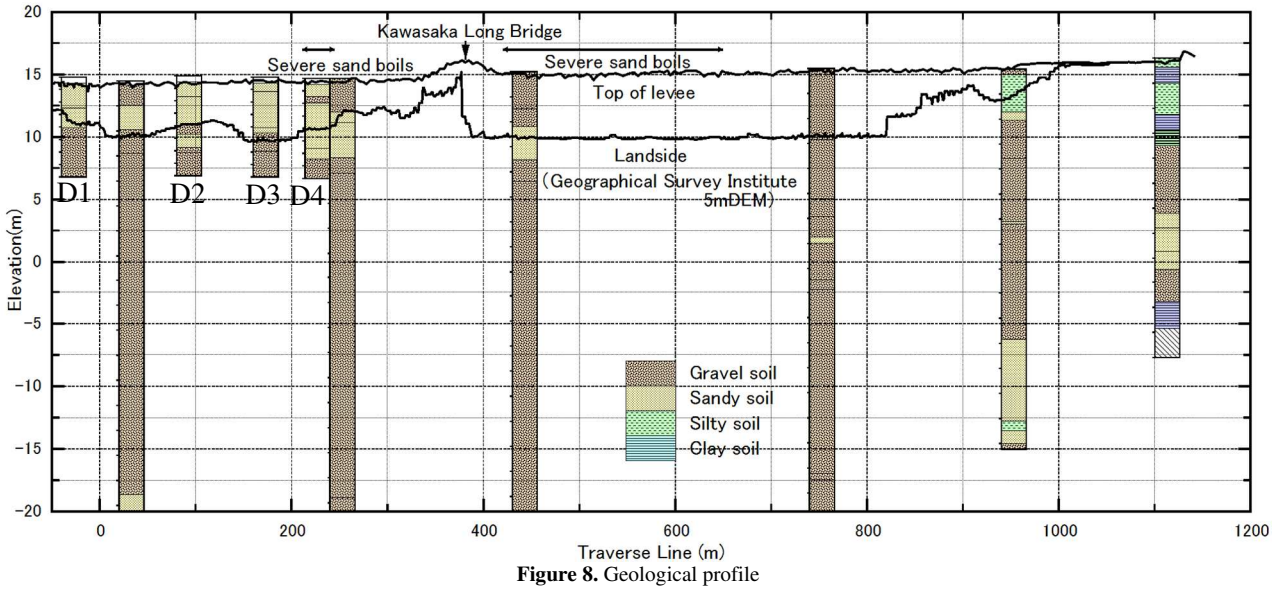
Figure 8. Geological profile

Fig. 8. shows the geological profile of the base ground structure. A thick gravel layer is distributed on the base ground widely. At its deepest points this gravel layer extends to about 50 m, and so the above-mentioned impervious sheet piles cannot completely cover the gravel layer. This is the reason why there have still be seepage and sand boils in spite of the laying of impervious sheet piles. It has been a feature of ranges of intense water leakage and sand boiling that there has been a 2-3m layer of sand distributed near the surface of the levees. According to an

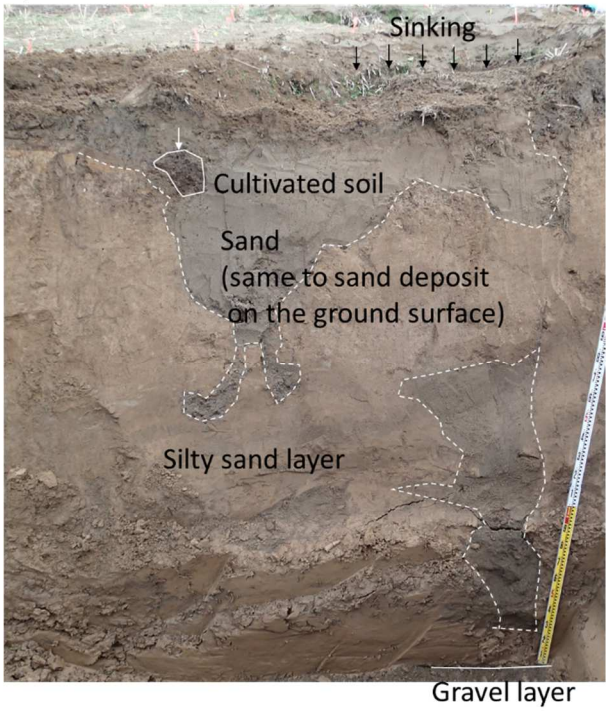
Figure 9. Base ground structure at sand boil observed in excavation survey

excavation survey of the location of sand boils shown in Fig. 9., because this sand layer included a lot of fine silt mixed in it is thought to have resulted in seepage as the water leaks from vein erosion. Sand that accumulates on the surface of the earth is assumed to be in the gravel layer, between the gravel.

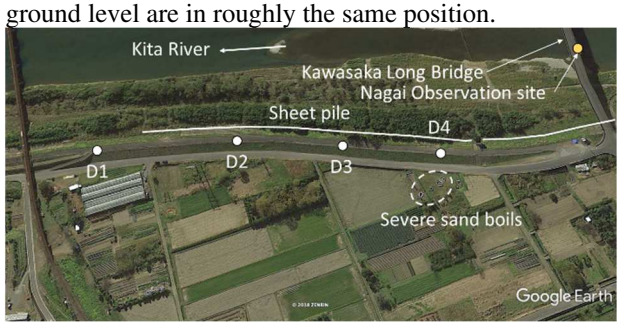
Figure 10. Ground water level observation sites (D1 to D4) and locations of seepage and sand boiling

Observation holes were installed in 4 locations as shown in Fig. 10. to measure the gravel layer pressure distribution directly under embankments at the locations of large-scale seepage and sand boiling and their surrounds.

The most downstream point, D1, was located outside of the impervious sheet pile installation range to verify the effect of the impervious sheet piles. However, it was clear from the boring work for the installation of the observation holes that unlike D2 to D4, the gravel layer at D1 is very dense. When setting the placement of the impervious sheet piles it was not known that there was a change in gravel layer properties between D1 and D2, but this change in gravel layer density happened to be in the location where the impervious sheet piles were laid. The most upstream point of D4 was the closest to the location of large-scale seepage and sand boiling.

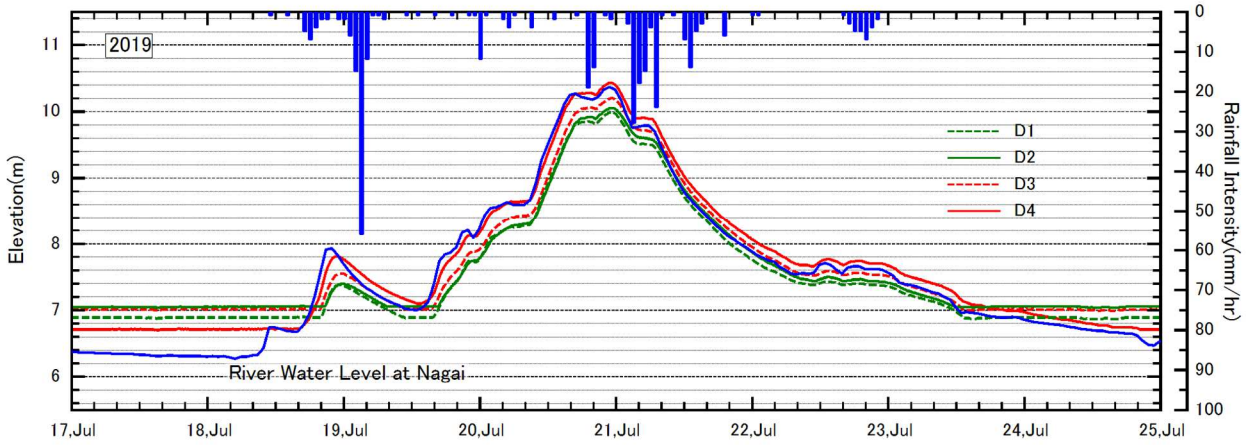
Figure 11. Observation results during July 2019 medium-scale flooding

In the July flood, the small peak was reached from the rain on the afternoon of the 18th. At this time, the water level in the borehole also peaked, with a time delay of 1 or 2 hours. The peak borehole water level was of an order that was close to the location of the large-scale seepage and sand boiling, but both were lower than the river water level, and it was assumed that the borehole water level changed due to pressure propagation due to river water levels. After this, the river water level rose significantly, peaking from the night of the 20th to the early morning of the 21st. At this time, D4 and the river water level rose about the same amount. While this is thought to be dominated by pressure propagation from the river, the rise to the same height as the river water level cannot be completely explained by pressure propagation from the river. Other factors could be thought to include ground water supply from the land sides. Prior to the rain on the 18th, there had been no rain for five days, so the ground water supply had been decreasing, suggesting that pressure propagation from the river had become dominant. Until the peak on the 20th, there was an increase in ground water supply due to rainfall on the 18th and 19th, and this may have led to the river water level being the same as the observation hole water level.

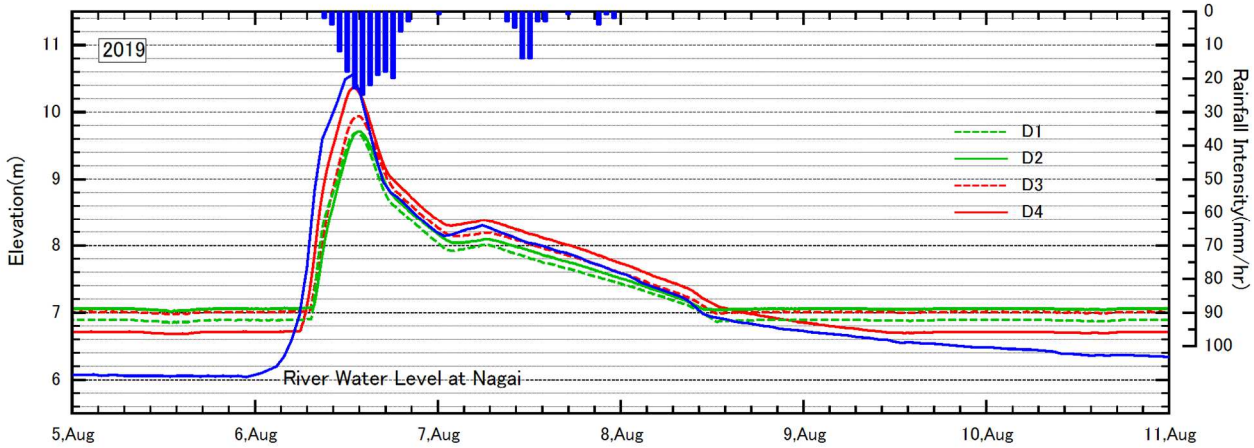
Figure 12. Observation results during August 2019 medium-scale flooding

A similar waveform can be observed to the July 18 night peak in the August flood. There was no rain over

the five days from August 1 through 5, and the ground water supply conditions are assumed to have been very similar to those of the night of July 18.

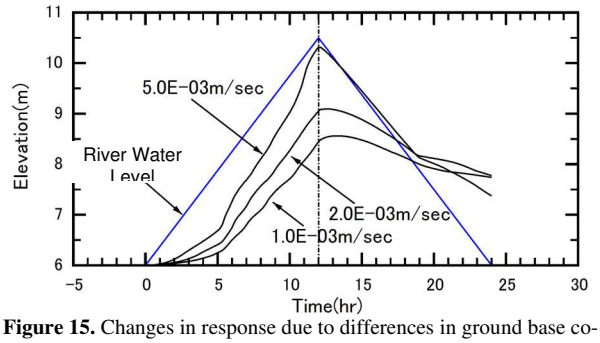
Figure 15. Changes in response due to differences in ground base coefficient of permeability

Fig. 15. shows the application of multiplying the gravel layer with the permeability of 1.0E-03m/sec, 2.0E-03m/sec and 5.0E-03m/sec. The permeability of 1.0E-03m/sec was obtained from the in-situ permeability test. According to these results, the speed of water level reduction was slow compared to actual results for the values of 1.0E-03m/sec and 2.0E-03m/sec, while 5.0E-3m/sec result showed the closest to actual behavior. Thus, in the following calculations the figure of 5.0E-03 m/sec is used for the permeability of the gravel layer. This value

also obtained a maximum borehole water level closest to actual values.

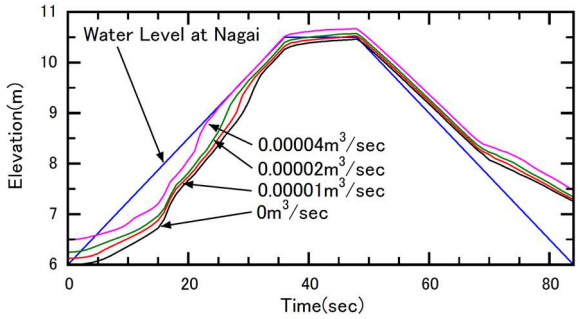
Figure 16. Changes in response due to differences in ground water supply

As a result, the borehole water level was considerably low with respect to the river water level and differed from observed results. Then, a source of current was applied to 5 nodes located at the border with the impermeable layer below the viscous soil on the land side. The amount of current from each node was of three types, 0.00001 m^3/sec, 0.00002 m^3/sec and 0.00004 m^3/sec. These results are shown in Fig. 16. By applying a current of 0.00004 m^3/sec, the borehole water level was confirmed to reach the same height as the river water level.

The ground water supply was thought to be derived from rainfall infiltration, but some of this was considered as rainfall applied to the ground surface with the seepage analysis. The ground water supply given from the current was thought to have appeared as ground water supply from rainfall over time in the surrounding area.

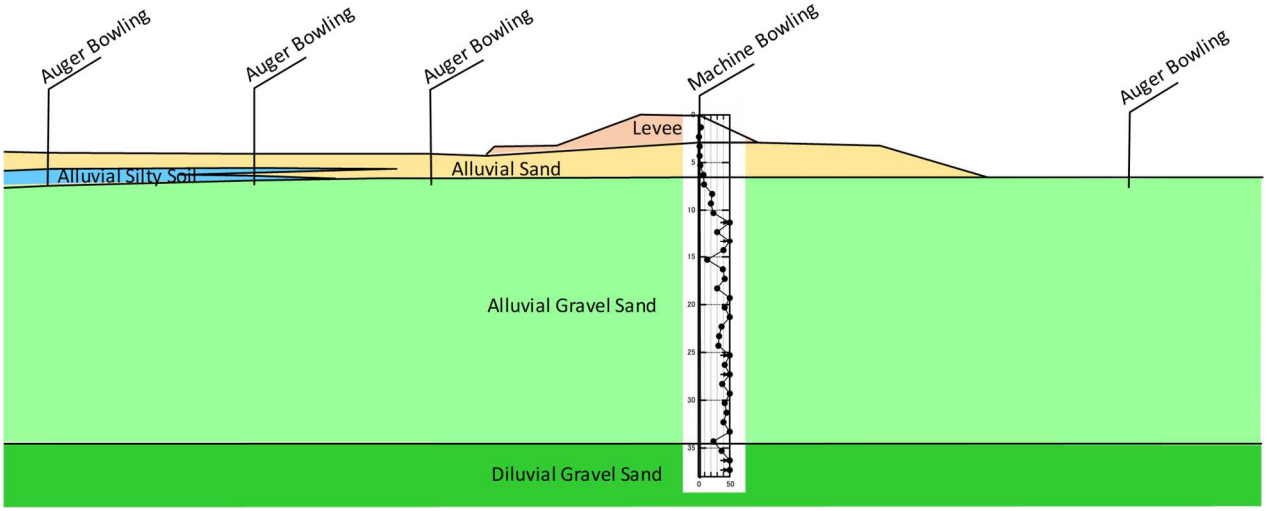
Figure 13. Observation results during July 2019 medium-scale flooding

Fig. 13. shows the geological cross-section from the results of a machine boring survey and auger boring survey in the location in which observation hole D4 was installed.

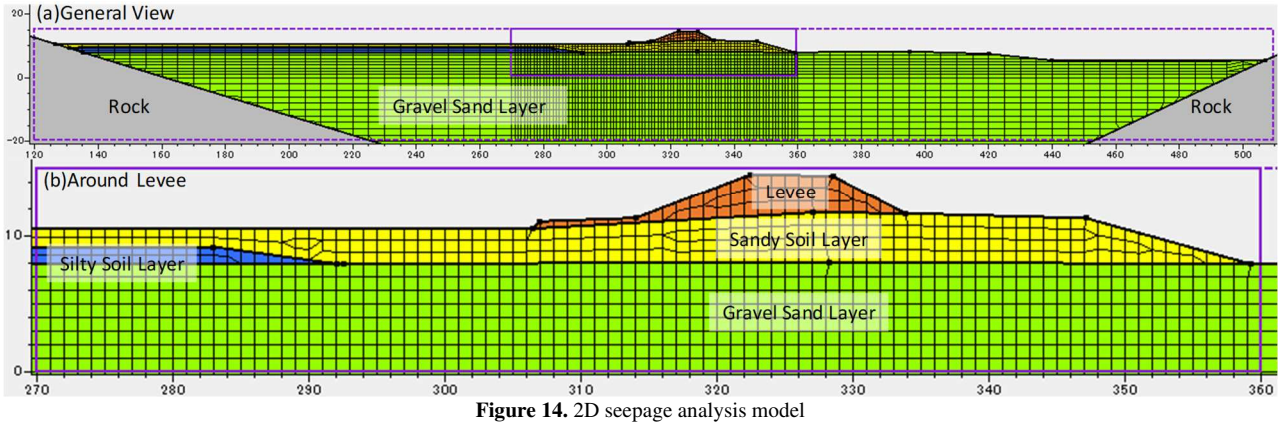
Figure 14. 2D seepage analysis model

The 2D seepage analysis model was created as shown in Fig. 14. from the geological cross-section and slope of surrounding mountains. In the analysis model including the sheet pile, the impervious sheet pile was expressed as a double node and a completely impervious boundary.

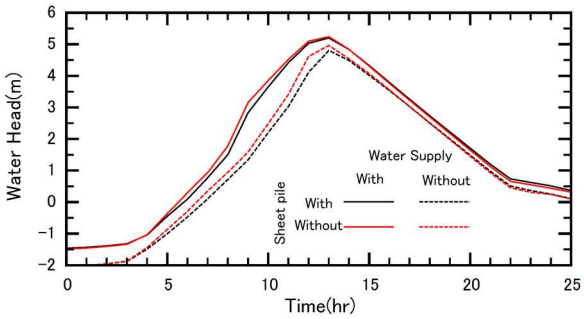
Figure 17. Slope foot base ground pressure head

Fig. 17. shows the nodal pressure head time series at the location of the border of the sand and gravel layers directly under the slope foot. It was found that the results changed a relatively large amount depending on the presence of ground water supply, regardless of the presence of impervious sheet piles. Viewed from the land side, impervious sheet piles appear to artificially create a dead end, but according to the results of the seepage analysis there was no impact. However, when viewed from the opposite perspective, it can also be said that when there is a ground water supply the effect of the impervious sheet pile does not appear. The original effect of impervious sheet pile was not leakage control but the suppression of piping formed directly below the embankment. Therefore, it can be considered that the effect of the impervious sheet pile should not be evaluated based on a single point of pressure directly below the slope foot, but based on the pressure distribution directly under the embankment.
