Characteristics of Ground Motion on Colluviums Slope Induced by Heavy Rainfall

Jeng C.J., Sue D.Z.
Huafan University, Taiwan

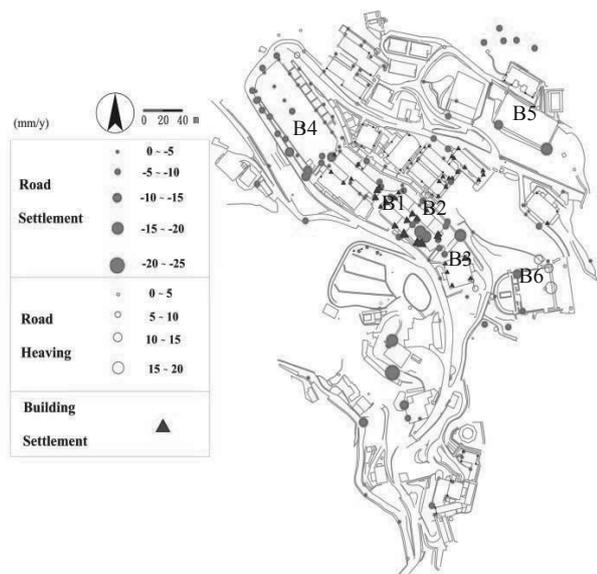
Figure 1 shows the results of the settlement distribution. The settlement marks around buildings are shown in solid triangle and the settlement marks for roads and other land are shown in solid circles, while the heaving points are shown in hollow circles. The values of settlement or heaving are discriminated into five levels from 5 to 25mm and are represented by different size circles. As indicated in Fig. 1, the maximum annual settlement is more than 20mm, distributed around the Hui-tsui building(B1), Chih-an building(B2) and Wu-Ming

building(B3). Although these values did not reach a dangerous level per the general management criteria, for some areas, the cumulated settlements reached over 10cm in the 10 years data. Moreover, when comparing the settlement distribution in Fig. 1 to the distribution of thickness of filled land, in the greater thickness of the filled land areas such as the Sport Ground(B4), the Basketball Court(B5) and Asoka Square(B6), the settlement is apparent. It is speculated that these higher settlement areas have something to do with the thicker fill. On the other hand, for the few heaving points like the upper slope of the Asoka Square, it is the result of the surface concrete pavement heaving caused by extrusion of the slope slide, not the ground surface condition.

Fig. 1 The settlement distribution diagram

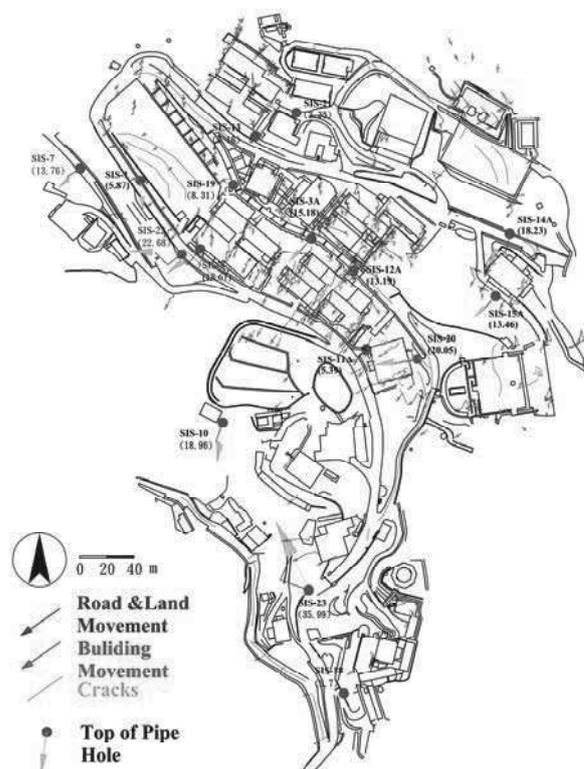
Figure 2 shows the displacement tracks of each observation mark on the plan map. The scale of displacement has been enlarged to 200 times to highlight its tendency. It is shown in Fig. 2 that the main displacement direction is downward to the slope in the southwest or south direction. Meanwhile, the larger displacement is distributed, same as the aforementioned settlement distribution, around the areas of Hui-tsui building, Chih-an building and Wu-ming building. However, the upper slope of the Asoka Square shows movement in the upward direction to the slope. This also can be attributed to the aforementioned heaving phenomenon caused by extrusion of the slope slide, such that an overturning condition occurred in that area. The cracks created in the crown can also confirm this situation. Additionally, the direction of movement for the Sport court is different from the upper slope Dormitory building. That is because they are departing into different sliding blocks.

Fig. 2 displacement tracks and ground surface crakes distribution

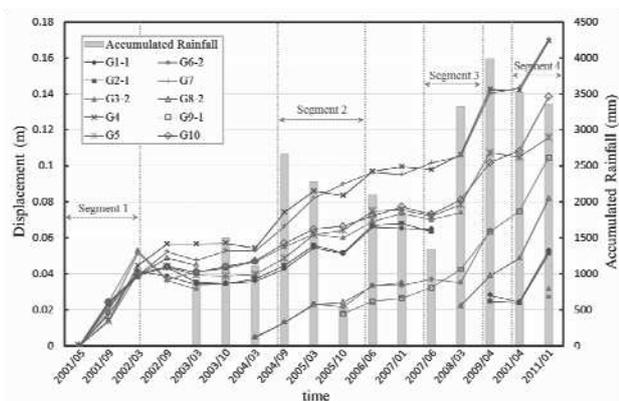
The tendency of displacement with respect to time shown in Fig. 3 is generally similar to that of settlement vs. time shown in Fig. 4. Based on the increment tendency, both can be separated into four distinct time segments: (1) May 2001 to March 2002, (2) September 2004 to June 2006, (3) June 2007 to April 2009; (4) April 2010 to January 2011.

When comparing the displacement and settlement time in Fig. 3 and Fig. 4 with the rainfall record, the displacement and settlement of the slope have a strong correlation with the rainfall record. In addition to the rainfall, another important influence factor to the displacement and settlement of the slope is the construction. For instance, within the third time segment, a new Library and Information Building were built with the excavation for the foundation at the toe of the slope. This may be the cause for the increased amount of displacement and settlement in the third time segment, despite the greater total accumulated rainfall in the second time segment (8973.5mm) versus the third (7241.5mm).

Fig. 3 Relation curves of displacement and rainfall for Hui-tsui building

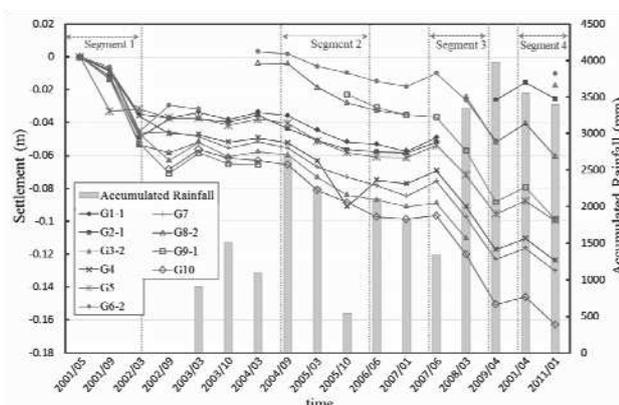
Fig. 4 Relation curves of settlement and rainfall for Hui-tsui building

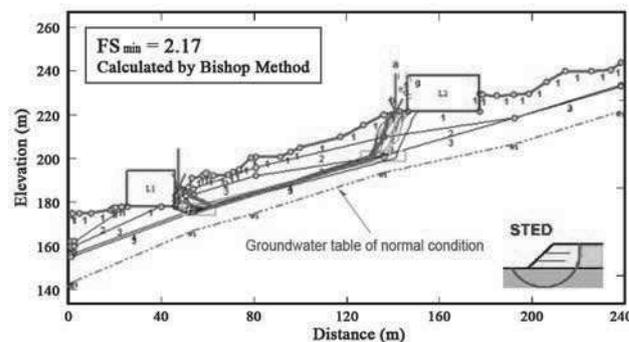
Figure 5 shows the slope stability analysis results for normal conditions. The safety factor is 2.17, which higher than the suggested value 1.5, remains within a stable state. However for rainfall conditions, when the ground water rises 3m, the safety factor decreases to 0.86. An unstable condition can then happen. Thus, it is concluded that the slope stability is significantly influenced by the rise in ground water during rainfall events.

Fig. 5 Slope stability for normal condition (FS=2.17)

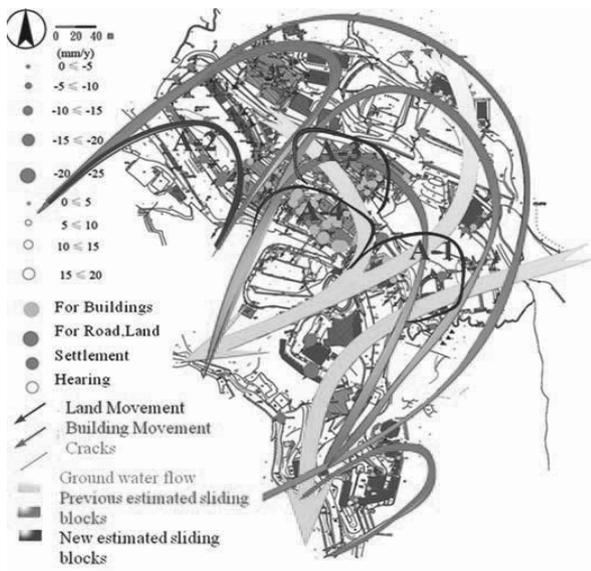
According to the inclinometer monitoring results provided by Jeng and Hsieh (2010), there are six sliding blocks within the slope. In that study, the sliding rate, depth and area of each block were presented. In addition to that information, this study evaluates the result of ground surface movement, including displacement direction and settlement, trend of ground water flow, and the distribution of ground surface cracks. A comprehensive evaluation was made to exam the previous sliding blocks study results. Fig.6 shows the finding which supports the presence of two sliding blocks. Among them, block No. A-1 is located in the area around Wu-Ming building, Asoca Square and the Chea-chau building; block No. A-2 is located in the area around Sport ground where there is 20m of fill. These two sliding blocks coincide with blocks R1 and L1 of the previous study (Jeng and Hsieh, 2010). Both blocks show movement in the shallow layer and are located in the active sliding areas. Numerous cracks can be found along the ground surface in these areas.

Fig. 6 Sliding blocks and movement distribution plane
