Reinforcement of pavements over expansive clay subgrades

J.G. Zornberg & R. Gupta
The University of Texas at Austin, USA

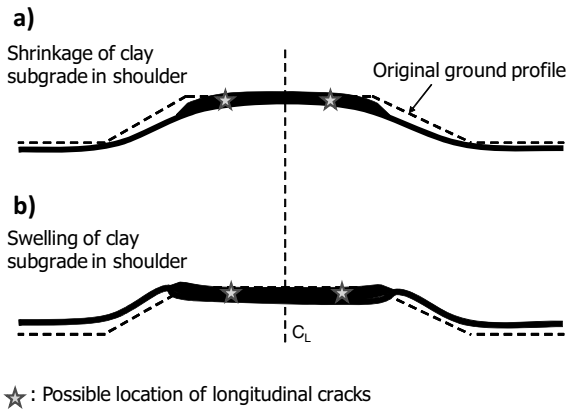
Figure 3. Mechanisms of pavement deflection over expansive clay subgrades: (a) settlements during dry season, (b) heave during wet season.

The mechanisms leading to the development of the classical longitudinal cracks are expected to be due to tensile stresses induced by flexion of the pavement during settlements caused during dry seasons. Figure 3 illustrates the envisioned mechanism that leads to the development of longitudinal cracks. During the dry season, there is decrease in the moisture content of the soil in the vicinity of the pavement shoulders (Figure 3a). This leads to settlements in the shoulder area, but not in the vicinity of the central line of the pavement, where the moisture content remains approximately constant throughout the dry season. On the other hand, during the wet season, the moisture content in the soil in the vicinity of the pavement shoulder increases (Figure 3b). In this case, heave occurs in the vicinity of the shoulder area, but not in the vicinity of the pavement central line. As shown in Figure 3, the cracks are developed in the region where the moisture front advancing and retreating from the shoulders reaches its maximum penetration under the pavement.

Longitudinal cracks have been reported to occur towards the end of dry seasons, which is consistent with this envisioned mechanism. They also have been reported to often partly close during the wet season.

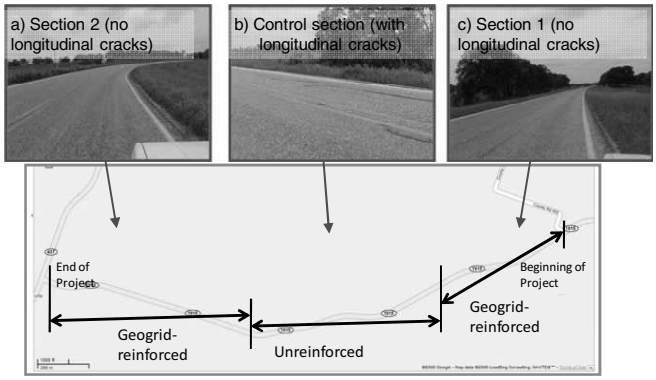
While falling weight deflectometer (FWD) testing was conducted to try to quantify the pavement performance, a clear evaluation was obtained based on condition surveys and visual inspection of the pavement. Specifically, the control section was found to develop significant longitudinal cracks only after a few months of use. On other hand, the two geogrid-reinforced sections were found to perform well, without any evidence of longitudinal cracking. While the actual mechanisms that led to the improved performance of the geogrid-reinforced sections are still to be fully defined, it is clear that an important lesson can be learned from this field experience: geosynthetic reinforcements have prevented the development of longitudinal cracks over expansive clays while unreinforced sections over similar clays have shown significant cracking. Figure 4 illustrates the extent of the three experimental sections and details the performance of the three sections.

Figure 4. Comparison of the performance of pavement sections over expansive clays (FM 1915): (a) Geogrid-reinforced Section 2; (b) unreinforced control section; (c) Geogrid-reinforced Section 1.

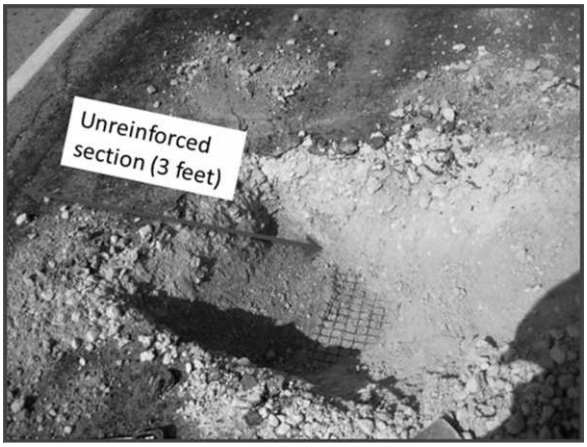
During the summer of 2004, longitudinal cracks were observed to develop in the pavement sections reinforced with Geogrid B, while pavement sections reinforced with Geogrid A were observed to continue to perform adequately. Upon excavation for forensic evaluation of the early developed longitudinal cracks, it was evident that Geogrid B had failed at their junction (i.e. the bonded portion of the geogrid where the longitudinal and transverse ribs intersect), as shown in Figure 6. The material properties of the two geogrids used in this project are listed in Table 3, along with the recommended values defined by project specifications.

Figure 5. View of edge of geogrid reinforcement, directly underneath longitudinal crack.

Figure 6. Separation of longitudinal and transverse ribs at junctions of Geogrid B at FM 1774

The geogrid B has lower junction efficiency than Geogrid A. The junction efficiency is defined as the ratio between the strength of the junction and the rib tensile strength. However, it should be noted that Geogrid B was considered to meet the specifications because the actual junction strength was comparatively high (the low junction efficiency was result of the fact that Geogrid B had a particularly high tensile strength).

Ultimately, it is clear that the currently available specifications based on tensile properties of the geogrid (both ribs and junction) may not be adequate to identify the geogrid properties that govern the performance of geogrid-reinforced pavements over expansive soils. This indicates the need for additional material characterization specifically mechanism based testing approach to provide insight into the actual causes of the differences in performance of various geosynthetics, when used in pavement applications.
