Ground freezing and groundwater control at underground station CS in Rotterdam

V.M. Thumann, G. Hannink, B.R. de Doelder
Rotterdam Public Works, The Netherlands

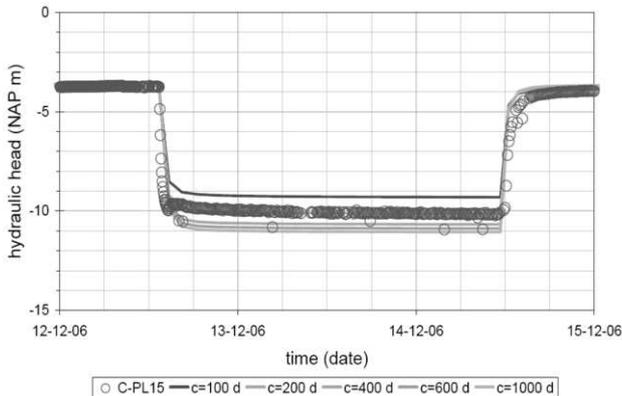
Figure 4 – Time record of hydraulic head at piezometer C-PL15 (points) during first pumping test vs. calculated values (lines) by the MicroFem code for varying resistances. Best fit is for c = 200 days.

The measured values of all available piezometers showed a reasonable fit with the calculated values for diaphragm wall resistance c = 200 days. The quality of the diaphragm wall therefore had to be considered as moderate (less than regular according to Table 3).

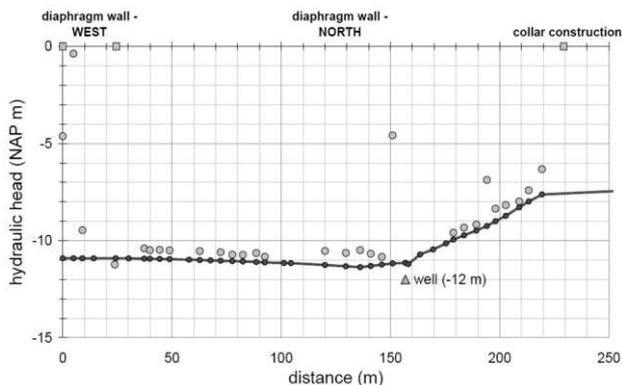
Figure 5 – Typical result of the first pumping test, showing measured hydraulic heads (points) in Pleistocene sand layer along northern diaphragm wall compared to calculated values (line), for dewatering at the middle of the excavation (well) to hydraulic head NAP -12.0 m.

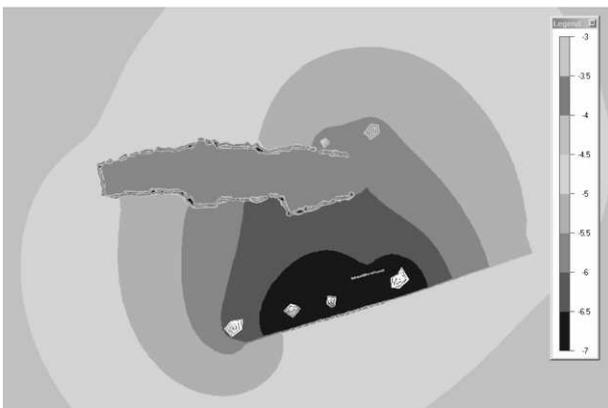
Before re-start, dewatering of the nearby Weenatunnel building pit had been initiated, resulting in a hydraulic head gradient of about 0.02 with flow velocities of around 1.5 m/day as calculated by the MicroFem code. It was recognized that this would at least hamper/delay the freeze-up period. Based on additional MicroFem calculations, it was therefore decided to install so-called mirror-wells to reduce the hydraulic head gradient at the collar construction location, as illustrated in Figure 7. Monitoring records showed hereafter that almost no hydraulic head gradient existed at the ground freezing location, indicating that this measure is very effective.

Figure 7 – Calculated hydraulic head contour lines in Pleistocene sand layer inside and around the building pit, including effect of the dewatering of the Weenatunnel (south) and mirror-wells (north).

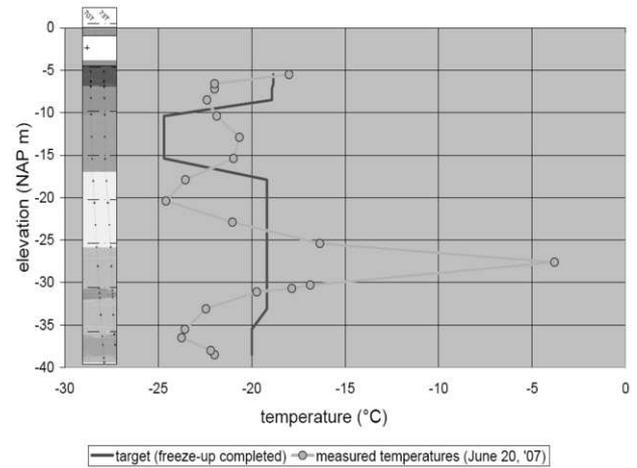
Figure 8 – Recorded temperatures (data by subcontractor MaxBögl) in monitoring casing close to diaphragm wall surface where the collar construction is generated. At NAP -27 m (sensor T70_9), temperatures (blue) are locally strongly deviating from target value (red) and temperatures at other depths, indicating closure has not yet been achieved there.

Detailed investigation of all available monitoring data revealed that an unexpected phenomenon had occurred. With help of the model calculations it became clear that, due to the local dewatering of the Weenatunnel project, the hydraulic head around the outer circumference of the building pit varied between NAP -4.5 m at the far west side of the building pit to NAP -5.8 m at the east side (collar construction) location. Consequently, this resulted in an average hydraulic head inside the building pit of around NAP -5.0 m induced by limited leakage through the diaphragm wall (between panel sections).

This implied that a rather steep hydraulic head gradient had developed at the collar construction location (NAP -5.0 m to NAP -5.8 m over a relative short horizontal distance), which effect was deteriorating in time due to the blocking effect of the growing (thickening) frozen soil columns around the freeze pipes. The blocking effect became noticeable in the monitoring data as off mid June 2007, as illustrated in Figure 9.

As soon as it was recognized that this effect had almost certainly caused the delay, additional dewatering wells were activated inside the building pit in order to balance the hydraulic

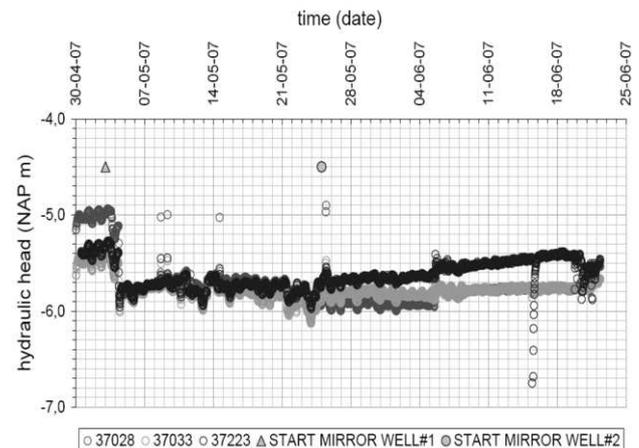
Figure 9 – Recorded hydraulic heads in time, showing a rising tendency inside the excavation (37223-blue) compared to outside (37033-green & 37028-red) due to the blocking effect. Note that the difference in hydraulic head outside the excavation (red at north vs. green at south) has been eliminated after activating mirror well#1.

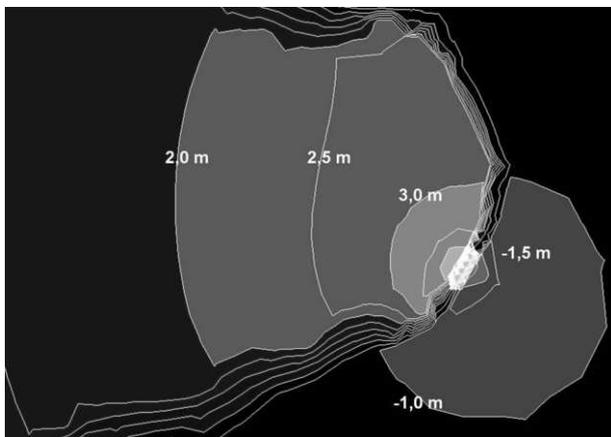
Additional groundwater calculations with the MicroFem code revealed that an increasing gap resulting from thermal erosion would cause significant changes of monitored hydraulic head and water discharge volumes, see Figure 10.

Figure 10 – Calculated contour lines for expected change of hydraulic head near gap in collar construction.

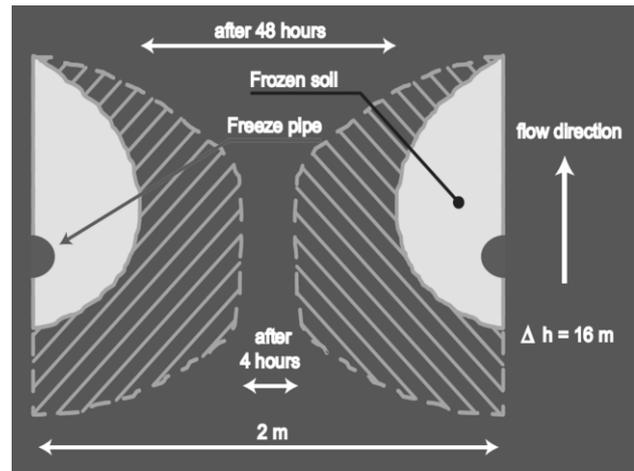
Additional thermal calculations as performed by CDM Consult GmbH have shown that thermal erosion will occur within a relatively short period of time, see Figure 11.

Figure 11 – Top view of frozen soil body between two vertical freeze pipes. Thermal erosion development is shown, 4 hours and 48 after introducing a large pressure gradient (difference of 16 m hydraulic head) over the initial gap (unfrozen soil) of 0.1 m in the collar construction.

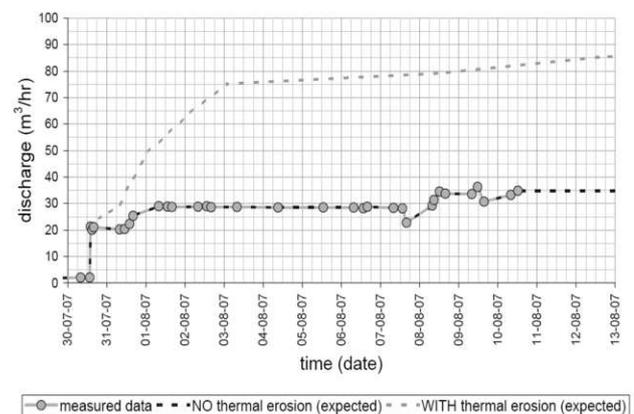
The watertightness test procedure was started after the initial observation that the collar construction was closed, based on temperature monitoring and thermal calculations. The testing protocol required daily interpretation of monitoring data, including approval by Rotterdam Public Works as well as contractor. As a result, the conclusion on 100% watertightness of the collar construction could be made immediately after the test period was completed, as none of the thermal erosion effects had shown up (see Figure 12). This allowed contractor to proceed with a.o. excavation works without further delay.

Figure 12 – Measured pumping rates for conditions without thermal erosion. In case of thermal erosion the measured values would progressively increase with time.

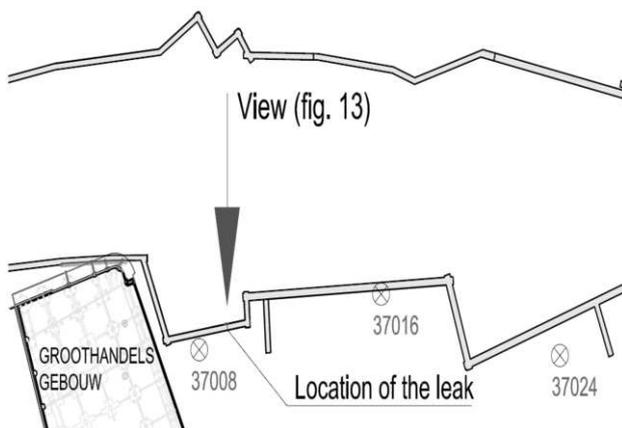
Monday morning, 17 December 2007 a major leak occurred at a joint of the diaphragm wall at the moment that the maximum excavation depth of 14 m was reached. A huge amount of water and sand entered the building pit, Figure 13.

The location of the leak is indicated in Figure 14. The distance between the location of the leak and the nearby monumental Groot Handelsgebouw is about 20 m.

Figure 14 – Location of leaking diaphragm wall joint and of piezometers 37008, 37016 and 37024 (see also Figure 1 for orientation).

The final solution consisted of a sheet pile wall in front of the leaking joint, outside the building pit, at both sides connected to the diaphragm wall by jet grout piles. Both sheet piles and jet grout piles had to be installed to the same depth as the diaphragm wall: a depth of NAP -38 m. This was realised in the beginning of 2008, but it appeared to be impossible to install the sheet piles to the required depth. It was therefore decided to install a complete wall of jet grout piles around the leak (and the sheet piles). This did not result in a watertight secondary wall. Drainage tests showed that there were openings between the piles, apparently due to small inclinations of the piles. Fortunately, during the whole period the PU foam functioned well, and no new leakage occurred during the installation of the sheet piles and the jet grout piles. The pumping by the additional drainage wells was stopped at the end of March and the intensity of the monitoring programme was reduced. No leakage occurred during the remaining part of 2008.

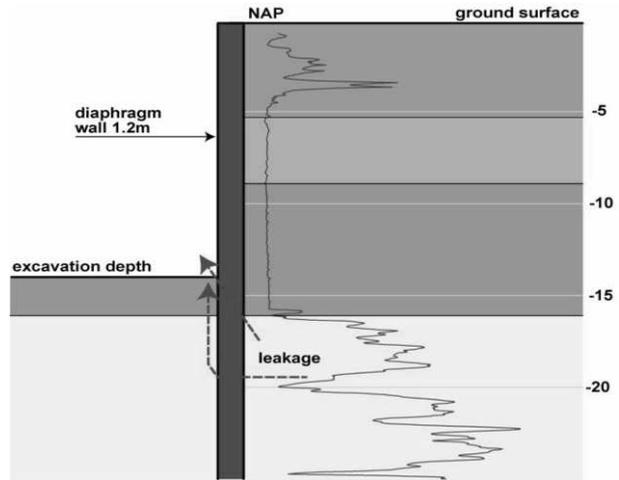
Almost immediately after the discovery of the leak, a PU foam was injected near the location where the leakage was visible and big sand bags were placed to limit the area with excess water in the building pit. The amount of water that entered the building pit was estimated to be 100 to 125 m³/hour. It was suspected that the water was coming out of the sand layer below NAP -16 m. As the water entered the building pit at NAP -14 m, it was concluded that a short cut had developed between this sand layer and the bottom of the building pit despite the presence of rather impermeable clay and peat layers on top of it. The most probable short cut location was the joint between the diaphragm walls, see Figure 15.

Figure 15 – Short cut of ground water through the diaphragm wall joint.

about 50 m^3/hour, and the transportation of sand into the building pit had stopped. Due to the reduction of the flow, it was now possible to inject the PU foam effectively. As a result the leakage was stopped.

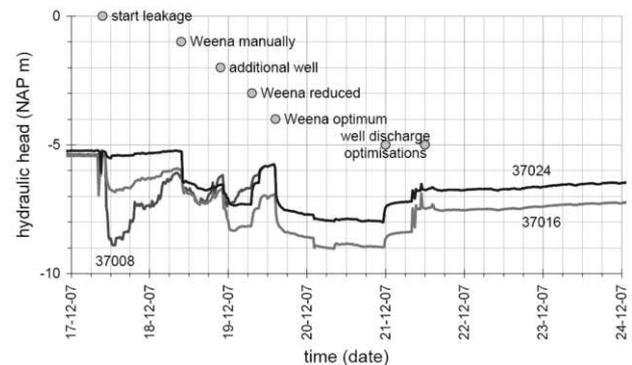
The construction of the nearby new Weenatunnel was at that time in operation. This building pit was surrounded by sheet pile walls. A dry excavation was made possible by using a dewatering system that decreased the water pressure head in the Pleistocene sand layer. As a result the hydraulic head near the leak before the calamity was about NAP -5 m. Piezometer 37008 nearby the location of the leak showed a sudden drop in the hydraulic head to NAP -9 m immediately after the break through. A recovery to NAP -6 m occurred during Monday due to the automatic correction of the Weenatunnel dewatering system, see Figure 16.

Figure 16 – Time recordings of hydraulic heads outside excavation in vicinity of leakage; piezometer identification numbers (37008 / 37016 / 37024) are also shown on Figure 14.

Wednesday morning 19 December 2007 the first drainage well at about 25 m distance of the leak was operational with a capacity of 100 m³/hour. As a result the hydraulic head of the groundwater in the sand layer near the leak was lowered from NAP -6 m to NAP -9 m, see Figure 16. Because of this lowering, the flow through the leak was significantly reduced to
