The Challenge of the Slope Failure Problem and Its Remedial Considerations at Mileage 39km, Mt. Ali Road, Taiwan

Chang M., Huang R.
National Yunlin University of Sci. & Tech., Taiwan

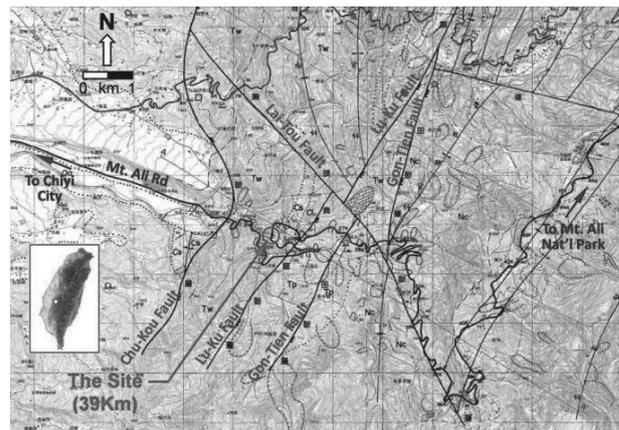
Although both regional and local geology generally show a complex geologic structure at the site, the subgrade materials and underlying rock appeared competent for about 20 years since the road's opening. Figure 1 shows the regional geology of the area, and Figure 2 illustrates the geologic profile of the road section and its adjacent slopes.

Figure 1. Regional geology of the area (Liu & Tseng 2000).

- A complex geologic structure at the site (Figure 1) where the underlying geologic units are generally fractured.
- The 1999 earthquake shaking that had weakened underlying geologic structure and enhanced deterioration process of the materials.
- The steep downhill slope geometry (60° angle & 200m deep).

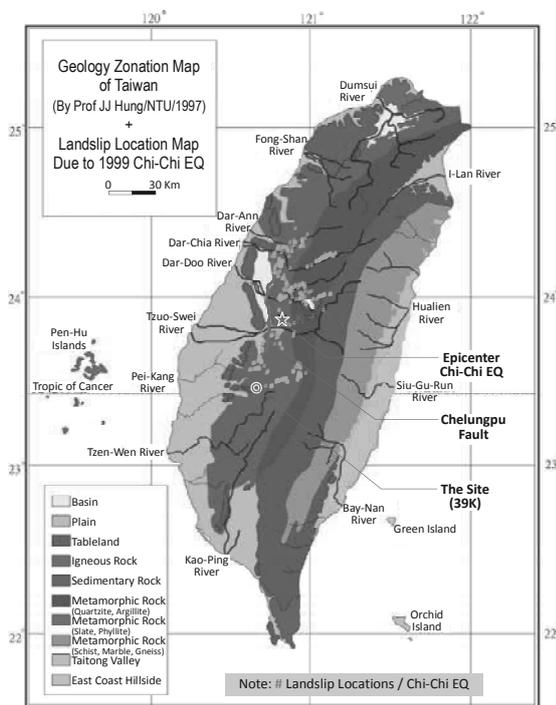
On September 21, 1999, a severe earthquake (Chi-Chi, $M_w = 7.6$) hit central Taiwan and caused numerous landslips or slope failures in the mountain range of the island, as indicated in Figure 3. Based on studies by National Center for Researches on Earthquake Engineering (NCREE 2000), approximately 1500-2000 landslides were directly induced by the earthquake. Although the shaking did not have immediate impacts at the site, the condition of the road and its adjacent side slopes appears to be deteriorating.

Figure 3. Locations of landslides due to Chi-Chi EQ (NCKUE 2000).
