Geotechnical Characterization, Stability Analysis, and the Stabilization Process for a Landslide in a area of Barreiras Formation and Granite Residual Soils, Pernambuco

Coutinho R.Q.

Silva da M.M.

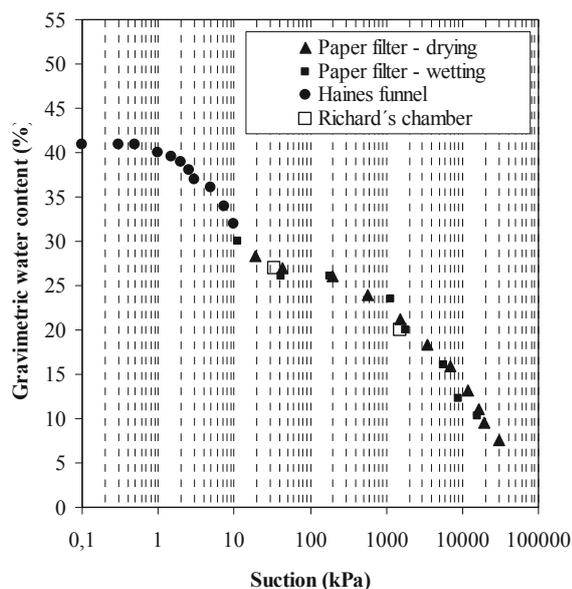
The soil-water characteristic curve obtained through the paper filter method, Haines funnel and Richard's chamber, is presented in Figure 2. The format of the curve displays a saddle aspect, allowing it to be divided into three distinct stretches. The curves indicate an initial air entry suction of 1 kPa, where desaturation begins. After that, a region approximating horizontal is observed, where suction varies from 20 to 200 kPa. In the last stretch, a second air entry value is depicted, where the water content starts to diminish with the increase in suction due to the removal of water from the soil micro pores (see more information in Silva and Coutinho, 2009).

Figure 2. Soil-water characteristic curve from mature residual soil from Camaragibe-PE - Silva and Coutinho (2009)

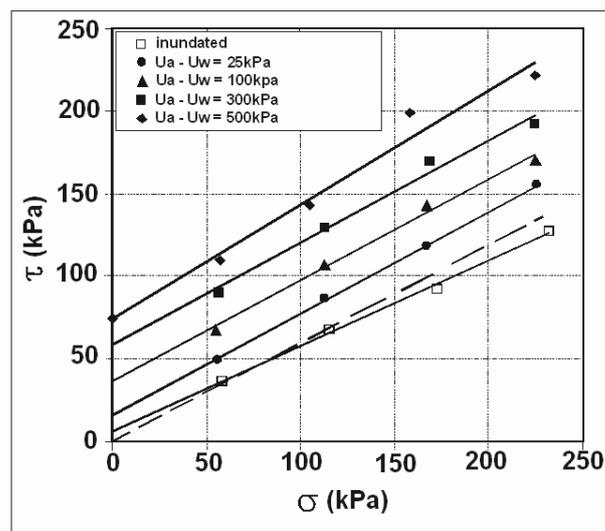
The shear strength envelopes in the plain (σ_v , τ) for the suction values of 25, 100, 300 and 500 kPa are represented in Figure 3. Envelopes considering suction of 0 kPa, obtained through conventional direct shear tests in the submerged condition, are also presented in this figure. It can be observed that the friction angle, in general, is close to 31°. The results indicate that the envelopes are near to linear in the stress range.

Figure 3. Shear strength envelopes for different values of suction - mature residual soil from Camaragibe.
