Importance of Shear Stress Anisotropy and bottom drainage on Tailings Dam Stability: a Case History

Jean-François Vanden Berghe,
Fugro Engineers SA/NV, JFVandenbergh@fugro.be

In February 2007, a tailings dam used as sedimentation pond of lime particles failed. As a result, an estimated volume of 150,000m³ of tailings flowed from the breach in the dam slope. Forensic investigations were carried out to determine the causes of failure, so that suitable changes could be made for the future safe operation of the tailings disposal facility. The investigation identified several features of the tailings material and dam behaviour that it is considered contributed significantly to the slope failure. Among them, a marked anisotropy in the effective shearing resistance of the tailings material and the water accumulation in the tailings were identified as important factors in the failure. The origin of the anisotropy is the method of tailings deposition per layer, and results in a much lower shearing resistance on horizontal planes. The water accumulation was the consequence of a permeability of the tailings being higher than expected due to shrinkage fissures and a significant reduction in

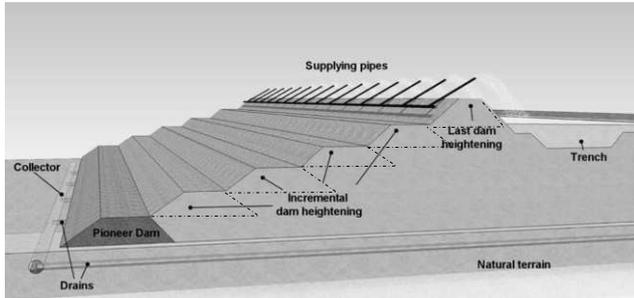
Figure 1 – Dam profile

1960s and have a height ranging from 15m to 30m. The construction sequences for these tailings dams are as follows (see Figure 1):

A series of drainage pipes is buried about 1m deep in the natural foundation soil of about 1m of fine-grained soils overlying silty sands. The purpose of these drains is to collect leachate that permeates downward from the tailings impoundment, and to transport it to a collector drain at the dam toe.

After consolidation, the dam is raised for the next phase of usage by building a new embankment with the coarser tailings material deposited close to the dam periphery. This material is excavated from a trench located close to the dam crest. The dams are raised in stages of 1.5m height.

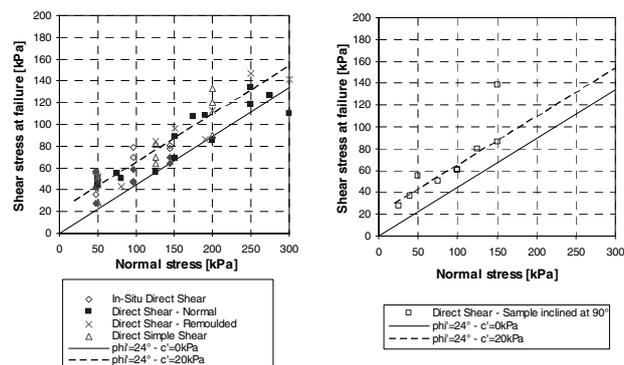
Figure 5 – Drained shear strength measured in various types of tests

For the relevant range of effective stress investigated (predominantly less than 200kPa), a shear strength envelope defined by a friction angle $\phi' = 24^\circ$ and a cohesion $c' = 0$ kPa was found to provide a lower estimate to the measured peak strength, as shown on Figure 5a. This may be considered applicable for shearing along fissures or discontinuities. An additional cohesive component of shear strength is applicable for shear through intact material, and may be represented by a simplified shear strength envelope with a friction angle $\phi' = 24^\circ$ and a cohesion $c' = 20$ kPa, as also shown on Figure 5a. At low effective stresses a tension crack is assumed to form at the crest of the slope.

A number of direct shear tests was completed on samples rotated by 90° to represent shearing on inclined surfaces through the tailings, across the natural stratification of the material. The data from these tests are plotted on Figure 5b and correspond quite well with the shear strength envelope assumed for the intact tailings material, Figure 5a.

a) shearing parallel to bedding b) shearing across bedding planes
