Slope failure movements controlled by unloading Glissement de pente contrôlé par déchargement

S. Cavounidis

M. Bardanis

ABSTRACT

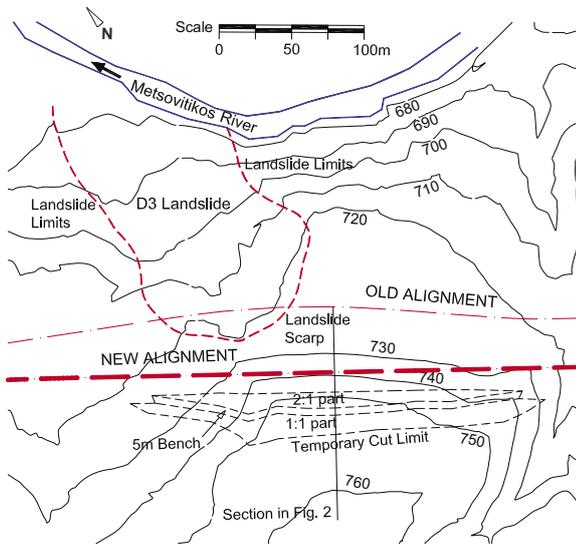
The Cut & Cover Tunnel S2 is located uphill of the landslide in area D3 of Section 3.1 (Fig. 1). Given that the flysch layer dip direction was opposite to the temporary cut slope direction and strength parameter estimations on the basis of GSI values led to satisfactory values ($c'=50\text{kPa}$, $\phi'=30^\circ$), a relatively steep cut slope was initially designed. The maximum height of the temporary cut was 33 m with the upper 11 m high part having a slope 1 over 1 without any support measures and the lower 22 m high part having a slope of 2 over 1 (vertical over horizontal) with 10cm thick fibre-reinforced shotcrete and 4m bolts as support measures (Fig. 2a). A 5m wide bench separated the two parts of the cut and excavation for the lower part was to proceed

Figure 1. Plan of D3 landslide area, old and new Egnatia alignment and initial cut limits.
