The leaning tower of Pisa: End of an Odyssey

M.B.Jamiolkowski - Technical University of Torino, Italy

This paper describes the geotechnical stabilisation of the Leaning Tower of Pisa carried out in the period 1990-2001 by the International Committee for its safeguard and consolidation.

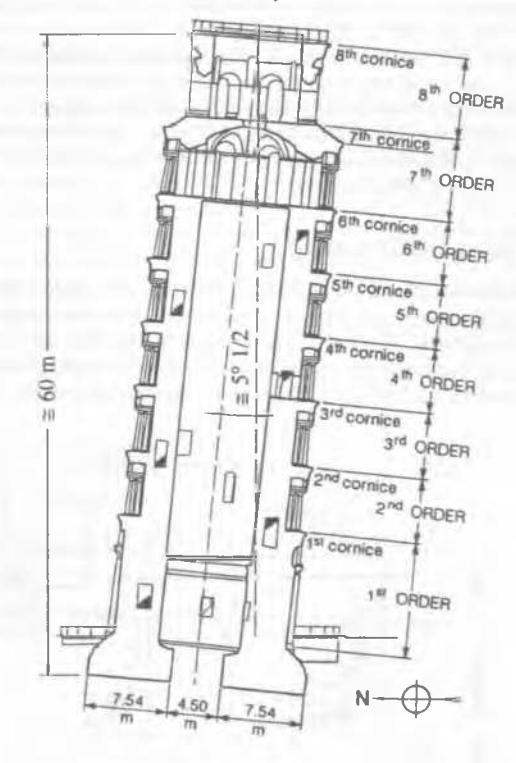
Fig. 2 - Leaning Tower of Pisa - Cross-Section.

$V \cong 142$ MN, $M \cong 327$ MNm, $e \cong 2.3$ m Situation in year 1990

As shown in Fig.2 the tower leans Southwards. In 1993, before starting the stabilisation works on the tower, its inclination approached 5° 1/2 leading to an overhang, with respect to the South edge of the plinth, very close to 4.5 m.

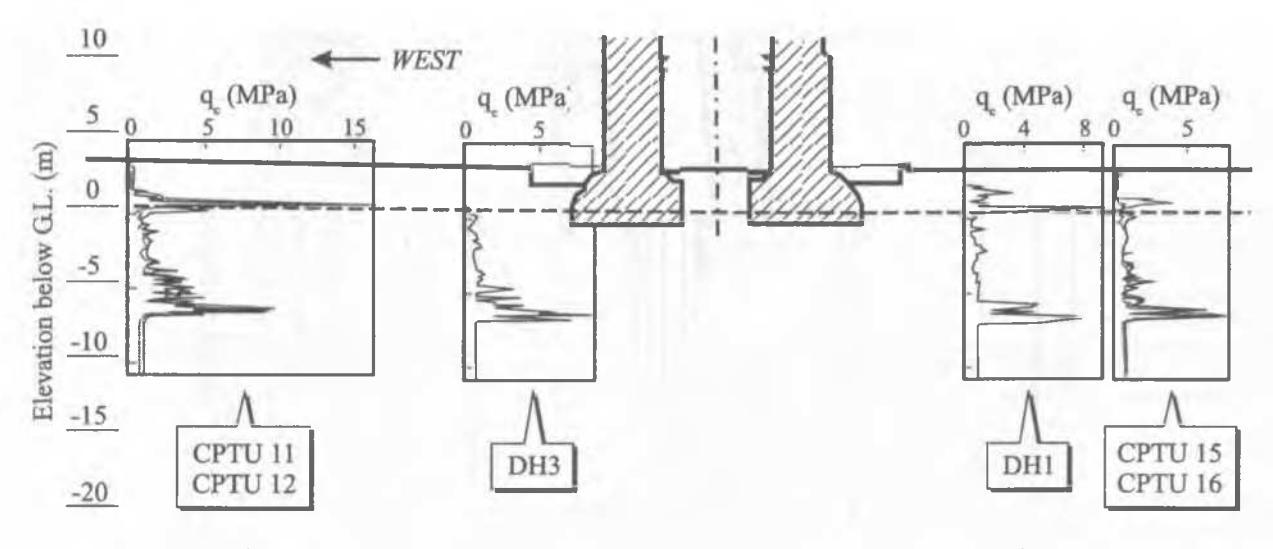
Fig. 5 - Leaning Tower of Pisa - Cone Resistance in horizon A, West-East Cross-section.

The same trend is observed comparing the piezocone data of the western to the eastern edge of the plinth (Fig.5).

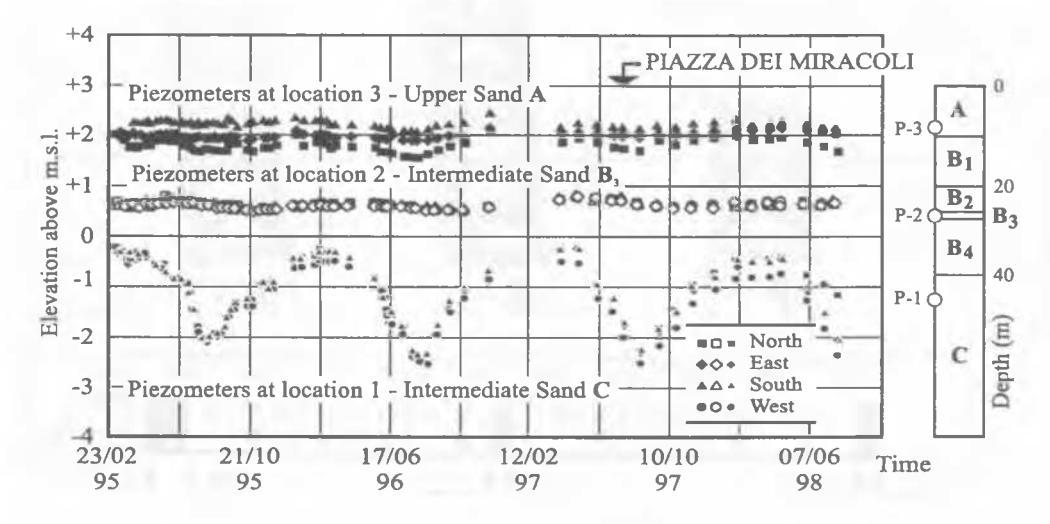
Fig. 6 - Ground water level beneath Piazza dei Miracoli.

The groundwater conditions under the Piazza can be inferred from the Fig.6. The water table in Horizon A oscillates between 1 and 2 m below the ground surface. Intensive and extensive pumping from Horizon C determined that the groundwater table in deep sand dropped down to an elevation varying between -0.5 and -3.0 a.m.s.l. over a period of one year. This drawdown induced the downward water flow responsible for the subsidence of Piazza described in detail by Croce et al. (1981).

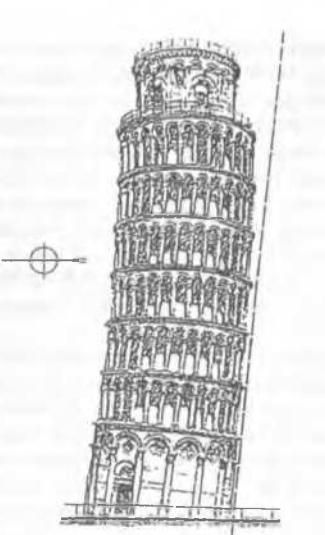
Fig. 9 - Shape of the Tower.

It was during the second construction stage that the inclination began to appear, see Fig.9. This reflects the attempts by the masons, charged with the construction works, to compensate against the on- going tilting. The position and the minor inclination of the added bell chamber, testify a further attempt to correct the geometry of the Monument and to balance the effects of the growing inclination. However, because there are few documents recording the history of the Tower, its inclination has been tracked also by looking at paintings and other historical evidences such as:

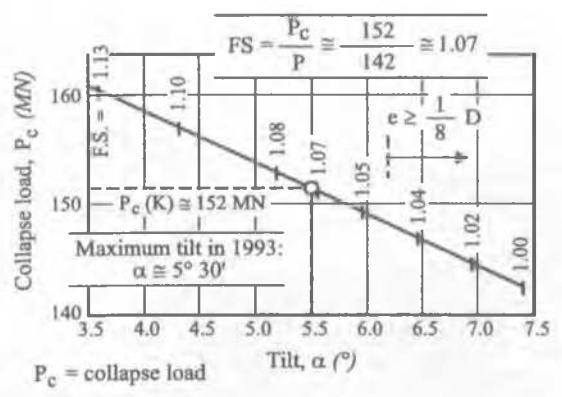
Fig. 14 - Leaning Instability of Pisa Tower: Evolution of safety margin with tilt, Pepe (1995).

All the mentioned attempts to model the leaning instability phethe conclusion that its factor against falling over is very low and falls in the range of 1.07 to 1.15, see examples by Lancellotta (1993), Desideri and Viggiani (1994) and Pepe (1995). Figure 14 shows the relationship between the collapse load P and the tilt α as computed by Pepe (1995) referring to the two degree of freedom spring model. In this computation has been adopted a non-linear relationship between the external moment (M) and α of hyperbolic type incorporating also the effect of the initial geometrical imperfections α_{a} .

It results that in 1993 when the α reached \cong 5° $\frac{1}{2}$, the ratio between the P, and the current weight of the Tower had approached the extremely low value of 1.07.
