Observations on groundwater leakage through cracks and segment joints in a concrete segmental tunnel lining

V. Tellioglu

Senior Tunnel Engineer, CH2M HILL, Abu Dhabi, UAE

ABSTRACT: Facing with the combined challenge of aging sewer infrastructure and rapid population growth, the Abu Dhabi Sewerage Services Company (ADSSC) embarked on a bold approach to build an enhanced sewer infrastructure with a deep gravity sewer tunnel at the center. The primary lining of the new 41 km-long deep sewer tunnel has been completed by tunnel boring machines (TBM). The concrete segmental lining has an internal diameter varying from 4 m to 5.5 m internal diameter, and is located at depths of 20 m to 80 m below the ground surface. This paper attempts to quantify the results of observations made on groundwater infiltrations and response to repair works experienced at different stages in construction of concrete segmental lining for deep sewer tunnels. The observations presented below have been based on the actual data obtained from a total of 10,872 rings installed in three TBM drives in Contract T-02 of Abu Dhabi's Strategic Tunnel Enhancement Programme (STEP).

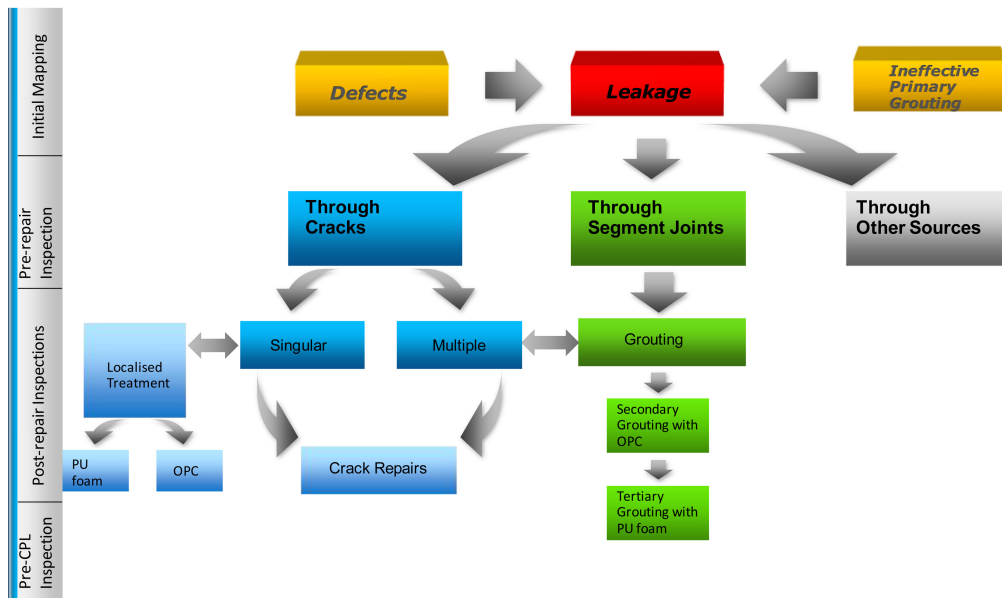
Figure 1. Simplified flow path for leakage control strategy.

The mutual interaction between cracks, infiltrations and response to repair works is a complex phenomenon, and it is hard to monitor precisely. The inter-relation among potential causes, path of infiltration, and corresponding rectification works in relation to the inspection phases are illustrated in Figure 1. For simplicity, the entire process is idealized by dividing into two major components; repair of cracks (either by filling or injection), and sealing of segment joints by suitable grouting.

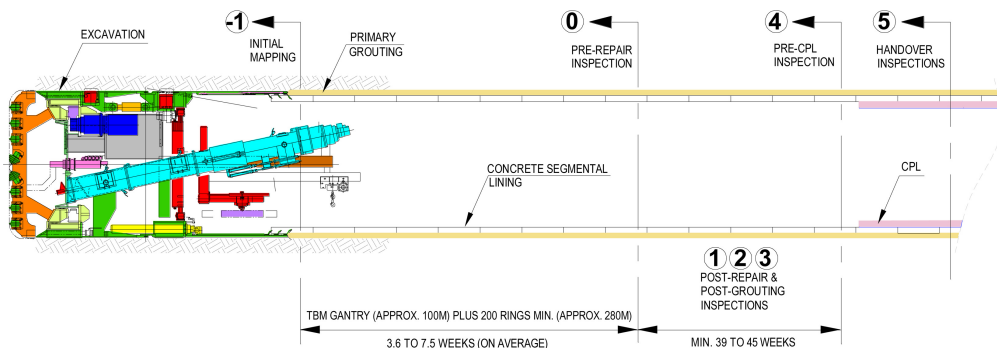
Figure 2. Inspection phases illustrated with approximate locations (Sketch not to scale).

The inspections held cover the initial mapping, before and after-repair observations, and a final check for infiltrations prior to CPL installation. The phases are illustrated in a schematic manner in Figure 2.
