AN ASSESSMENT OF THE FAILURE OF THE WADI DERNA DAMS AND LESSONS FOR ENHANCING DAM SAFETY

Attribution. Please cite the work as follows: World Bank, UNESCO, The Netherlands and ICOLD. 2024. *Breaking Point: An Assessment of the Failure of the Wadi Derna Dams and Lessons for Enhancing Dam Safety*. Washington, DC: World Bank. <https://hdl.handle.net/10986/42940>

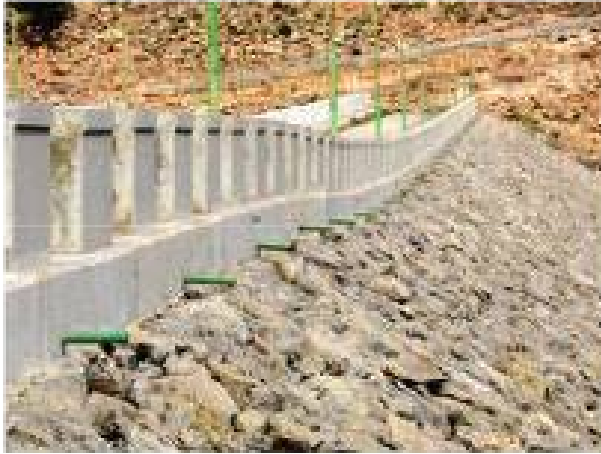
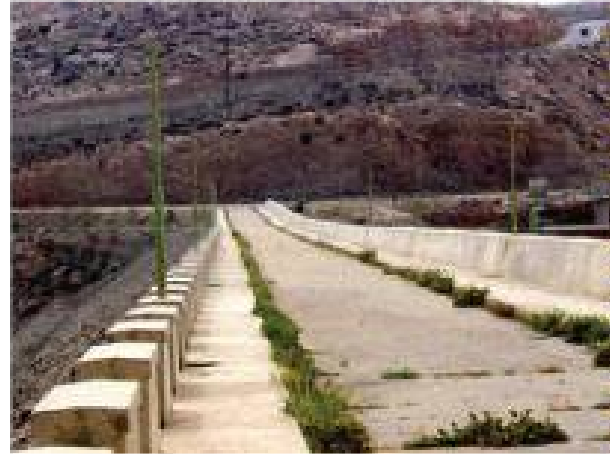
None of the reports from the designer, the contractor, or those involved in the monitoring of the dam until July 1985, question the validity of the settlement measurements (except for point 11, Figure 2.3). It is therefore appropriate to consider that the settlement reflects the actual behavior of the dam. This is supported by the topographic surveys carried out in 2004 that show roughly the same phenomenon. The designer attributed these high magnitude settlements to the "low quality of the material that composes the embankment". No information on the testing data from construction (material testing, compaction testing, etc.) has been identified. The only material requirement for the clay in the design drawing is the maximal permeability of 5×10^{-9} m per second. However, there is no explanation how this was checked during construction, meaning that there is no guarantee on the application of high-quality clay. Test carried out on the clay in 2004 (Stucky 2004) found a low plasticity (=lean clay), suggesting that the maximal permeability for the clay was optimistic. It is unusual to observe a settlement of this magnitude near the banks, where the embankment is not so thick and founded directly on bedrock, and of a similar scale as the central sections. In such instances, the primary cause can only be settlement of the foundation and/or erosion of the embankment. This is consistent with the significant seepage observed, as described below, the development of sinkholes and voids in the dam foundation left by the eroded materials.

PHOTO 2.3. Vertical deformation as seen from the right abutment of the Abu Mansour Dam (a) and horizontal deformation as seen from the left abutment (b).

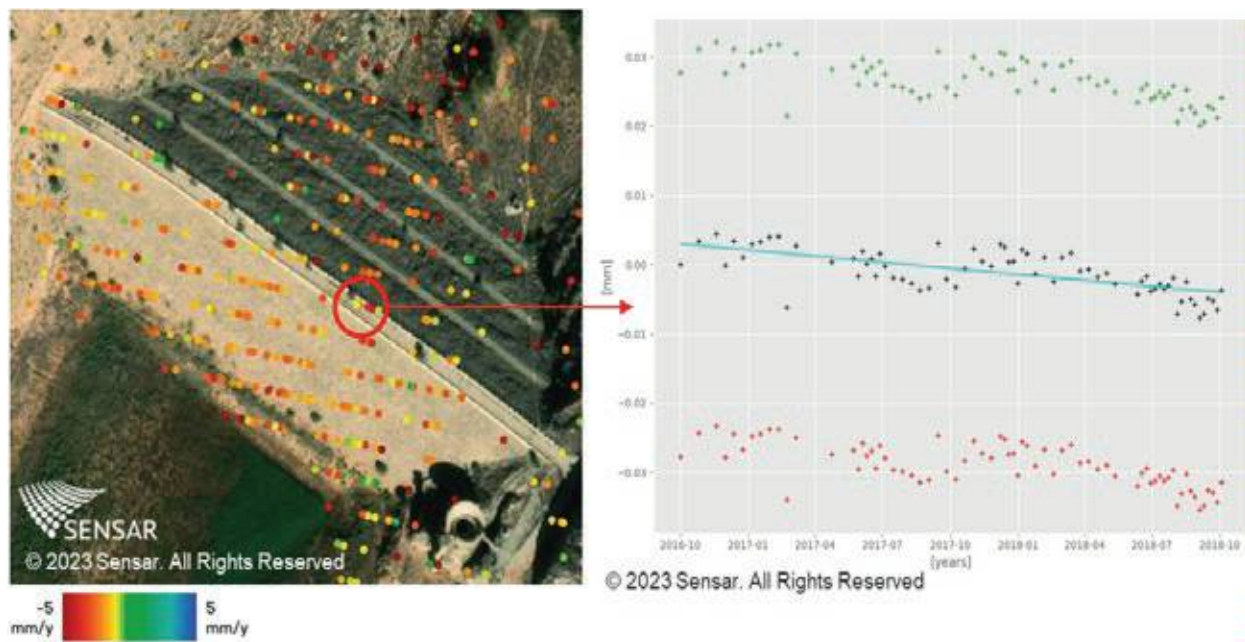
While there is no information on the dam behavior since the 2004 topographic survey, satellite data provides some insights. Vertical deformation measurements from Sentinel 1 interferometric synthetic aperture radar (inSAR) show a linear deformation of -5 mm per year of the crest of the dam during the period of October 2016 until October 2018 (Figure 2.6).³ An analysis of LIDAR data suggests that the crest level before the Abu Mansour Dam collapsed was likely between 226.5 to 227.5 m above sea level and not 228.9 masl as per the original design specifications, suggesting continued settlement of more than 2m (see Figure 2.7).⁴ While there is a margin of error associated with satellite derived data, the observed settlements have resulted in a 'V-shape' of the dam in which the crest was lower than the dam sides, thus reducing the volume needed for overtopping.⁵

FIGURE 2.6. Single-stack inSAR measurements of the Abu Mansour Dam, Sentinel 1 2016-2018.

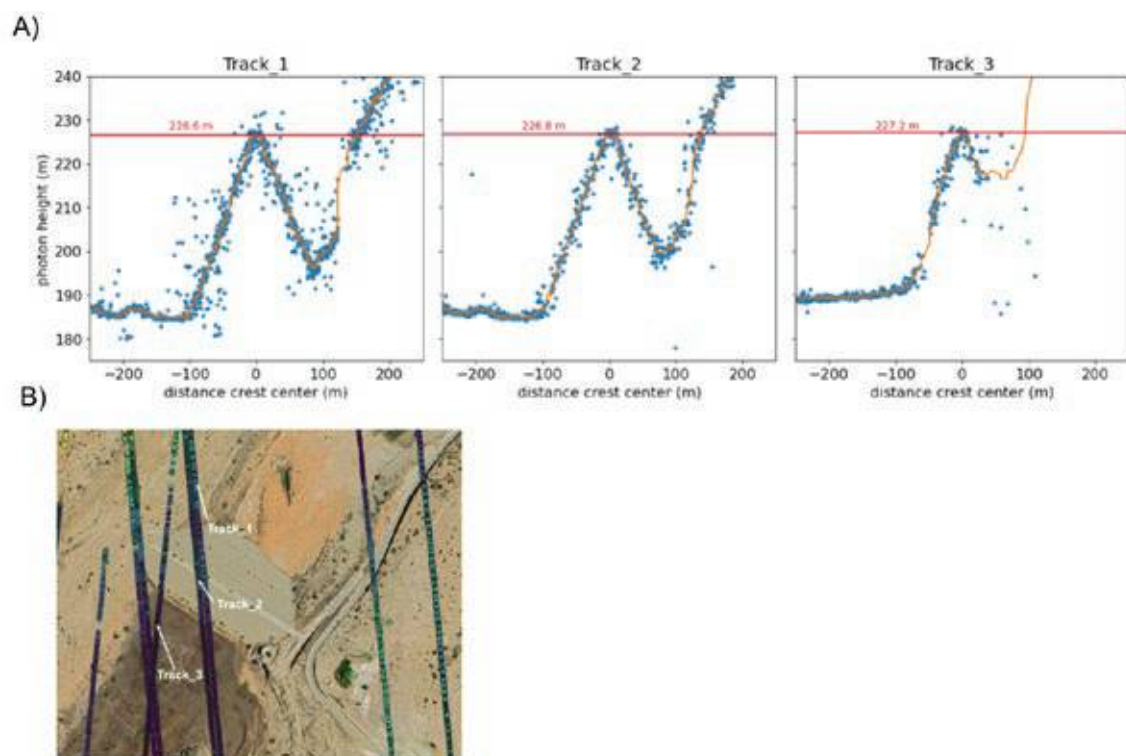
FIGURE 2.7. LIDAR altimetry: (a) Elevation at crest level of different sections of the dam; and, (b) footprint of the three different tracks over the Abu Mansour Dam.

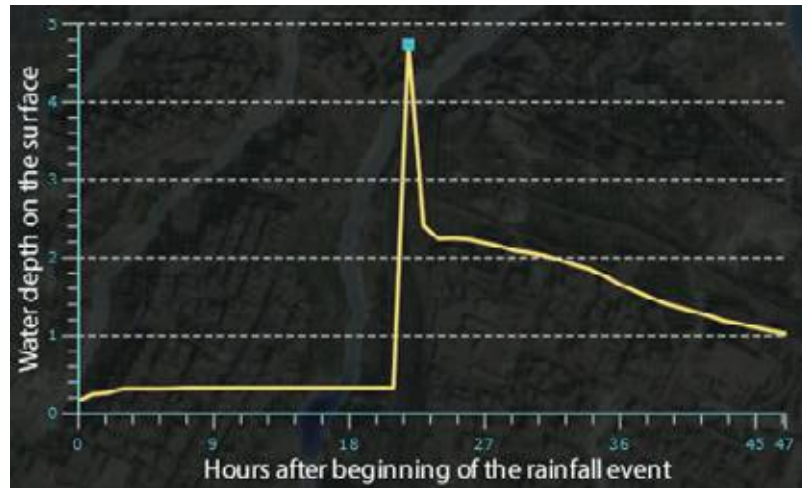
destruction and loss of human lives (see Box 3.2). When the water distributes over the city, the water level drops and sinks out at about 1 meter in approximately 24 hours. While such values correspond to the lower part of the estimations based on simplified hydraulic estimation, eyewitness reports largely confirm this chain of events, in line with the model results.

FIGURE 3.14. Water level rise downstream in Wadi Derna.

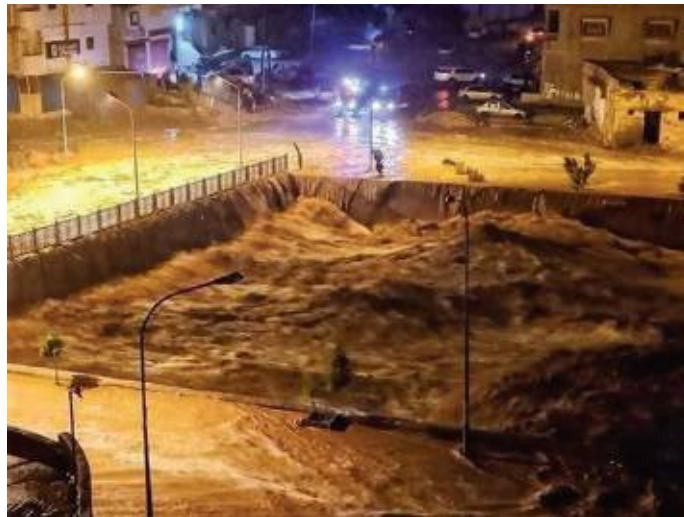
PHOTO 3.4. The water level in Derna during the 2023 flood event.

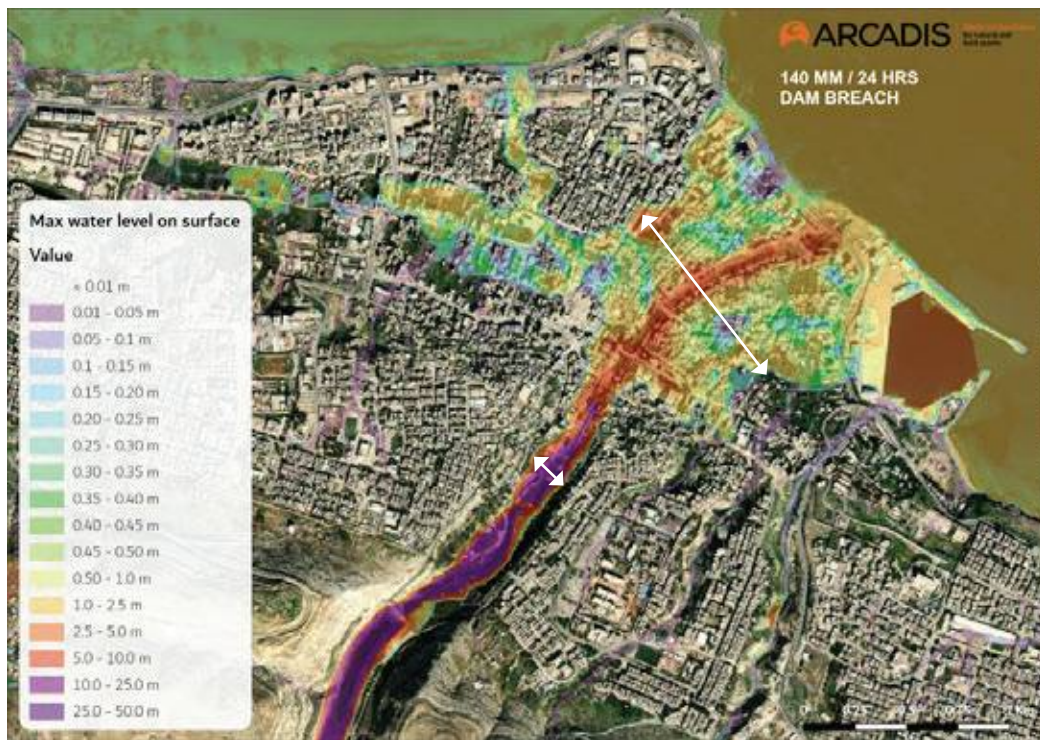
There is considerable uncertainty around the hydrological estimates and the sequence of the dam failures. However, the failure of the Derna Dam is estimated to have generated a flood wave with a flow ranging between 1,500 m³ per second. These estimates are based on observations during the disaster and illustrated by photos taken during the night (Photo 3.4). Such a water discharge can flood a significant part of Derna city. Simulations of the flood wave that was caused by the collapse of the Abu Mansour dam suggests the water level in the city of Derna rose between approximately 5 to 8 m within 30 minutes. These estimates depend on the assumptions used in the Tygron model that was used to simulate flood wave event that was caused by the collapse of the Abu Mansour dam (Figure 3.14). No such computer simulation was made for the collapse of the Derna Dam. The width of the main flow channel would have extended over 800 meters (indicated by white arrow in Figure 3.15) while the maximum water flow velocity is calculated at more than 8 m per second (color red; mainly inside the Wadi Derna, but also on the sides) (Figure 3.16).

FIGURE 3.15. Maximum water level after the dam breach at a rainfall event of 140 mm/24 h.

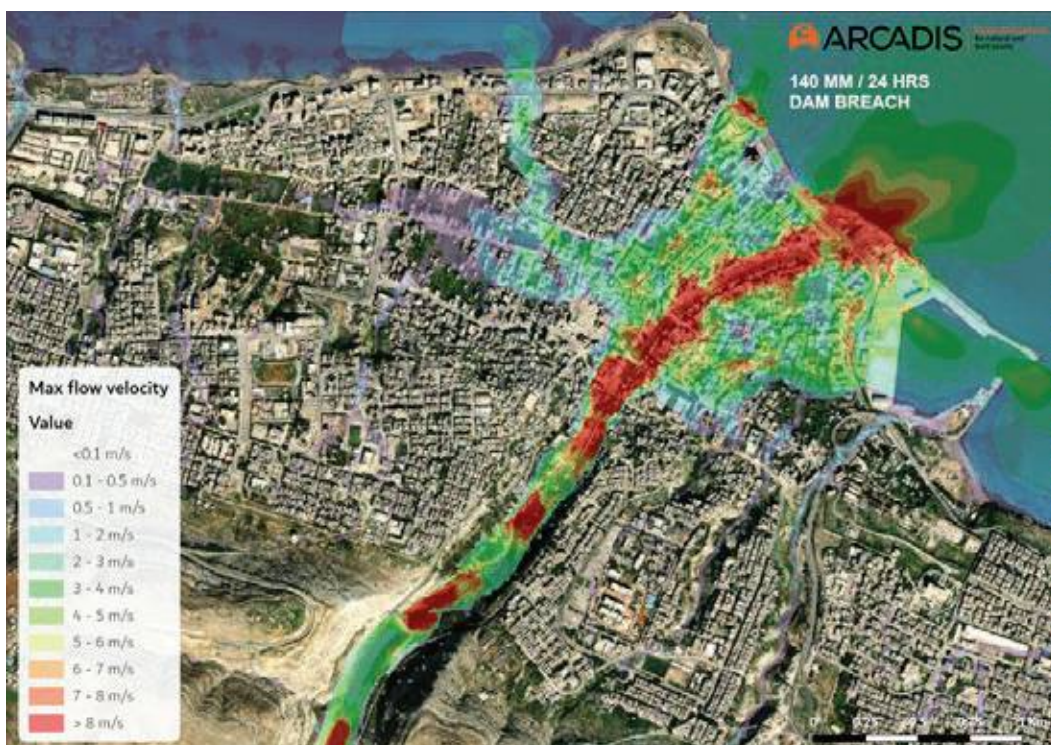
FIGURE 3.16. Maximum flow speed after the dam breach at a rainfall event of 140 mm/24 h.

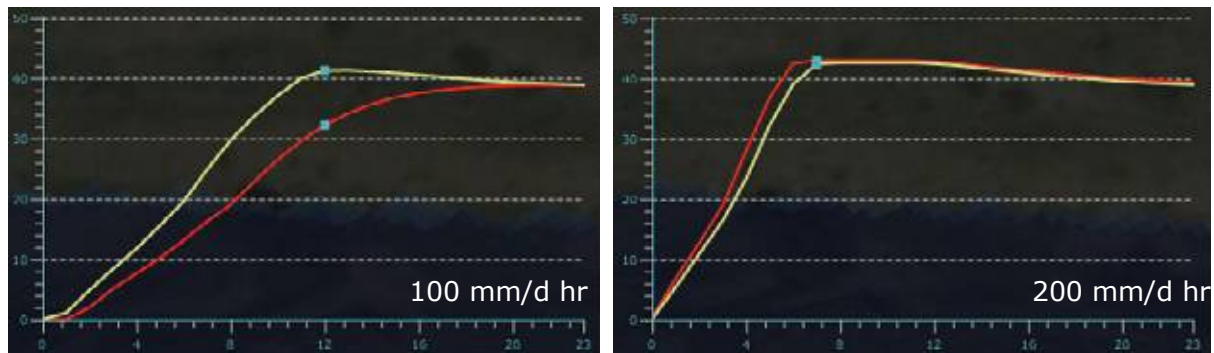
FIGURE 4.4. Water levels in Abu Mansour reservoir.

The different measurement sources available suggest that the event was very likely capable of inducing an overtopping at both the Derna and Abu Mansour dams. With an estimated maximum capacity of between 23.7 and 28.5 MCM, the Abu Mansour Dam would probably have exceeded its capacity with an accumulated average precipitation of 150-200 mm in the catchment. In theory, the water level within Abu Mansour's reservoir remains below the crest at this rainfall quantity, but the crest level is predicted to be lower than 227 masl due to settlement. This becomes clear when 150 mm is multiplied with the surface area of the entire catchment area giving a possible storm volume of nearly 70 MCM (not accounting for infiltration). Similarly, the water level in the Derna reservoir overtops the dam's crest with rainfall more than 150mm. More than 200mm of rainfall leads to the submersion of both dams.

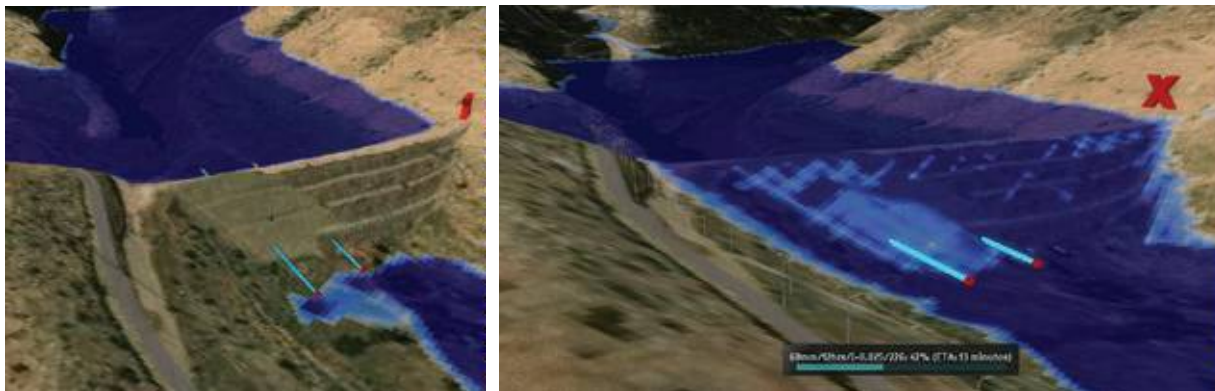
FIGURE 4.5. Screendumps of Tygron results before (left) and after the overtopping of the Abu Mansour Dam.

Shortly after the overtopping of the Abu Mansour Dam, the embankment began to wash away. This occurred on the right bank due to its steeper slope and in the central part because of the lowest crest levels. The erosion was more pronounced on the right bank, as evidenced by the deep scouring of the rock. The deposition of eroded material at the foot of the left

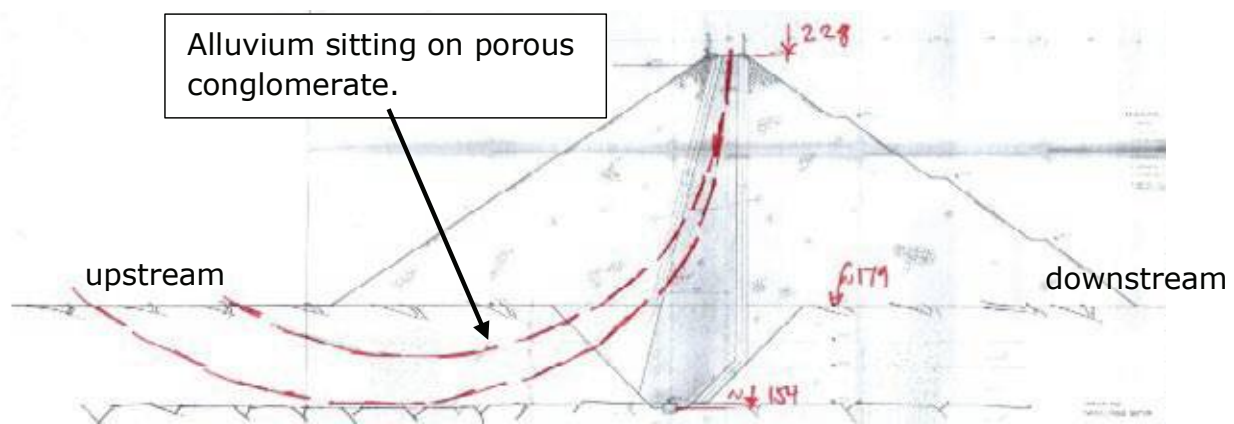
bank is also an indicator of the concentration of the flow along the opposite bank. The shear surface shown in Photo 4.4 is likely the result of sliding that developed during the flood (Figure 4.6), indicating that a structural weakness was present and possibly initiated long before September 2023. While not a trigger for the failure, this sliding could have been reactivated during the heavy rainfall observed at the dam site before the arrival of the flood, or at the beginning of the overflowing, leading to a relatively rapid decrease in the upstream level. The breaching process slowed down when the thickness of the core became sufficient to resist the flow. The erosion of the remaining downstream shoulder continues, followed by the upstream shoulder through the breaches in the core. These eroded channels correspond approximately to the location of the vertical settlement tubes where compaction could not be properly achieved.

FIGURE 4.6. Types of possible sliding surfaces.

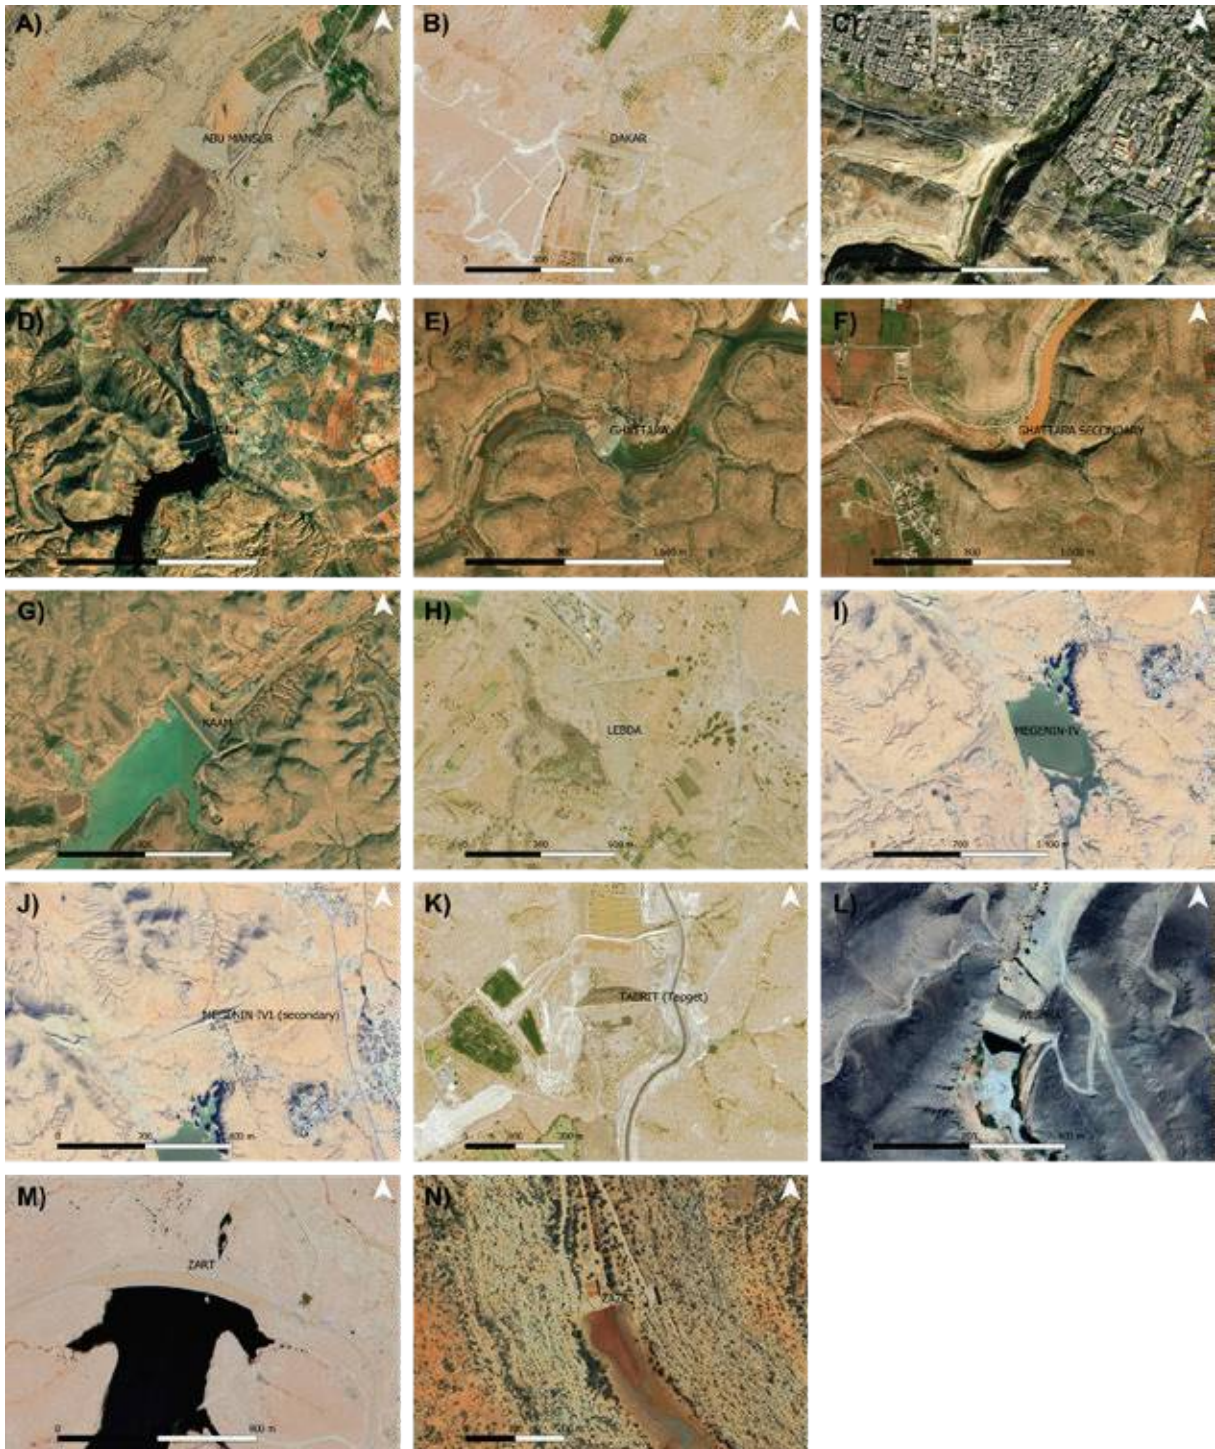
PHOTO 5.1. Detail images from the georeferenced ICOLD's World Register of Dams for Libya.

The existing inventory of large dams in Libya includes 14 dams according to the World Register of Dams (WRD). This is a global database of large dams curated by the International Commission on Large Dams (ICOLD) that includes more than 62,000 records from over 166 countries. The attributes include characteristics specific to the dams (year of commissioning, height, length, type, etc.), the associated reservoirs (volume of the reservoir, area of the reservoir, purposes, etc.), stakeholders (owners, design offices, contractors, etc.) and elements relating to geography (country, river concerned, locality). Most of the large dams registered in the WRD are dedicated to flood-protection or irrigation purposes. The 14 records for Libya have been curated by updating and verifying the coordinates and their contributing catchment area. These are displayed along with some of the attributes reported by the WRD (such as height, crest length, storage, and spillway capacities) (Table 5.1). Most of these dams were designed and built during the 1970s to the 1980s (Photo 5.1).

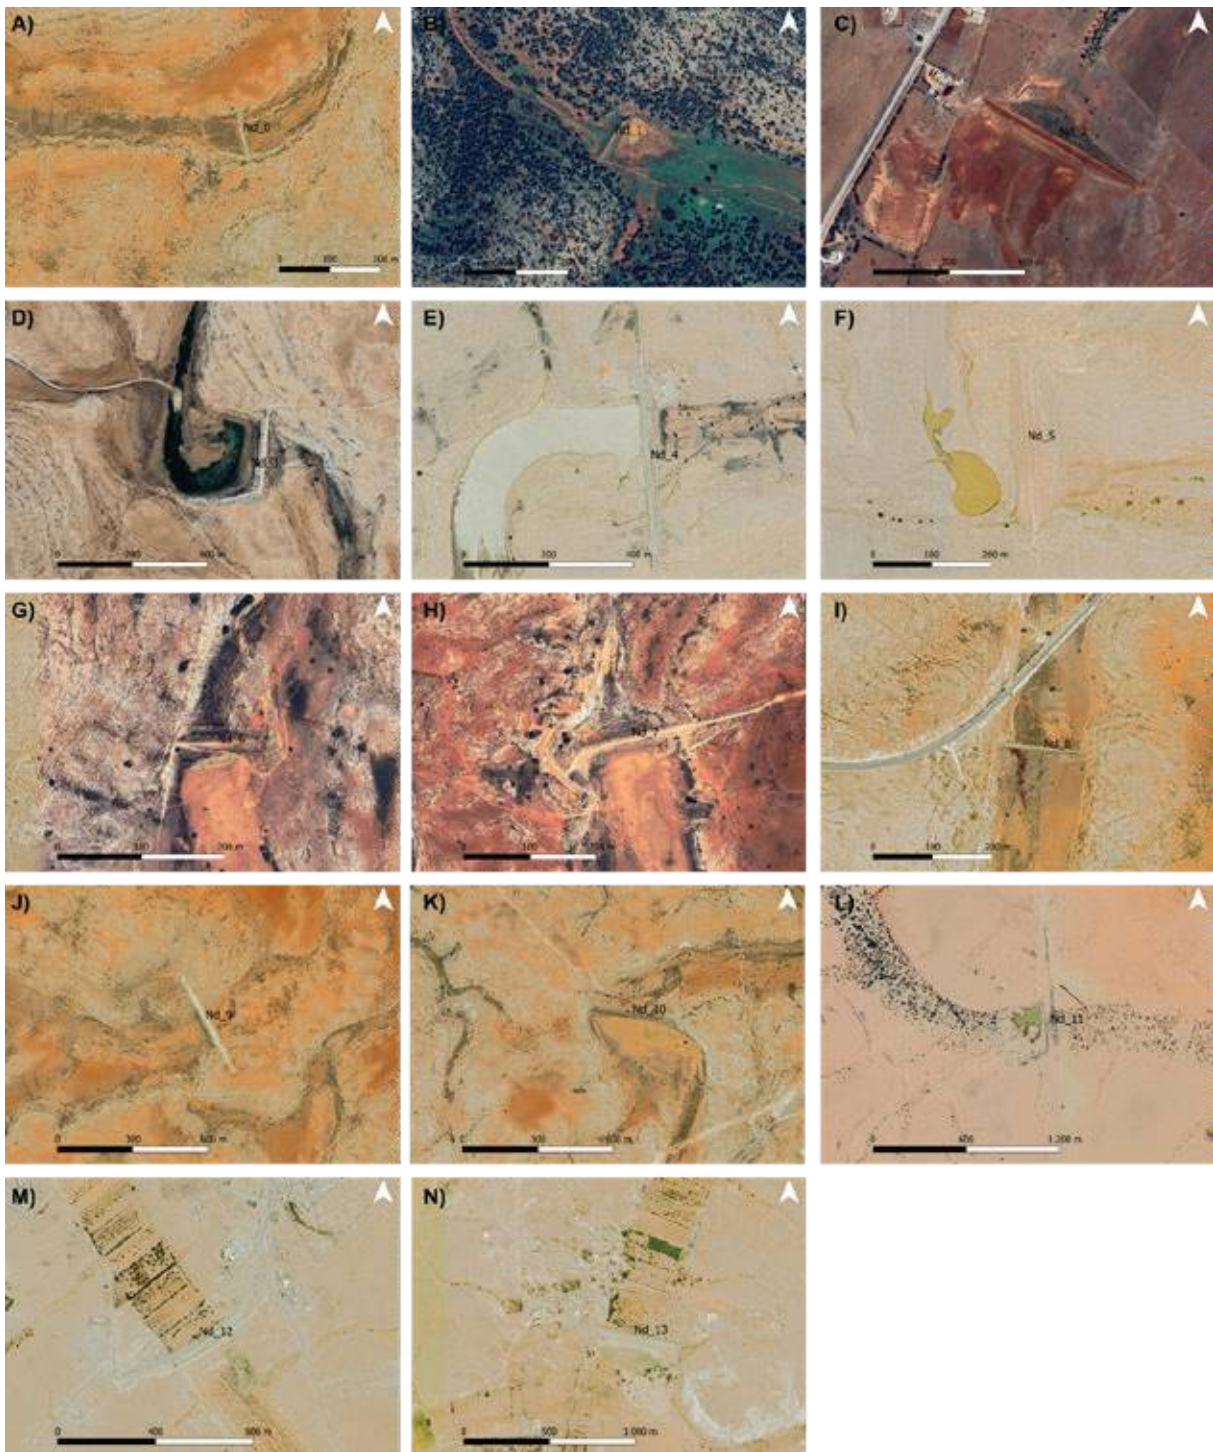
PHOTO 5.2. Detail images from the georeferenced newly detected dams.

An updated inventory was prepared using a semi-automated routine based on remote sensing data to identify dams not reported in public records. First, a national water occurrence map was derived from multispectral imagery of Landsat and Sentinel 2. This identified the presence of surface water (NDWI thresholding) in any satellite image, thus identifying potential water bodies. Due to the ephemeral nature of the waterways in Libya and the minimal water retention in dams along the wadi systems, an additional topographic analysis was conducted. This consisted of identifying presence of sink-regions in a digital elevation model (Copernicus GLO-30 DEM) which could lead to dam-like structures. Both methods created a list of potential locations of dams, which were first run through an automated classification algorithm, and manually reviewed and curated. Several relatively small (2-12 m) height earth-filled dams were identified, with those that were categorized as dams of significance and showed signs of previous water retention retained in the inventory (Table 5.2). The height of the dam body and length of the crest were extracted, and the dams further classified according to construction type. Many of these structures are dedicated to erosion and flood mitigation in the predominantly dry wadi systems that are only active during significant rainfall events, as well as irrigation activities (Photo 5.2).

While none of the dams identified through remote sensing are reported to be over 15m, several are above 5m and may impound more than 3 MCM and could thus be considered large dams.¹³ It should also be noted that the dam heights were derived from a DEM (Copernicus Glo-30) that could potentially have an error of between 2 to 5 m in high-slope areas. Thus, the actual height values remain with a certain degree of uncertainty and should be verified through physical inspections. This notwithstanding, good industry practice would ensure dam safety provisions are applied to any dam that could cause safety risks, regardless of size or retention capacity. Such provisions apply to all World Bank financed investment projects and are outlined in the Environmental and Social Framework, Environmental and Social Standard 4 (ESS4) Annex 1.¹⁴ A number of dams identified exhibit downstream populations (for instance ND_02 and ND_09 have a sparsely populated area 2 and 5 km downstream respectively). Several of these structures were identified in the proximity of the Wadi Derna, with ND_08 and ND_10 damming a small lateral tributary to Derna, after the Abu Mansour Dam, with others draining to wadi systems to the south and east of Derna.

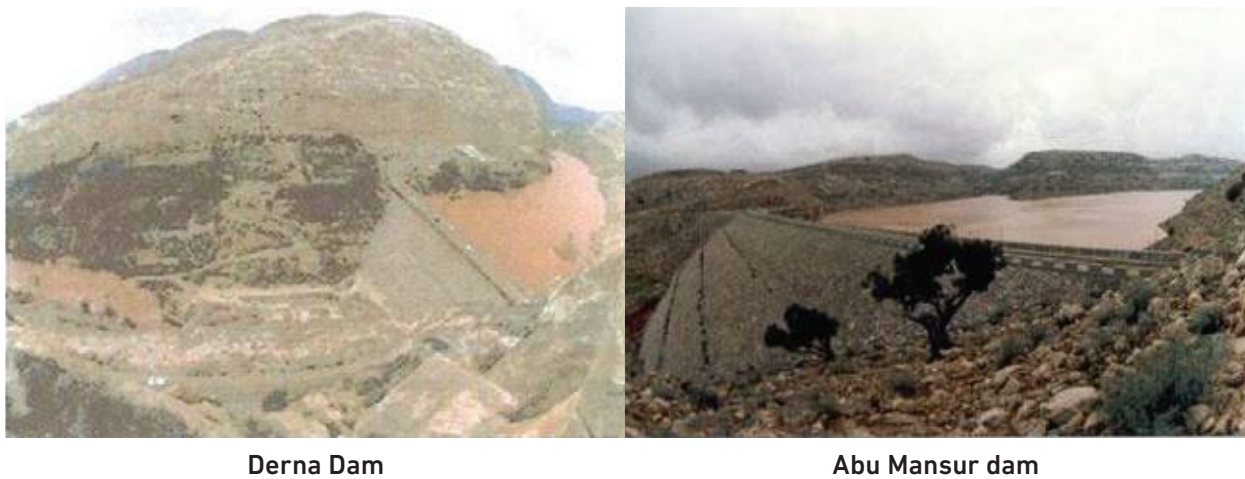
FIGURE A1.3.: The filling state of the dams during the flood event of 1986.

The flood event in 1986 is characterized by a small variability in rainfall. The maximum water level and rainfall of the flood of 1986 are known. Five rain gauges allowed a good assessment of the daily watershed rainfall. Both dams were fully filled in 1986 (Figure 20).

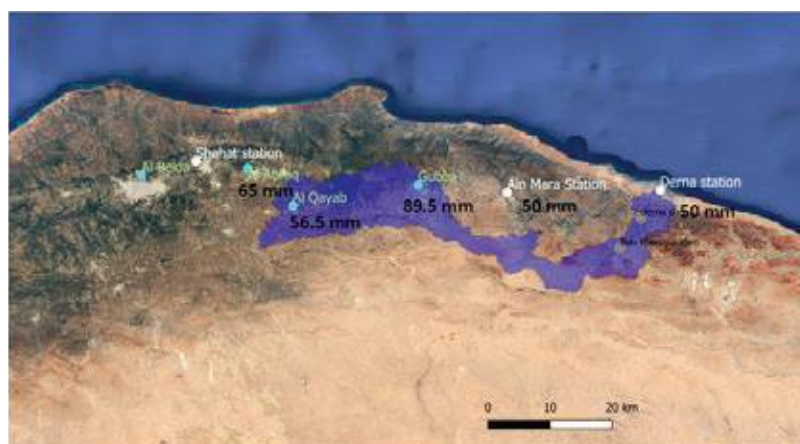
FIGURE A1.4.: The daily precipitation recorded in 1986.

The floods records of 1986 event provided by the dams Administration (Figure A1.4) shows that the maximum water level reached by the reservoir is limited to 216.65 masl, which is 7.85m below the spillway elevation. Additionally, during the first 24 hours, between 28 and 29 November, the reservoir lost about 1.3 Mm³. The bottom outlet, located around 100m downstream of the dam, appears to be closed according to the photo in Figure A1.3. Therefore, the average seepage losses are estimated at 15 m³ per second for a reservoir el. 216 masl. when considering no inflow, distributed between the reservoir and the dam foundation, which is enormous. The part passing through the dam foundation is unknown but still important.

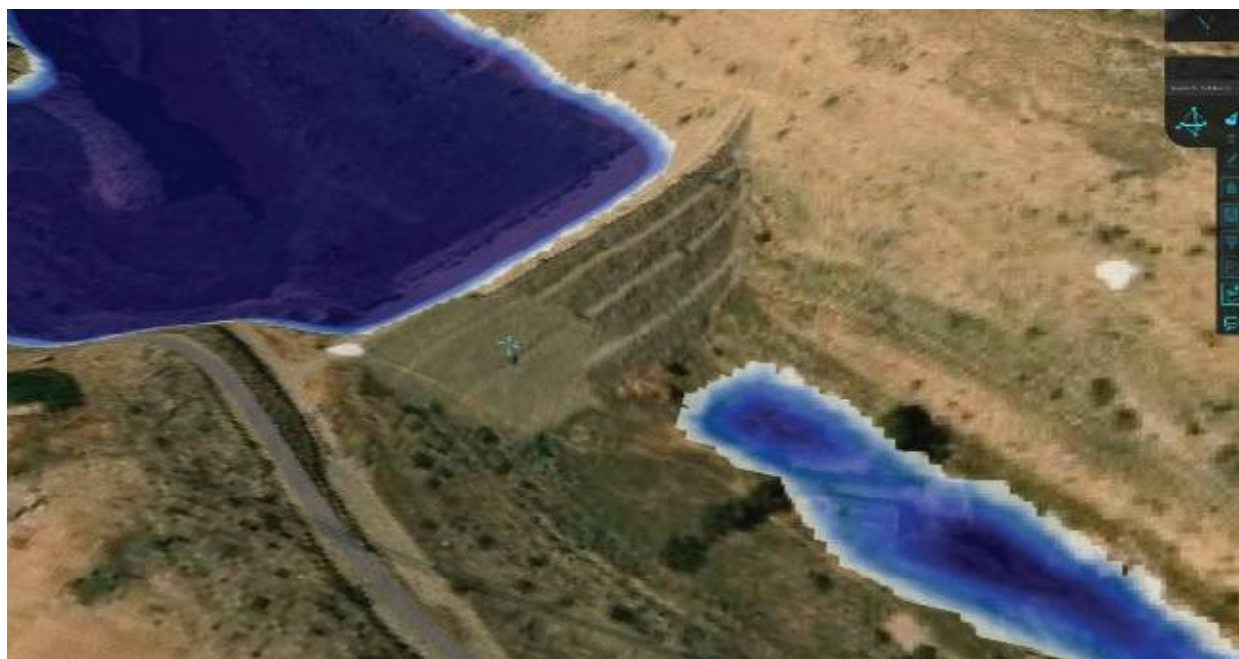
FIGURE A2.2.

a 'V-shape' of the dam in which the crest was lower than the 'shoulders' of the dam (more information in section 4.4). The simulations were made with the dam crest height on +226 and +227 masl, as part of the bandwidth for dam crest height. See figure figure A2.2 below for the schematization of the Mansour Dam in the model.
