# Failure paths for levees

Final draft

December 2021

PREPARED BY  
Technical Committee on  
Geotechnical Aspects of Dikes and Levees  
(TC201)

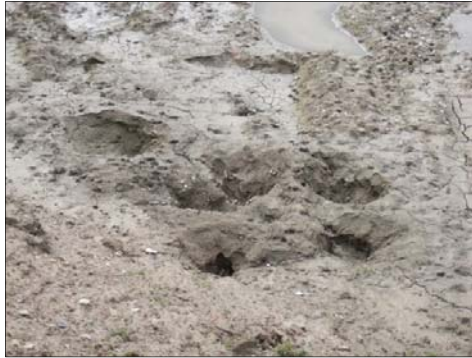
The presence of an old field drain beneath the levee is believed to have influenced the failure. The alignment of the drain can be seen on the LiDAR image and evidence of seepage was found during the post-breach inspections.

Possible evidence of piping failure on landward side of levee at the location of the breach appears to coincide with the location of historic land drain. This seepage may have led to softening of the toe or possibly uplift beneath the landward slope of the embankment.

Figure 3.5 Close-up of the situation.

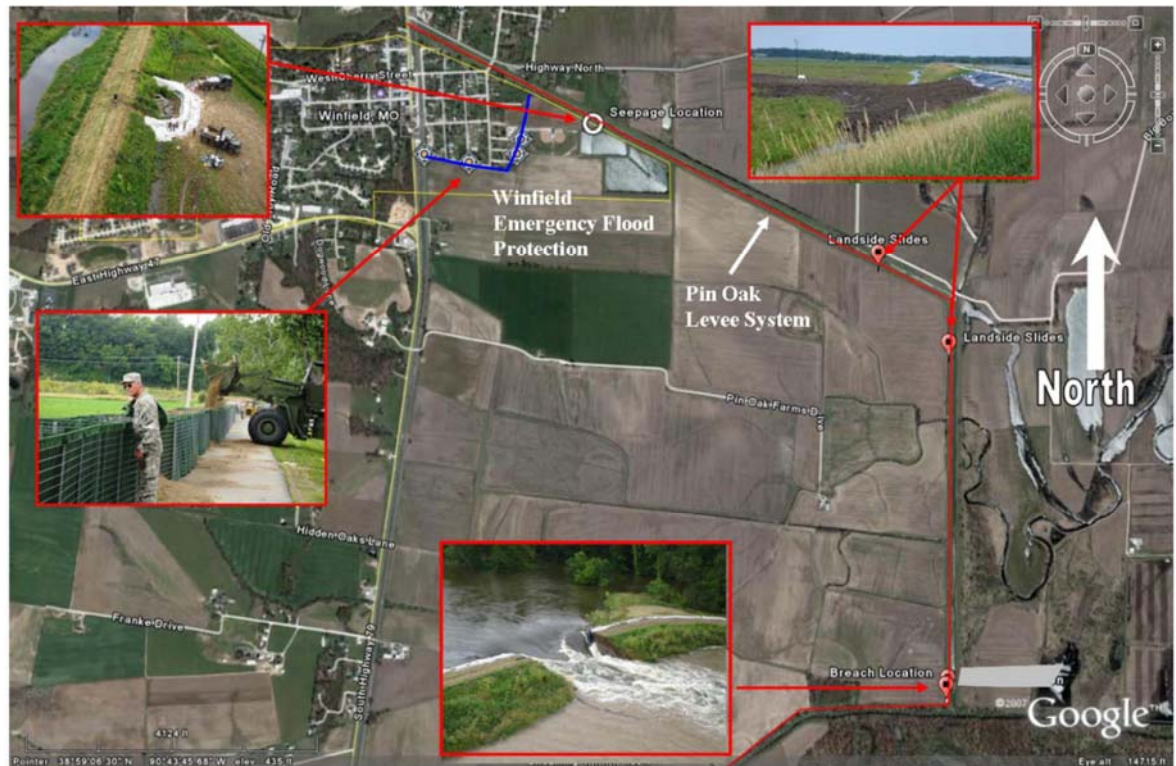
As shown in Figure 3.8, the Pin Oak Levee system experienced significant distress and subsequent breach during the Spring 2008 Flood. The Spring 2008 Flood lasted approximately three weeks and ended in a breach of the system on 27 June. Based on information provided by the USACE St. Louis District, the flood event was considered to be a 50-year event at the Pin Oak Levee system.

Figure 3.8 Aerial view of the Pin Oak Levee system.

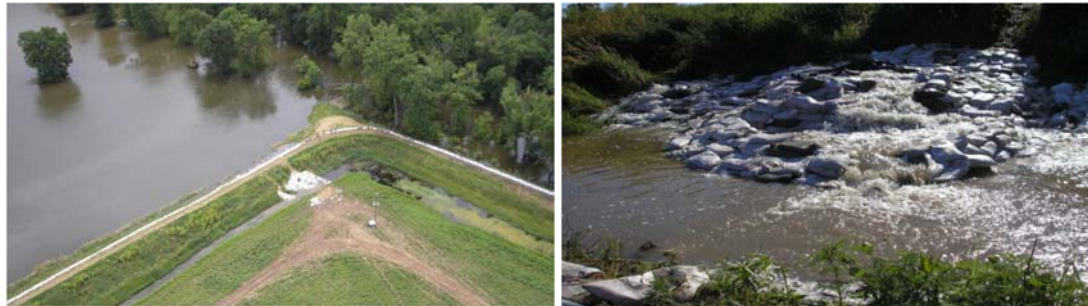
other small mammals were observed diving in the area where the plastic tarp was placed. Several people reported that an animal burrow was located on the flood side of the levee and that the seepage was associated with muskrat or other rodent holes/dens. On 27 June 2008, the levee breached at this site. Figure 3.9 and Figure 3.10 show images of the levee.

Figure 3.9 Seepage occurring at the toe of the levee prior to breach (taken around 0800 hr, 23 June 2008) (left), and Sand bag effort prior to breach (taken around noon on 26 June 2008) (right).

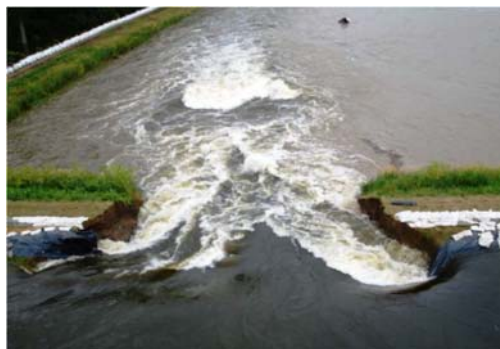
During the site visit, the width of the breach measured approximately 46 m. However, photos taken during the breach show a narrower initial width, indicating that the breach enlarged with continuing flow. The cross section of the embankment was exposed on both sides of the breach allowing the assessment team to inspect the levee embankment materials. Based on the cohesive nature of the soil, the levee embankment materials appear to be clay. A sample of the levee material (taken about mid-height in the levee profile) was removed for laboratory testing for geotechnical properties (e.g., Atterberg limits, sand content, organic content, and soil classification). The results of the tests were used to provide a description of the levee embankment material. The information can also be used to estimate erodibility, cracks, or concentrated leaks in embankments. From these soil properties, the erosion rate of the levee embankment material would be estimated as moderately rapid.

Figure 3.10 Breach occurring (taken around 0700 hr, 27 June 2008).

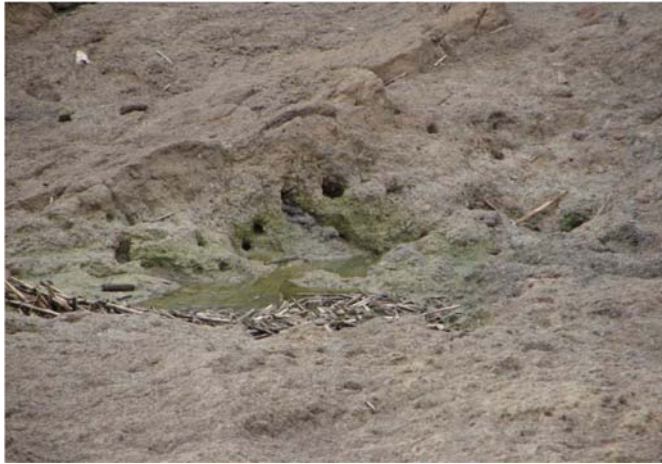
Along the alignment of the levee, the breach scour depth only extended down to the foundation level. However, rodent holes (ranging from 5 to 7 cm in diameter) were found around the perimeter of the levee and at the water side toe of the breached levee section. There were also indications of rodent holes about 1.3 m below the flood side mid-slope near the base of the levee (see Figure 3.11).

Figure 3.11 View of animal burrows beneath water side mid-slope of breach section (22 July 2008).

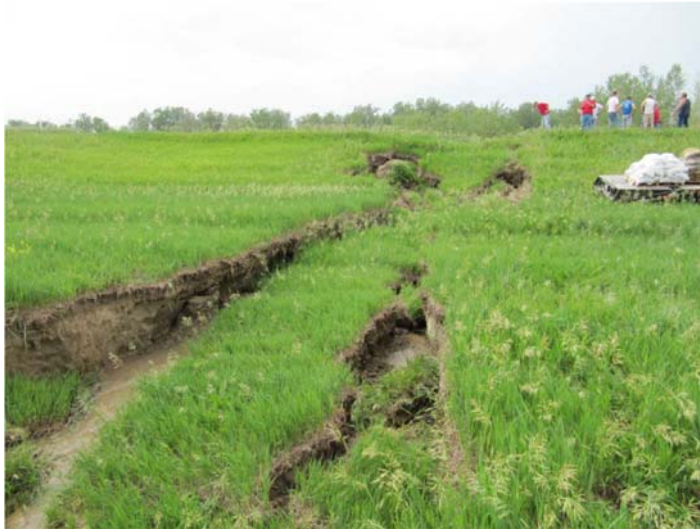
One of the breaches that occurred during the Missouri River flooding of 2011 occurred in the L-575 levee district which protects a large area of agriculture along with the city of Hamburg in southwest Iowa. The breach occurred in an area that had demonstrated several incidents of levee underperformance. Initial distresses, as shown in Figure 3.13 and Figure 3.14, narrowly avoided a full breach as the levee collapsed on itself, sealing off the underseepage path. Emergency repairs were initiated to reinforce this section of levee. The contractor and levee personnel were on site when the next distress appeared. There was a report of a “gurgling” sound, and then the levee collapsed on itself beginning from the protected side (land side) seepage berm and continuing toward the water side. As seen in Figure 3.14, an alluvial fan appeared at the protected side toe of the seepage berm. One additional incident (for 3 total) like this occurred before the final section of the levee breached. For all of these incidents, including the breach, there were a few meters of freeboard on the levee at that time.

Figure 3.13 The initial distress in the levee L-575.

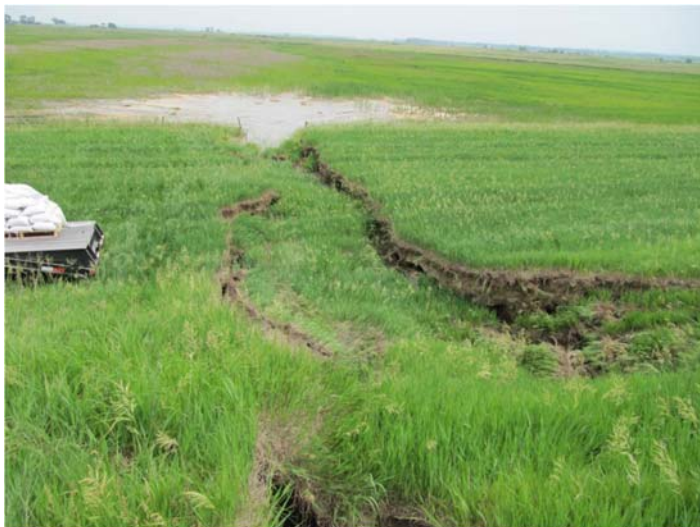
Figure 3.14 Initial distress in levee L-575 showing alluvial fan.

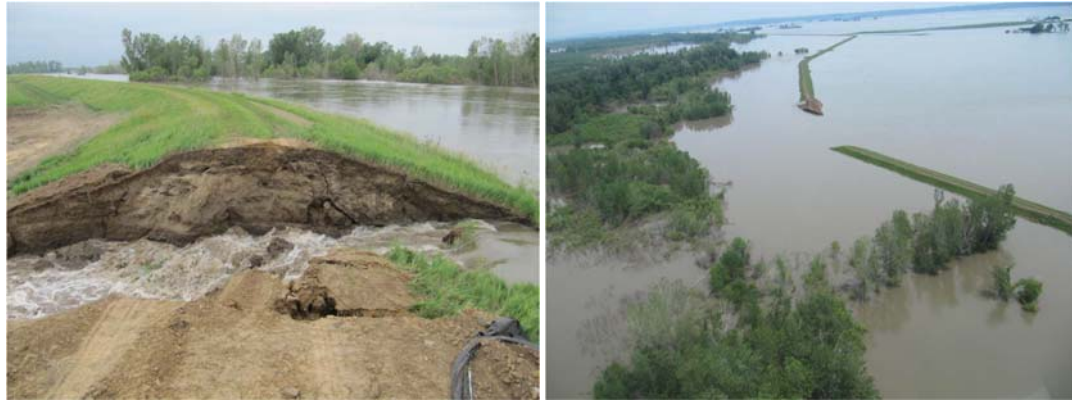
When the fourth incident occurred, the levee was not able to collapse on itself and seal the underseepage path. When Corps personnel arrived on-site several minutes after the breach was reported, the breach was about 3 m wide. While on-site, the breach continued to widen and deepen, Figure 3.15. The protected side continued to flood, eventually equalizing with the river as shown in Figure 3.15. Due to the forecasted water levels and the threat of breach due to the distresses showing up in the main stem levee, a temporary levee was built to protect the city of Hamburg. The temporary levee successfully held back the Missouri flood waters for the duration of the flood.

Figure 3.15 The initial breach of the levee L-575 (left), and the levee breach after complete interior flooding (right).

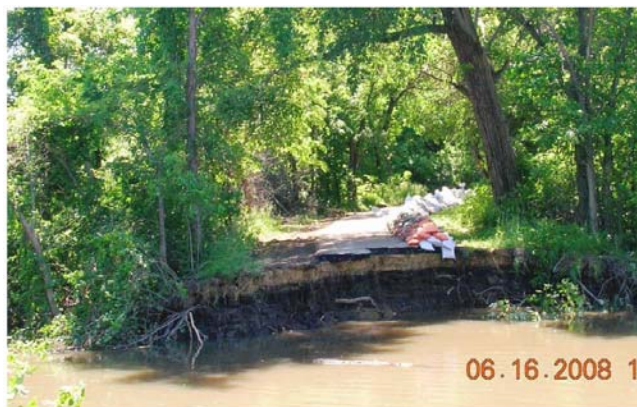
In the area behind North High School, local residents reported that the levee was “sinking” and that the water was “waist high” by 1600 hr. Figure 3.18 shows an image of the breached levee.

Figure 3.18 View looking to the southeast over the Birdland Levee breach (16 June 2008).

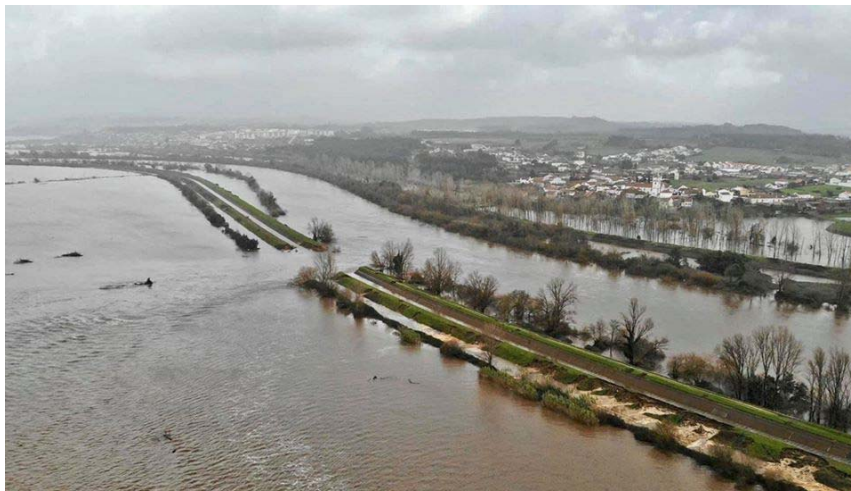
The causes of the failure are still being studied. Available information indicates that there was overtopping before the collapse.

The collapse led to the flooding of the fields in the Central Valley of the Lower Mondego and the cutting of communication routes. Infrastructure was severely damaged, not only the embankment but also the road and the conducting channel at the right bank, for the water supply of agriculture and industries.

Figure 3.21 View of Santo Varão after collapse of the embankment <sup>5</sup>.

A plan is currently under development to reinforce the Mondego embankments. This plan will consist of integrated solutions, to be implemented in the coming years.

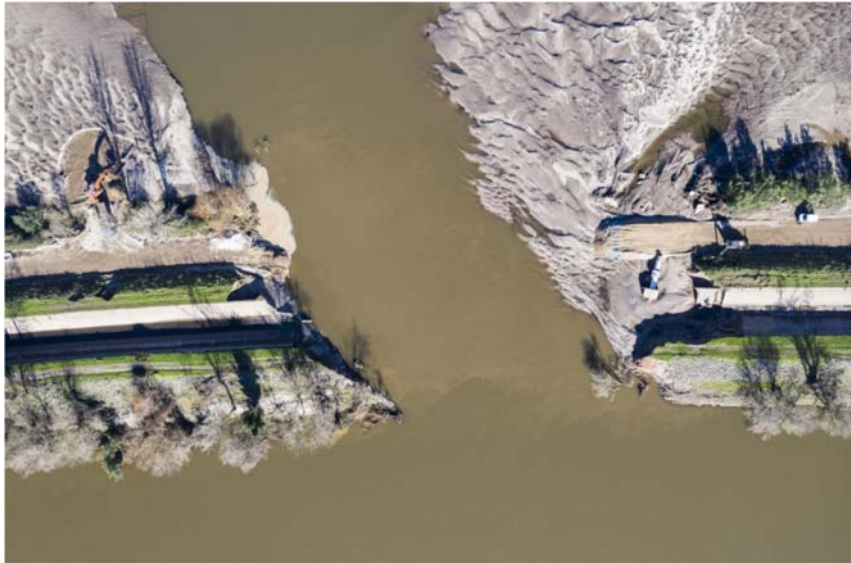
Figure 3.22 Top view of collapsed embankment in Santo Varão <sup>6</sup>.

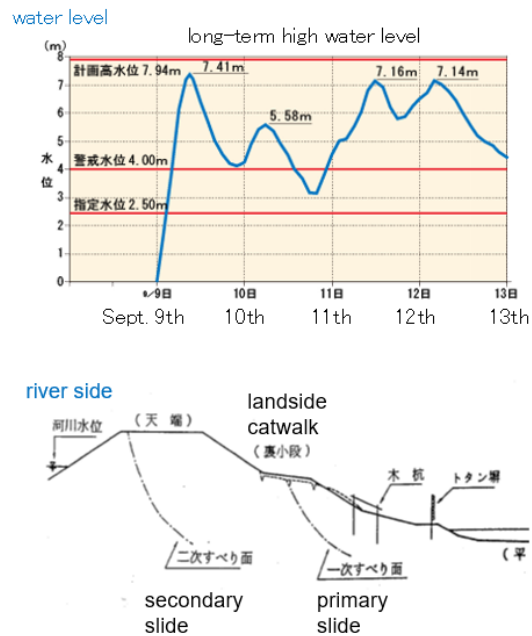
Failure time tree and the process were written down; from cracking to secondary large slide.

- ✓ Sept. 12<sup>th</sup>, 06:30 --- crack in landside catwalk
- ✓ Sept. 12<sup>th</sup>, 07:40 --- a crack line in the center of landside catwalk, paralleled to levee
- ✓ Sept. 12<sup>th</sup>, 08:10 --- two crack lines of landside catwalk: the lengths of 40cm, 60cm and the width of 5-10cm
- ✓ Sept. 12<sup>th</sup>, 09:10 --- herbicidal works
- ✓ Sept. 12<sup>th</sup>, 09:30 --- levee protection works with pile driving. Growth of cracks with level difference of 50cm on landside catwalk
- ✓ Sept. 12<sup>th</sup>, 10:20 --- Primary slide on landside catwalk, and then secondary slide from levee crown in a couple of minutes.
- ✓ Secondary slide and inflow of river water....breach

Figure 3.24 Example of slope slide from the presentation 'Picture-Card Show Project' in JGS-JSCE by K. Maeda, M. Ishihara and H. Mori, using materials from the Ministry of Land, Infrastructure, Transport and Tourism in Japan.

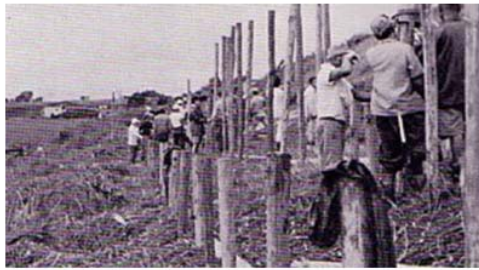
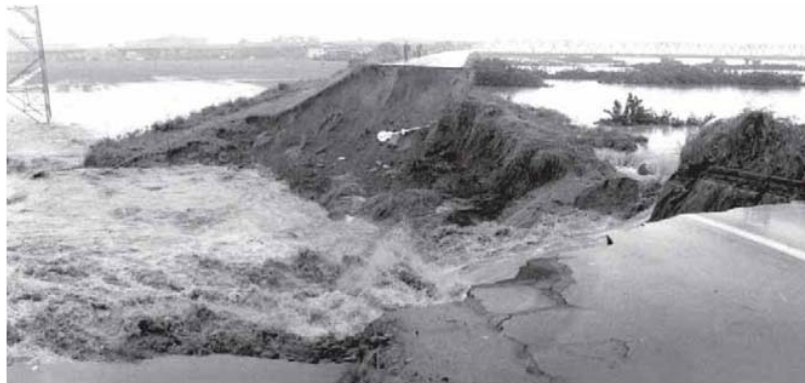
Figure 3.25 illustrates the protection works that were installed as well as the situation following the breach.

Just after  
breach

Figure 3.25 Example of slope slide from the presentation 'Picture-Card Show Project' in JGS-JCES', contribution by K. Maeda, M. Ishihara and H. Mori, using materials from the Ministry of Land, Infrastructure, Transport and Tourism in Japan.

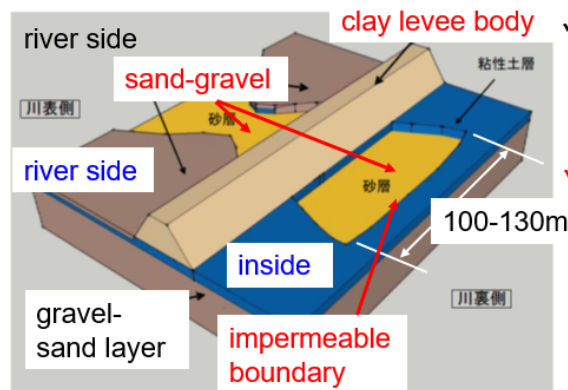
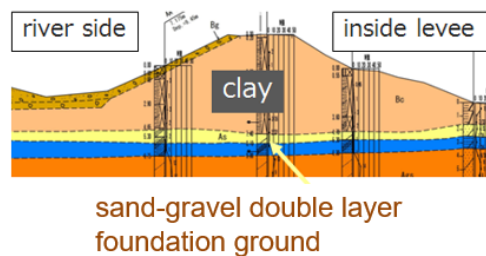
✓ The river water flow was concentrated in sand-gravel base layers during 5 hours. "piping": scouring in base layer, and collapse and fall of levee body.

✓ Levee body is clay. Base layer of levee is almost clay, but in some locations, sand-gravel parts exists in narrow parts of base layers.

Figure 3.28 Example of piping erosion from the presentation 'Picture-Card Show Project' in JGS-JCES', contribution by K. Maeda, M. Ishihara and H. Mori, using materials from the Ministry of Land, Infrastructure, Transport and Tourism in Japan.

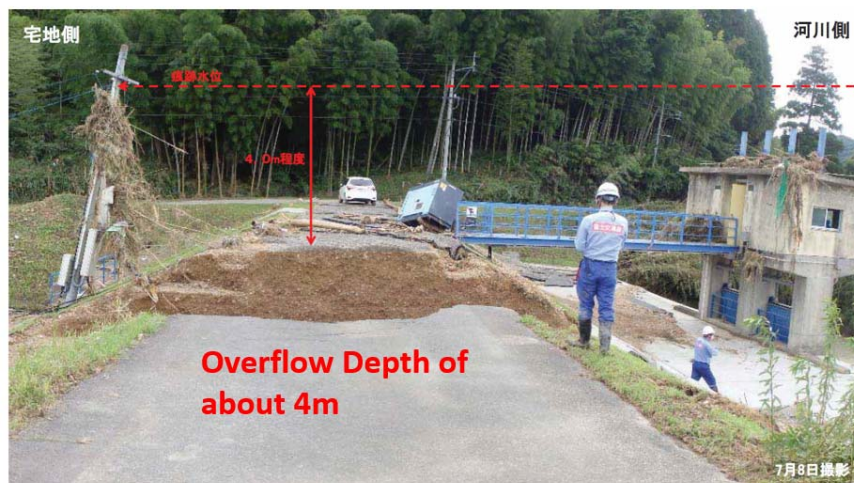
The figures below show some sites where overtopping erosion occurred on the Kuma river in 2020.

Figure 3.32 Picture of overtopping from the presentation 'Picture-Card Show Project' in JGS-JCES', contribution by K. Maeda, M. Ishihara and H. Mori, using materials from the Ministry of Land, Infrastructure, Transport and Tourism in Japan.

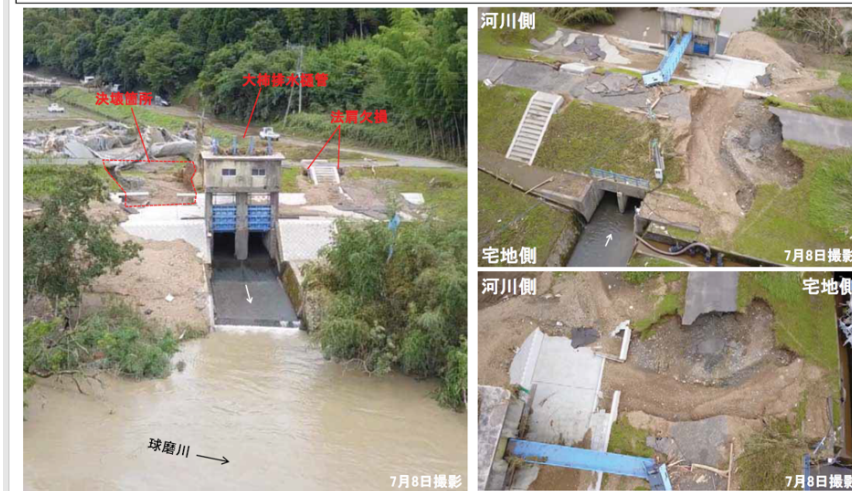
Figure 3.33 Example of overtopping from the presentation 'Picture-Card Show Project' in JGS-JCES', contribution by K. Maeda, M. Ishihara and H. Mori, using materials from the Ministry of Land, Infrastructure, Transport and Tourism in Japan.

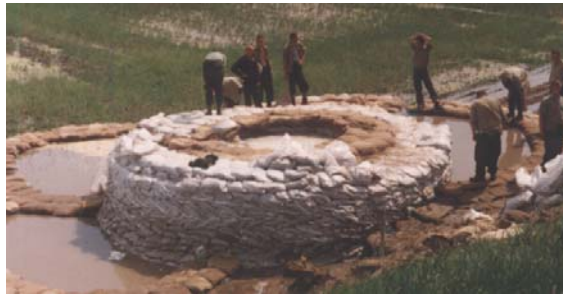
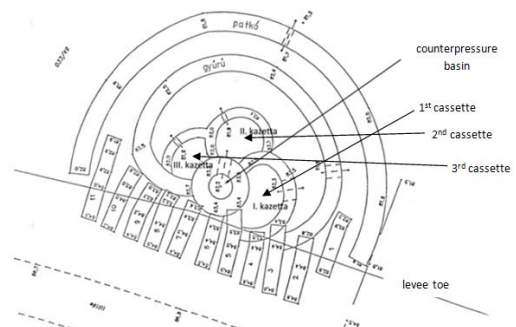
A secondary sand boil arose with a quite strong blow-up under the counter-pressure basin around 3:00 pm. Therefore, the water level in the counter pressure basin, which was already built up, lowered almost by 0.5m in a few minutes. The power of the blow-up was very concerning. Construction of the counter-pressure basin of the first cassette was carried out by soldiers and civils, its walls were 3 sandbags wide and 8 high. The basin of the first cassette fitted the previous semi-circumference shaping. Then, there was a need for building a new counter pressure basin (2<sup>nd</sup> cassette) in order to prevent another failure (see Figure 3.39).

Figure 3.39 Counterpressure basin for related cassettes (left) and location of sand cassettes (right).

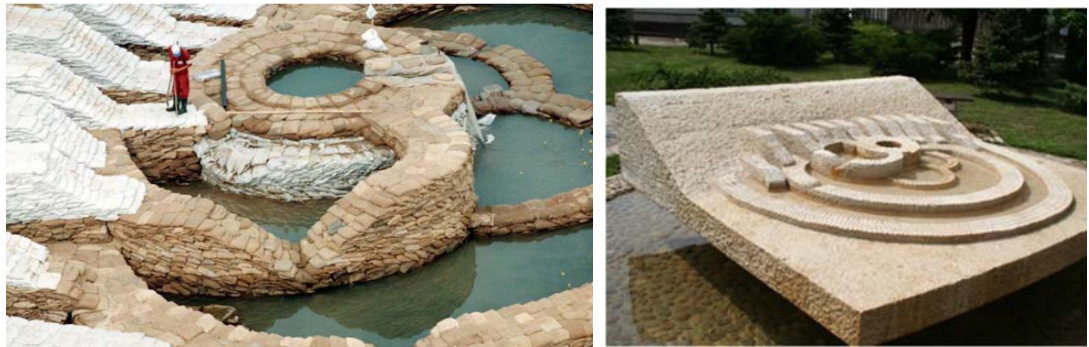
Figure 3.41 Tiszasas sand boil on 1st of May (left) and memorial of Tiszasas sand boil (right).

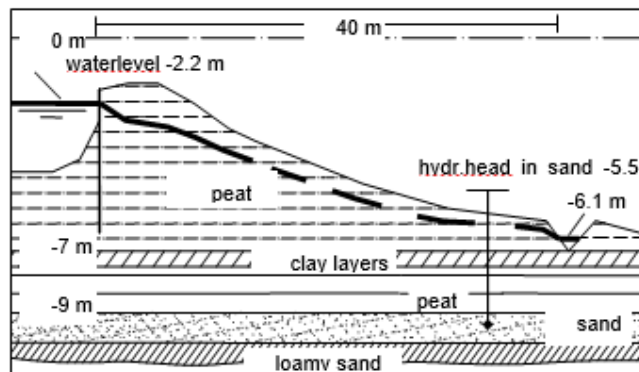
The illustration in Figure 3.56 provides an overview of the piezometric levels, build up and geometry of the levee, canal and terrain at Wilnis before failure. The levee has a grassland cover. A sheet pile wall with board lengths up to 4.5 m, had been placed along the canal about a decade ago for bank protection. Maintenance dredging of the canal to a water depth of about 2 m was carried out 1 year before the failure. A wide ditch drained the toe of the levee and was lined with shrubs and some tall poplar trees. The clay layers in the subsurface increase in thickness towards the west along the levee and decrease in thickness eastwards from the failed section.

Detailed historic maps of the area show that the levee at the location was in use as shipyard terrain when the mined-out area (now the polder) was still a lake; notably small harbour inlets did occur at the site. The levee crosses a riverine shoestring sand, locally about 1.5 m below the surface at the toe of the levee.

*Figure 3.56 Cross section with relevant geometry specifics for the Wilnis location.*

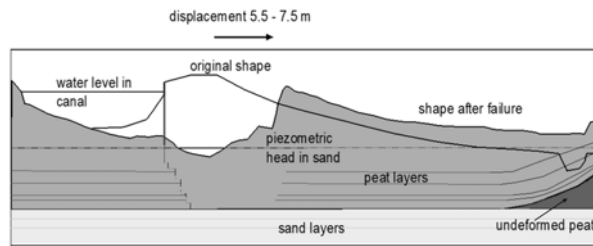
Figure 3.57 Embankment geometry before and after the failure at Wilnis. The various layer boundaries in the subsurface are indicated after failure, as well as the original water level in the canal and the piezometric head in the sand.

The failure consisted of coherent horizontal translation of about 6 m over a 60 m stretch. Vertical displacement was less than a few decimetres. A planar horizontal basal sliding plane was reconstructed from borehole and excavation data and located to have been at the base of the peat, i.e. at the top of the sand. The failed slices were bound laterally by major linear fractures oriented outward at angles smaller than  $45^\circ$ , indicating the wedge to have been pushed by a force from the canal. Displacement of the slice was accommodated in part by filling a ditch and, mainly, in a subsequent upthrust over the existing terrain surface. A tall poplar tree at the toe of the slide had remained in place with its roots firmly anchored in the underlying sand, cutting the about 4 m thick sliding peat and clay mass.

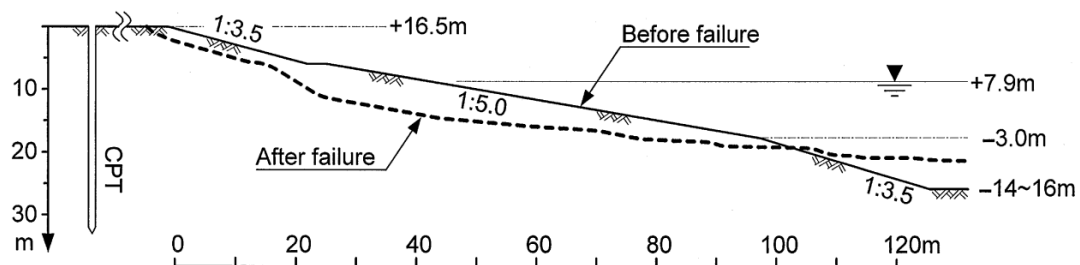
An example of a flow slide geometry from (Yoshimine, Robertson, & Wride, 1999) is given in Figure 3.66. Interestingly the slide extends above the river level, presumably with a regressive like mechanism as a noticeable scarp is evident at the river level after the failure.

Figure 3.66 Example of flow slide geometry at Jamuna (from Yoshimine et al., 1999, with permission NRC of Canada), Source: Jefferies and Been (2014).

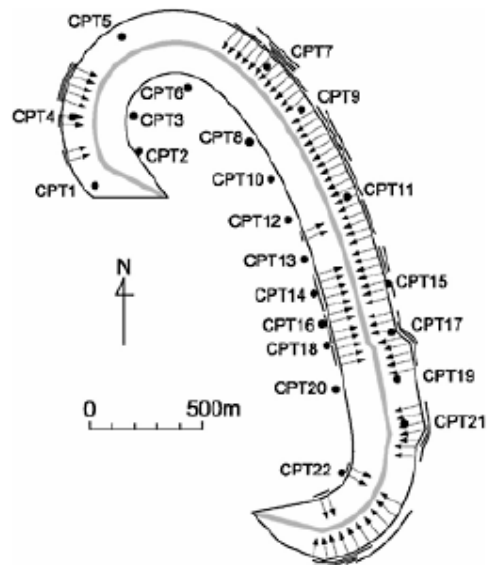
In the dredged area, which was about 300 m wide by 3 km length, is shown in Figure 3.67 and with the various slides being indicated by arrows (Yoshimine, Robertson, & Wride, 2001). Slides seem to be randomly distributed with the whole area being viewed as having much the same potential for flow slides.

Figure 3.67 Plan view of west guide bund of Jamuna Bridge showing CPT locations (from Yoshimine et al., 2001, with permission NRC of Canada) . Source: Jefferies and Been (2014).

Detailed analysis of 22 CPTs by Jefferies and Been, applying the critical state approach, revealed that, despite of the large uncertainties, that the flow slides may well be caused by static liquefaction of the micaceous fine sands.
