Failure paths for levees

February 2022

PREPARED BY
Technical Committee on
Geotechnical Aspects of Dikes and Levees
(TC201)

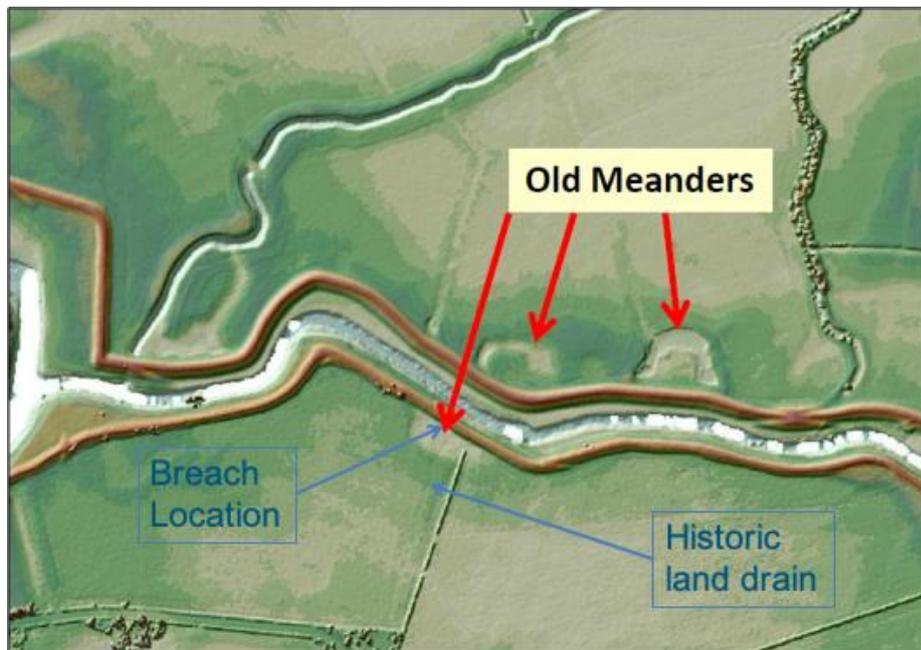
A forensic review of recent LiDAR images showed that the original crest level at the location of the breach was up to 100 mm lower than at surrounding areas. Furthermore, the location of the breach was underlain by both an in-filled historical meander and an old field drain. It is likely that the localized settlement of the crest in the vicinity of the breach was originally caused by consolidation of the in-fill material in the old meander. This meant that the crest level at this location was lower than at surrounding areas; overflow at this location caused rapid external erosion of the levee because of the steepness of the landward slope, about 30 degrees, the quality of the levee fill material (erodibility) and the lack of a landward berm.

Figure 3.4 Overview of the situation.

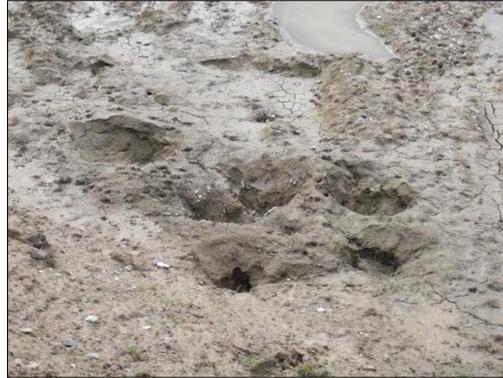
The presence of an old field drain beneath the levee is believed to have influenced the failure. The alignment of the drain can be seen on the LiDAR image and evidence of seepage was found during the post-breach inspections.

Possible evidence of piping failure on landward side of levee at the location of the breach appears to coincide with the location of historic land drain. This seepage may have led to softening of the toe or possibly uplift beneath the landward slope of the embankment.

Figure 3.5 Close-up of the situation.

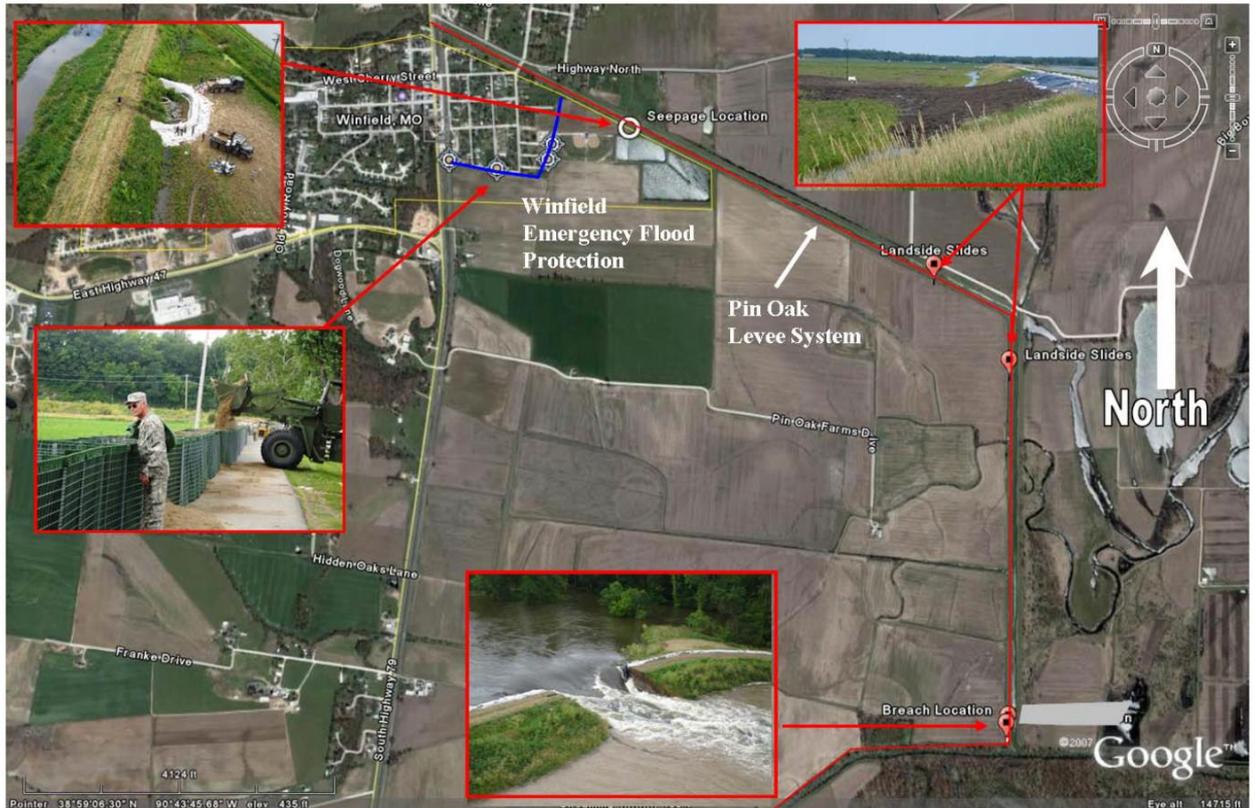
As shown in Figure 3.8, the Pin Oak Levee system experienced significant distress and subsequent breach during the Spring 2008 Flood. The Spring 2008 Flood lasted approximately three weeks and ended in a breach of the system on 27 June. Based on information provided by the USACE St. Louis District, the flood event was considered to be a 50-year event at the Pin Oak Levee system.

At the time of the breach, some portions of the sandbag stack/wall were not loaded while other portions were inundated up to 0.5 m. After the breach occurred, local, state, and federal forces made a heroic effort to protect the city from flooding by constructing an emergency flood protection wall around the city (see Figure 3.8).

Figure 3.8 Aerial view of the Pin Oak Levee system.

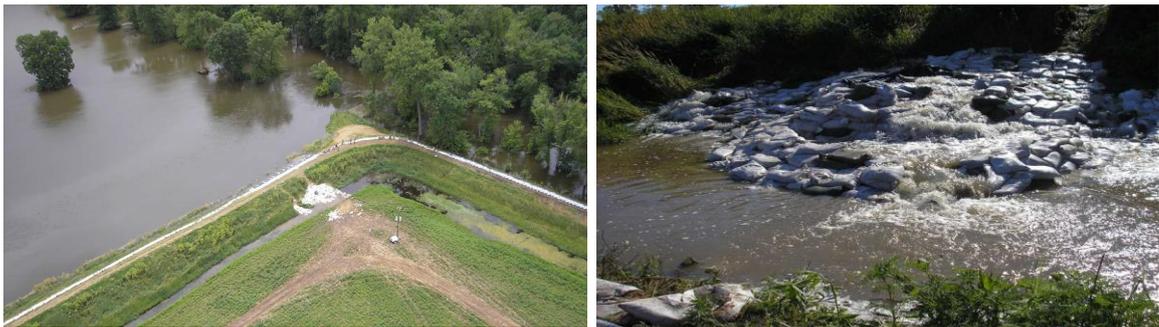
other small mammals were observed diving in the area where the plastic tarp was placed. Several people reported that an animal burrow was located on the flood side of the levee and that the seepage was associated with muskrat or other rodent holes/dens. On 27 June 2008, the levee breached at this site. Figure 3.9 and Figure 3.10 show images of the levee.

During the site visit, the width of the breach measured approximately 46 m. However, photos taken during the breach show a narrower initial width, indicating that the breach enlarged with continuing flow. The cross section of the embankment was exposed on both sides of the breach allowing the assessment team to inspect the levee embankment materials. Based on the cohesive nature of the soil, the levee embankment materials appear to be clay. A sample of the levee material (taken about mid-height in the levee profile) was removed for laboratory testing for geotechnical properties (e.g., Atterberg limits, sand content, organic content, and soil classification). The results of the tests were used to provide a description of the levee embankment material. The information can also be used to estimate erodibility, cracks, or concentrated leaks in embankments. From these soil properties, the erosion rate of the levee embankment material would be estimated as moderately rapid.

Figure 3.9 Seepage occurring at the toe of the levee prior to breach (taken around 0800 hr, 23 June 2008) (left), and Sand bag effort prior to breach (taken around noon on 26 June 2008) (right).

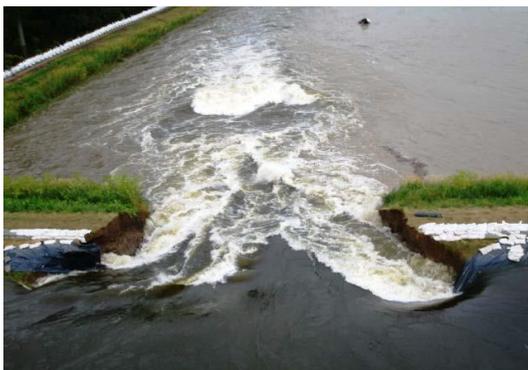
Figure 3.10 Breach occurring (taken around 0700 hr, 27 June 2008).

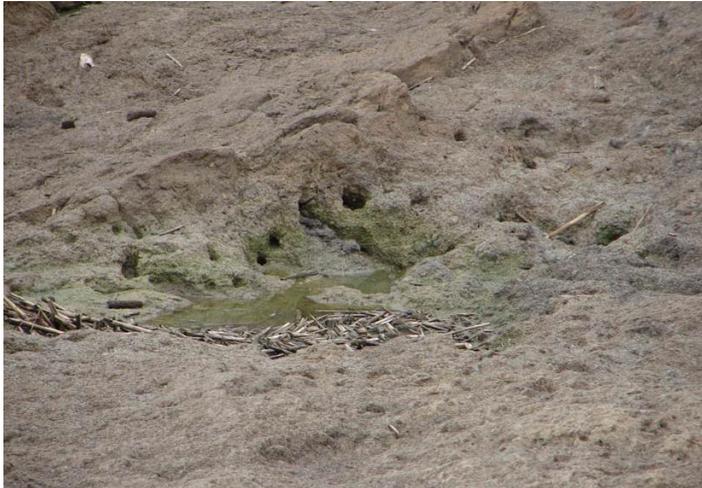
Along the alignment of the levee, the breach scour depth only extended down to the foundation level. However, rodent holes (ranging from 5 to 7 cm in diameter) were found around the perimeter of the levee and at the water side toe of the breached levee section. There were also indications of rodent holes about 1.3 m below the flood side mid-slope near the base of the levee (see Figure 3.11).

Figure 3.11 View of animal burrows beneath water side mid-slope of breach section (22 July 2008).

During the Spring 2008 Flood, animal burrows and dens may have had adverse impacts on the Pin Oak Levee system. As stated previously, animal burrows and dens in the levee at the breach site are suspected to have caused the seepage and subsequent internal erosion causing a breach. Also, it is likely that animal burrows and dens caused the severe seepage that occurred along the northern alignment of the levee system. Both sites are appealing to muskrats as often water inundates the flood side (from the drainage canal). At the breach site, water periodically inundates both the flood side (from the drainage canal) and land side (interior drainage ditch) toe of the levee. With these conditions at the breach site, muskrats can burrow into the levee on both sides. The burrows/dens on each side of the levee may become connected through the levee by rupture or hydraulic fracture caused by pressure from flood loading.

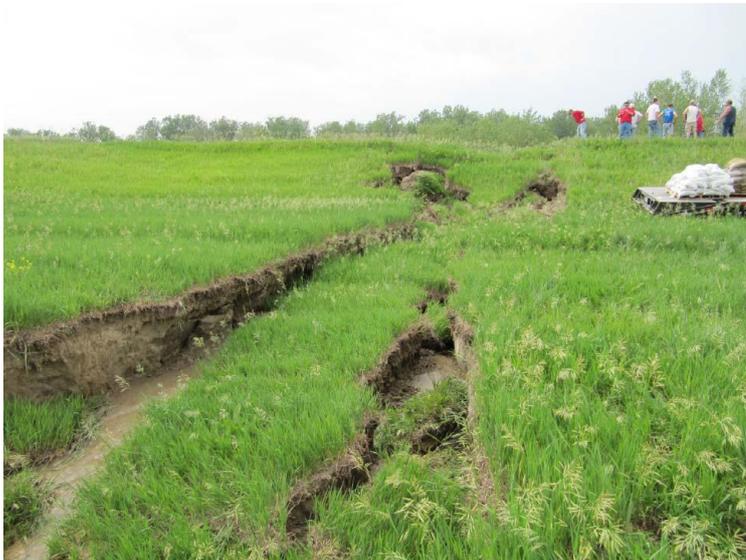
One of the breaches that occurred during the Missouri River flooding of 2011 occurred in the L-575 levee district which protects a large area of agriculture along with the city of Hamburg in southwest Iowa. The breach occurred in an area that had demonstrated several incidents of levee underperformance. Initial distresses, as shown in Figure 3.13 and Figure 3.14, narrowly avoided a full breach as the levee collapsed on itself, sealing off the underseepage path. Emergency repairs were initiated to reinforce this section of levee. The contractor and levee personnel were on site when the next distress appeared. There was a report of a “gurgling” sound, and then the levee collapsed on itself beginning from the protected side (land side) seepage berm and continuing toward the water side. As seen in Figure 3.14, an alluvial fan appeared at the protected side toe of the seepage berm. One additional incident (for 3 total) like this occurred before the final section of the levee breached. For all of these incidents, including the breach, there were a few meters of freeboard on the levee at that time.

Figure 3.13 The initial distress in the levee L-575.

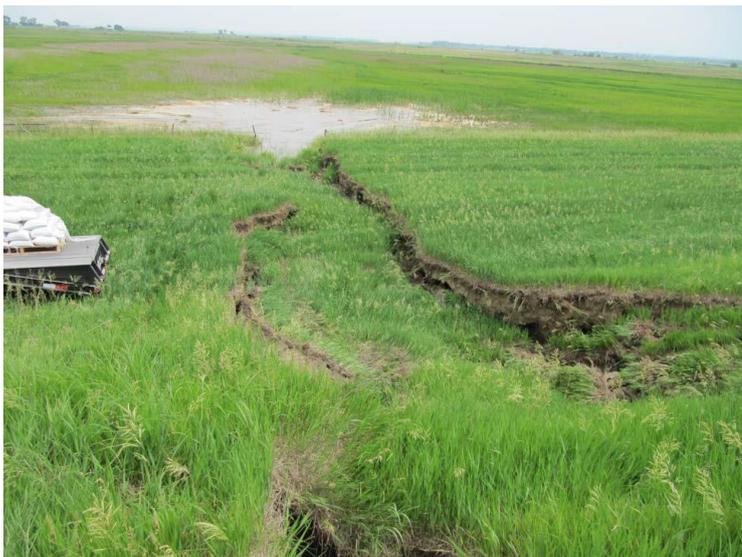
Figure 3.14 Initial distress in levee L-575 showing alluvial fan.

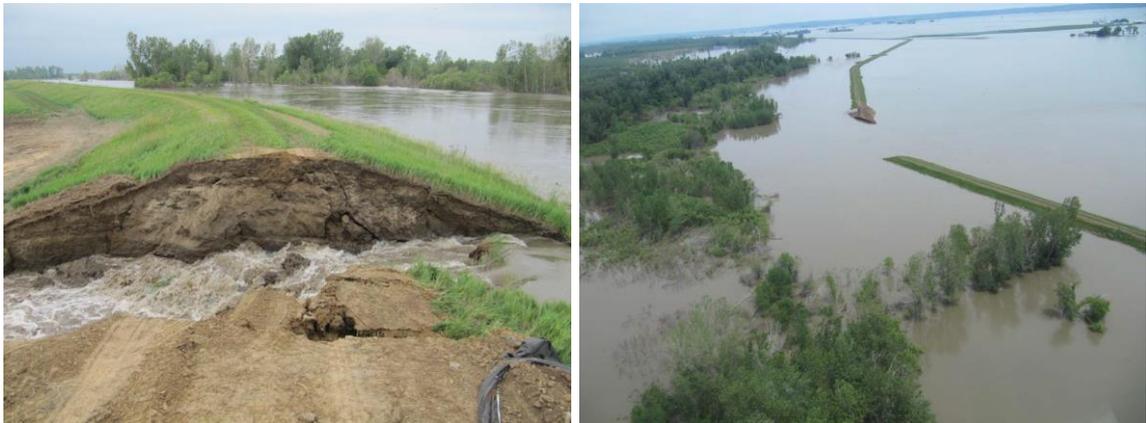
When the fourth incident occurred, the levee was not able to collapse on itself and seal the underseepage path. When Corps personnel arrived on-site several minutes after the breach was reported, the breach was about 3 m wide. While on-site, the breach continued to widen and deepen, Figure 3.15. The protected side continued to flood, eventually equalizing with the river as shown in Figure 3.15. Due to the forecasted water levels and the threat of breach due to the distresses showing up in the main stem levee, a temporary levee was built to protect the city of Hamburg. The temporary levee successfully held back the Missouri flood waters for the duration of the flood.

Figure 3.15 The initial breach of the levee L-575 (left), and the levee breach after complete interior flooding (right).

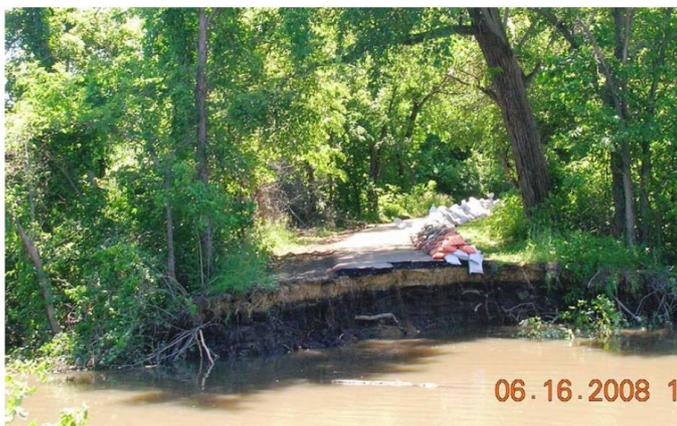
In the area behind North High School, local residents reported that the levee was “sinking” and that the water was “waist high” by 1600 hr. Figure 3.18 shows an image of the breached levee.

Figure 3.18 View looking to the southeast over the Birdland Levee breach (16 June 2008).

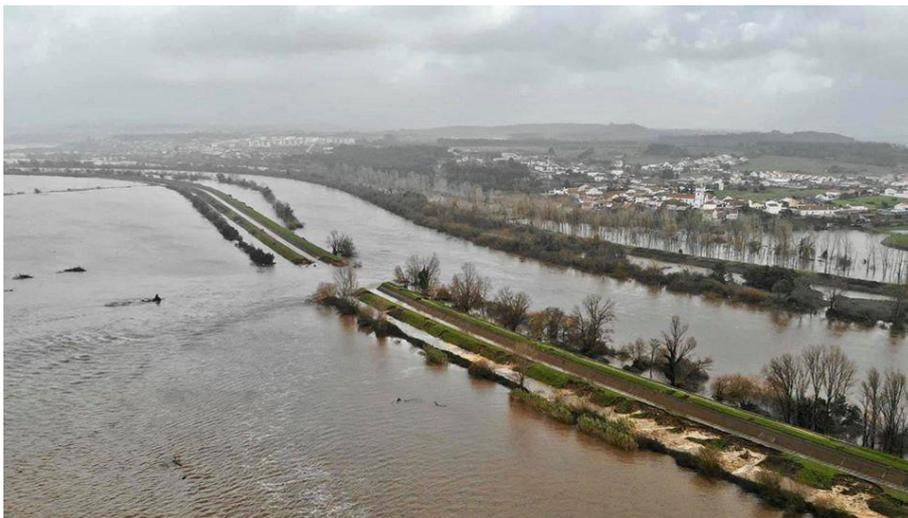
The causes of the failure are still being studied. Available information indicates that there was overtopping before the collapse.

The collapse led to the flooding of the fields in the Central Valley of the Lower Mondego and the cutting of communication routes. Infrastructure was severely damaged, not only the embankment but also the road and the conducting channel at the right bank, for the water supply of agriculture and industries.

Figure 3.21 View of Santo Varão after collapse of the embankment ⁵.

A plan is currently under development to reinforce the Mondego embankments. This plan will consist of integrated solutions, to be implemented in the coming years.

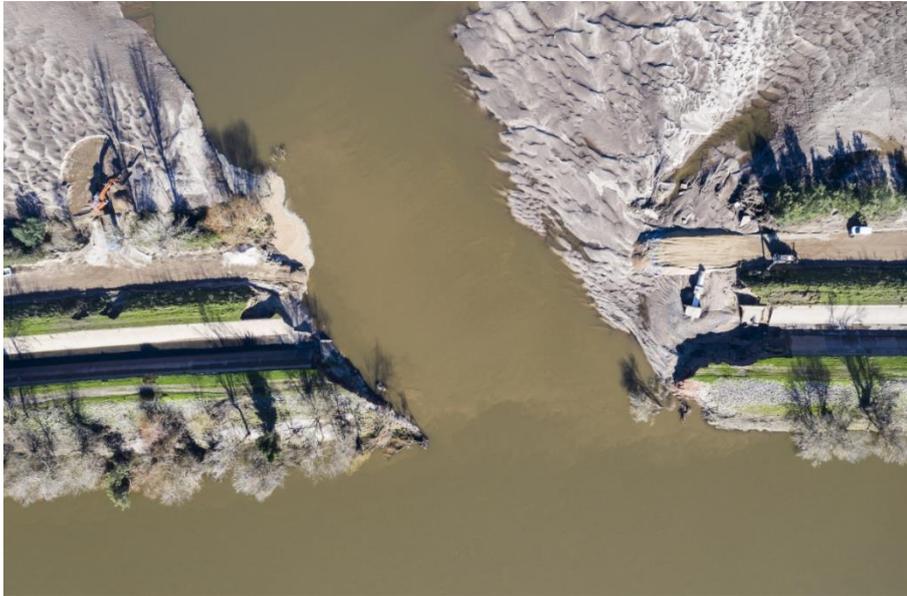
Figure 3.22 Top view of collapsed embankment in Santo Varão ⁶.

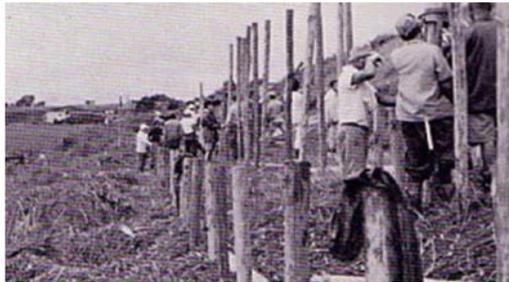
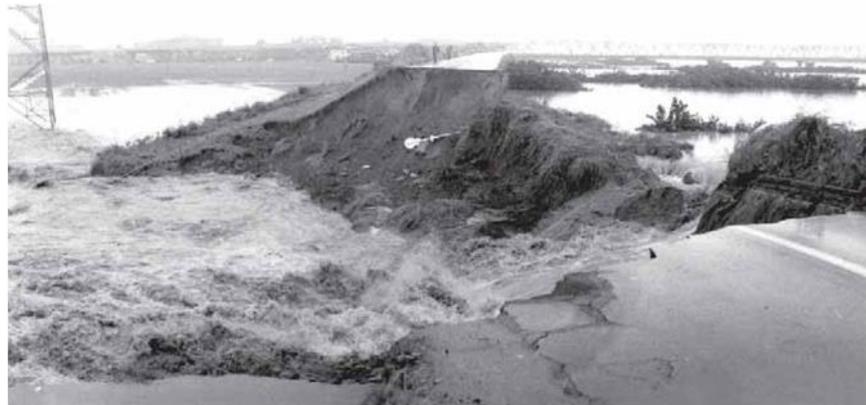
Figure 3.25 illustrates the protection works that were installed as well as the situation following the breach.

Figure 3.25 Example of slope slide from the presentation 'Picture-Card Show Project' in JGS-JCES', contribution by K. Maeda, M. Ishihara and H. Mori, using materials from the Ministry of Land, Infrastructure, Transport and Tourism in Japan.

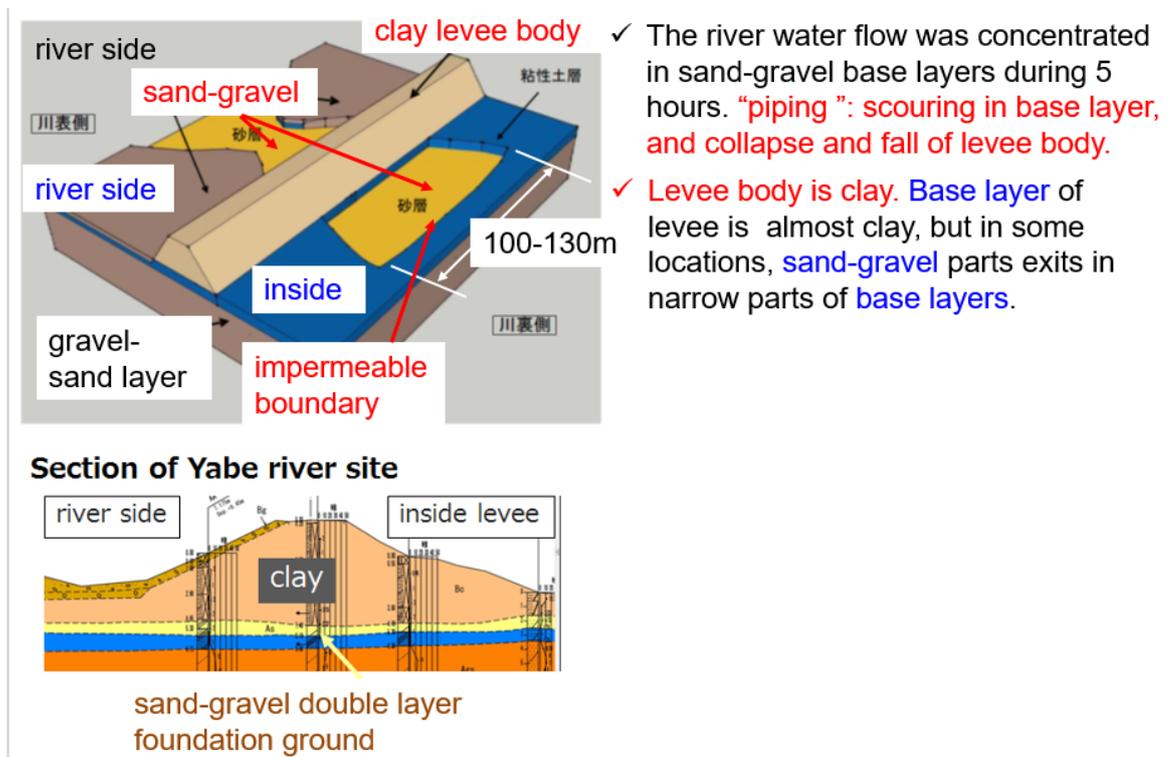
An example of levee failure due to piping erosion is illustrated below for a case on the Yabe river in 2012. In this example the high-water event caused erosion in a sand gravel layer at the base of the levee, which resulted in an eroded ‘pipe’ below the levee base. This resulted in collapse of the levee body and washing out of the levee, see Figure 3.27.

Figure 3.28 Example of piping erosion from the presentation 'Picture-Card Show Project' in JGS-JCES; contribution by K. Maeda, M. Ishihara and H. Mori, using materials from the Ministry of Land, Infrastructure, Transport and Tourism in Japan.

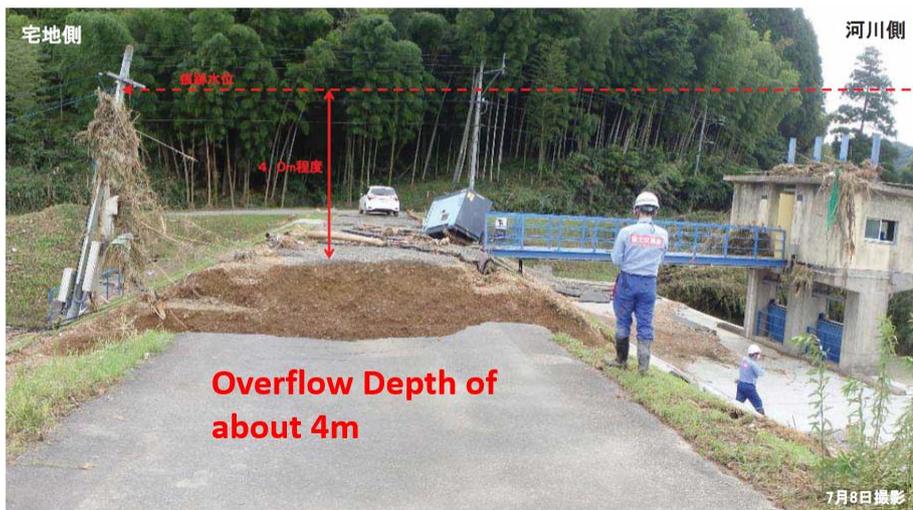
The figures below show some sites where overtopping erosion occurred on the Kuma river in 2020.

Figure 3.32 Picture of overtopping from the presentation 'Picture-Card Show Project' in JGS-JCES', contribution by K. Maeda, M. Ishihara and H. Mori, using materials from the Ministry of Land, Infrastructure, Transport and Tourism in Japan.

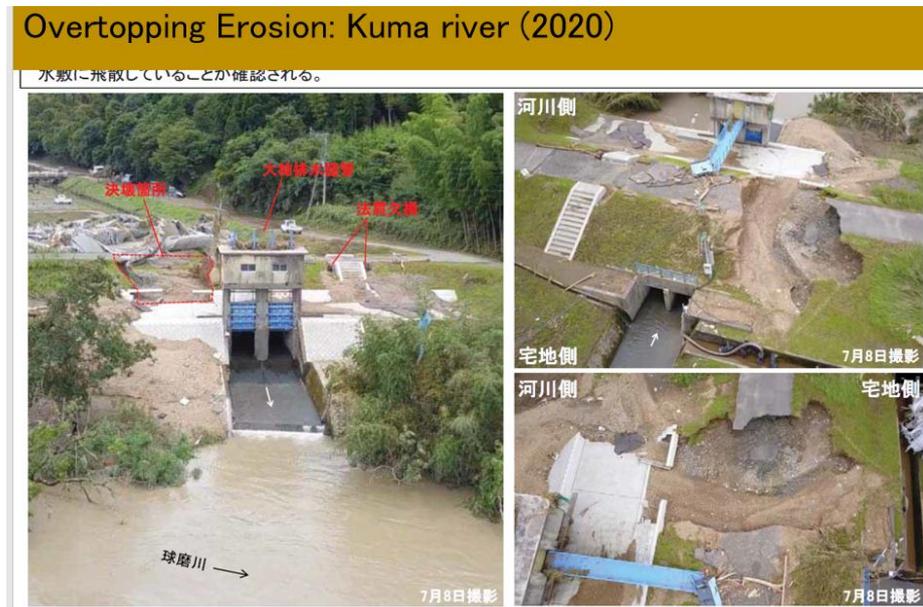
Figure 3.33 Example of overtopping from the presentation 'Picture-Card Show Project' in JGS-JCES, contribution by K. Maeda, M. Ishihara and H. Mori, using materials from the Ministry of Land, Infrastructure, Transport and Tourism in Japan.

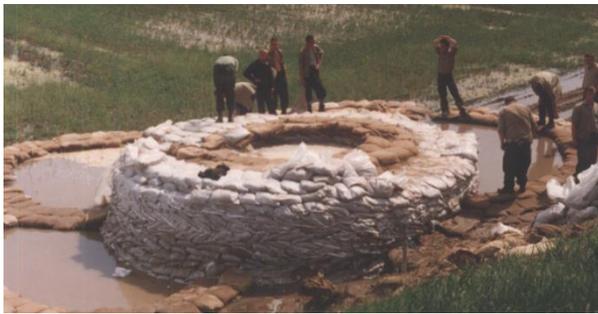
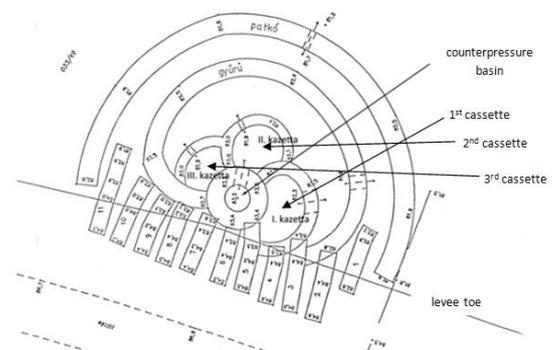
A secondary sand boil arose with a quite strong blow-up under the counter-pressure basin around 3:00 pm. Therefore, the water level in the counter pressure basin, which was already built up, lowered almost by 0.5m in a few minutes. The power of the blow-up was very concerning. Construction of the counter-pressure basin of the first cassette was carried out by soldiers and civils, its walls were 3 sandbags wide and 8 high. The basin of the first cassette fitted the previous semi-circumference shaping. Then, there was a need for building a new counter pressure basin (2nd cassette) in order to prevent another failure (see Figure 3.39).

Figure 3.39 Counterpressure basin for related cassettes (left) and location of sand cassettes (right).

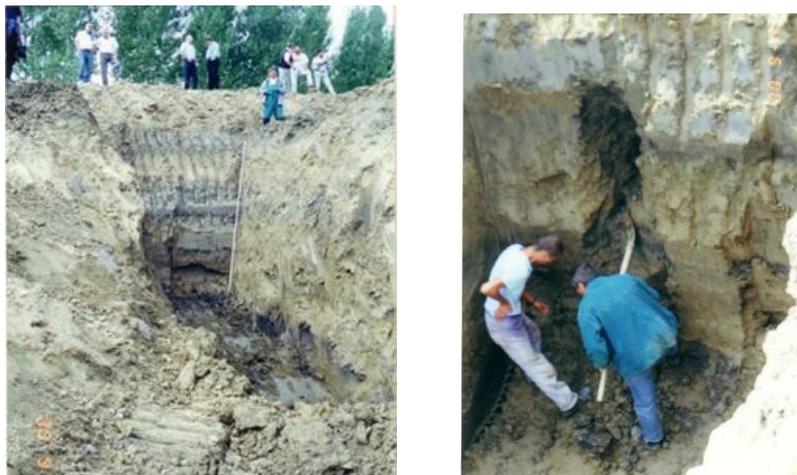
Soil investigation showed that basically the embankment was constructed by fine grained soil, but a layer of transitional soil was also discovered. The layers of the embankment and the upper part of the subsoil were relatively mixed. There was a clay layer from 5.9 m beneath the crest, which had absolutely nothing to do with the occurrence of the sand boil. The site investigation also showed that the problem is not the sand boil in the subsoil, but it appears that the pipe formed in the dike body.

Based on the washout soil, which was more than two cubic meters, a sieve analysis was carried out. The uniformity coefficient of the silty sand was $C_U = 2,74$, $d_{80} = 0.11$ mm. The opening of the sand boil could only take place at the beginning of September. The cut through the levee showed the stratification and the path of the sand boil, which was first deep at the bottom and then it went up the waterside. Figure 3.40 shows the investigation and suggested that the sand boil occurred in a thick silty sand layer, which was covered with arched clay.

Figure 3.40 Opening of the sand boil.

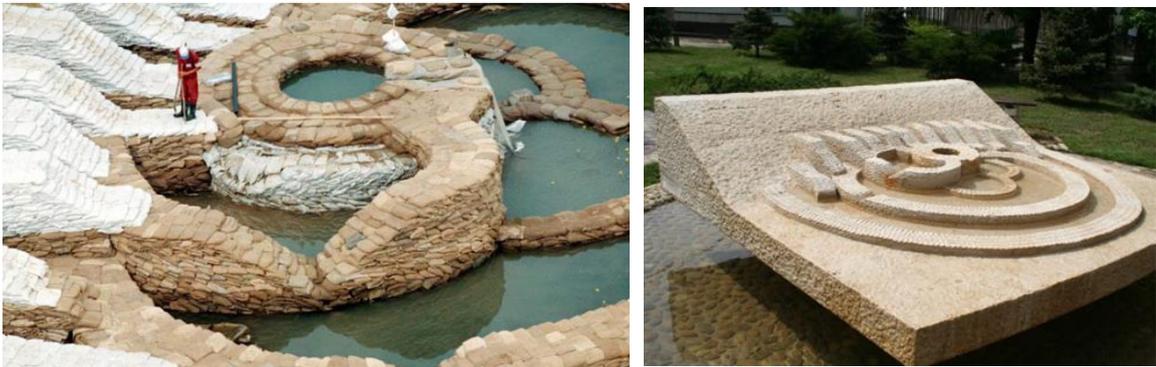
The sand boil of Tiszahas proved that the big as well as the medium-sized sand boils always need to be constantly observed and measured. These measurements must be analysed. A decision can only be made based on the observations. The measurement possibilities are limited regarding the fact that the stability of the levee cannot be endangered. Therefore, possible measurements are: observation of the surface like the blurriness of the water of the counter pressure basin, the temperature and amount of the leaking water, the amount of eroded soil from the counter pressure basin as well as its development in time. The behaviour of the levee must be valued based on these factors. Probably the great sand boil of Tiszahas is the only one in the world which has a Memorial (see Figure 3.41).

Figure 3.41 Tiszasas sand boil on 1st of May (left) and memorial of Tiszasas sand boil (right).

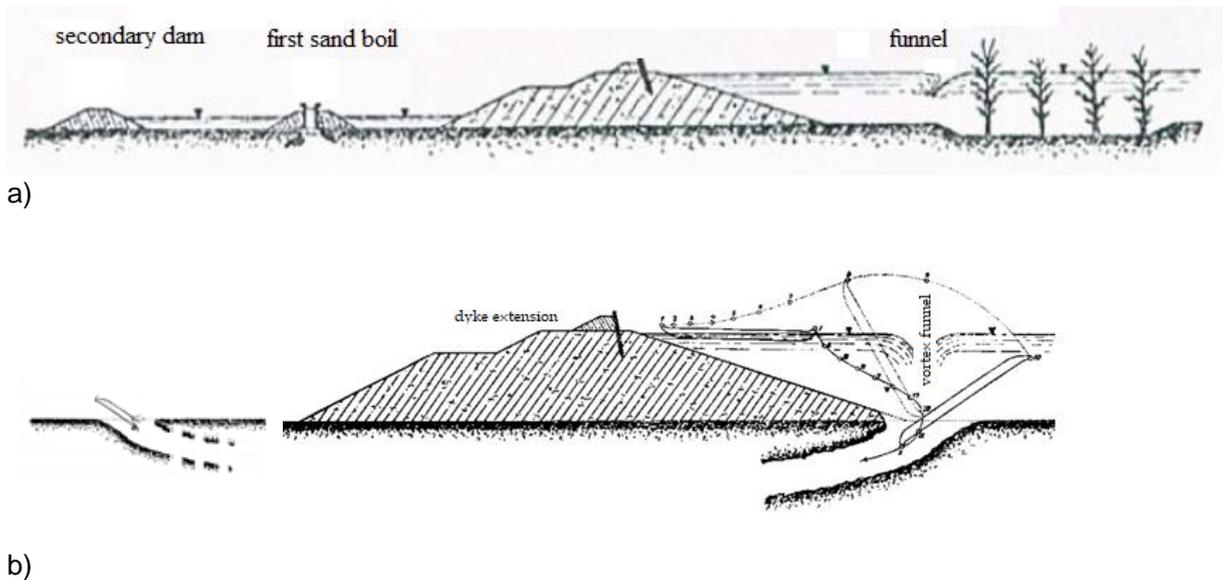
- Breach day: The breach happened as follows within some minutes. A mud geyser appeared at the spot of the first sand boil. Seeing this, the chief engineer immediately ran up to the embankment crest and glanced at a funnel about 30 m from there, which was constantly approaching the embankment (see Figure 3.42). He allegedly set the boat perpendicular to the embankment and carried earth sacks in the tail of the boat to sink (see Figure 3.42). During this time, there were again two to three volcanic muddy water eruptions at the land side and these were already stronger than the first.

When the vortex water funnel - constantly approaching the embankment - was in 15-20 m away from the crest, the boat according to observers began to tilt, his nose staring at the sky and made a path marked with numbers while diving under the water. Reports from the time indicate that the boat appeared on the other side of the levee. Subsequently the crest began to crack. At the same time, the embankment settled to a length of 8 to 10 m, the water began to flow into the saved area, and the dike breach soon widened to 80 to 100 m. The depth of the washout at the rupture site was 24 m below the level of the flood.

Figure 3.42 Illustration of the boat diving to the pipe, (a) condition some minutes before breach, (b) the path of the boat, which ended on the land side at around the first sand-boil spot.

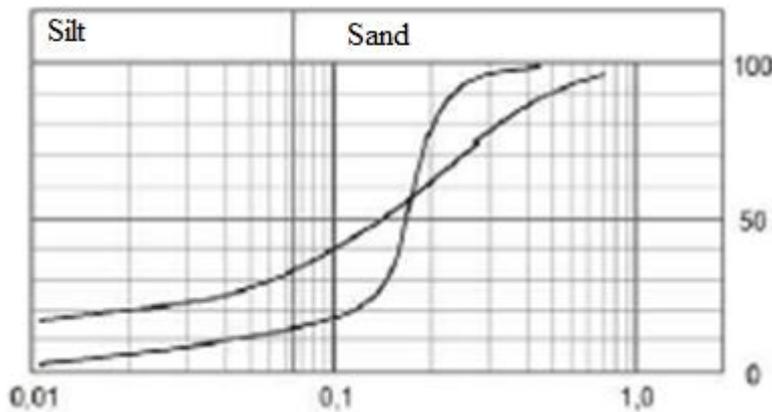
At 6:35 a.m., the guards were about 100 m away when a very strong water geyser spurt was observed. The water, they reported, was "black and thick muddy." The dike burst took about 5 minutes. Width of the tear grew rapidly, reaching a final width of 78 m. This was the first dike failure where detailed soil mechanical exploration was made afterwards. What happened was possibly a dynamic liquefaction of the extremely loose and thick sand lens, at the thickest dimension of the layer. The possible dynamic effect was the tearing off the clay cover layer at the first geyser spot and the sudden displacement of the dike body due to the increased horizontal load.

Figure 3.43 Kettős Körös, Hosszúfok in 1980, fast piping failure, failure location at top from (Szepessy, J.(1983)), with time history of flood. Bottom: grading curves, indicating the very loose sand inclusion with $3 < Cu$ and $e \sim 0.8$.

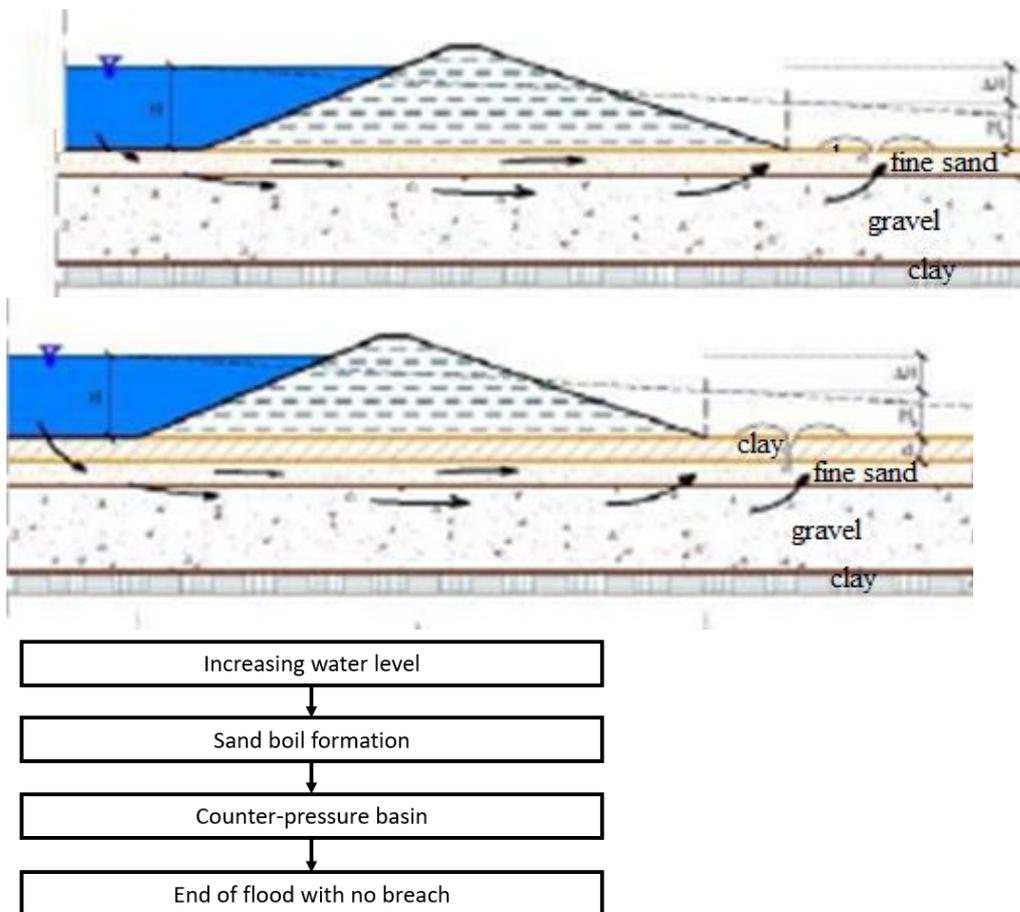
In Danube delta, slow piping may occur in the case of a thin layer of poorly graded fine sand (see site geometry in Figure 3.44). The sand boil is started by individual grain movements on a micro level due to upwards seepage forces.

Figure 3.44 Event tree of slow piping in 2 and 3-layer systems, please note the thin (poorly graded) fine sand layers.

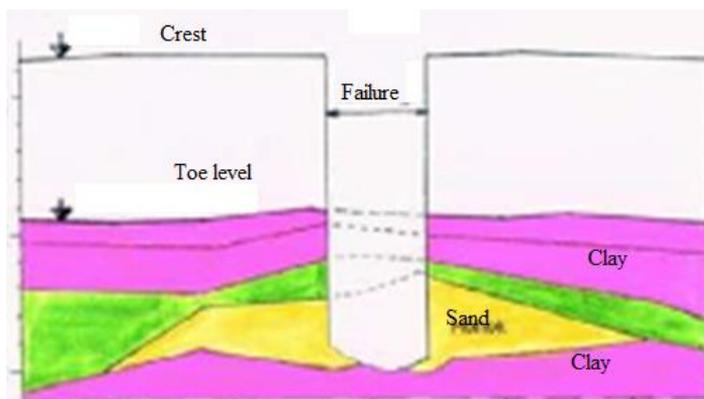
Fast piping may occur in the case of thick layer of extremely loose and poorly graded fine sand, generally in the vicinity of some old river bend crossings (see Figure 3.44 and Figure 3.45). The breach may happen within seconds/minutes of observation of the

Figure 3.45 Fast piping in case of **thick and loose cover layer**, deposited in an old meander with arching; this process may start with a sand boil in case of a clayey cover (adapted from Szepessy, J, 1983).

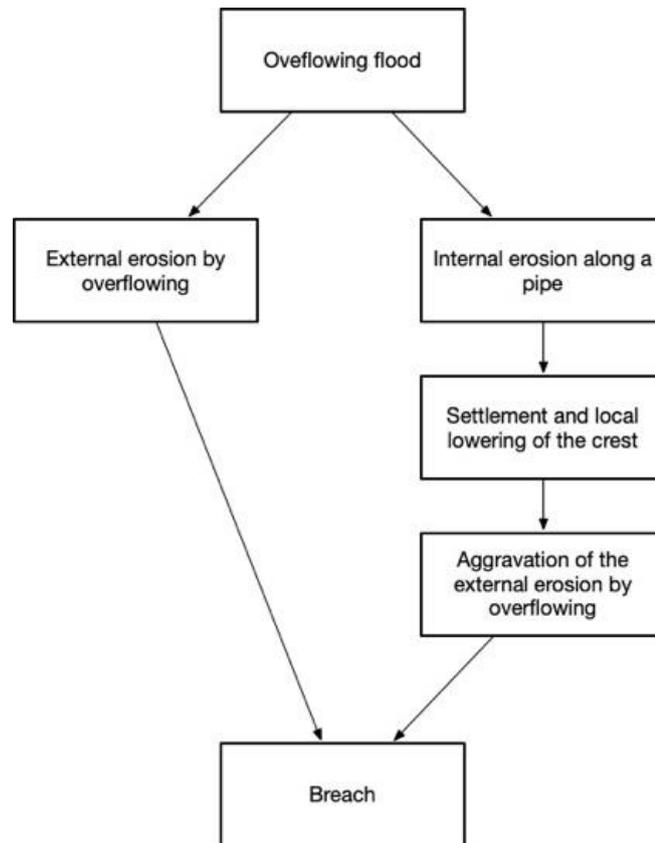
The 1999 breach has been caused by overflow at the location of the waste water treatment plant where internal erosion along a pipe crossing the levee also took place. This pipe probably aggravated the situation, because many other parts of the levee also were damaged by overflow but did not breach. Figure 3.50 shows this in the form of a diagram. It is even possible

Figure 3.50 Failure path for the 1999 Agly breach (Rémy Tourment).

Works after the event included repairing the breach, repairing the eroded land slope (with drains and compacted fill) and repairing the damaged toe protection. Some non-exhaustive work also took place to prevent leakage (masonry on the river side) and sand boils (drainage and seepage system) in different places for each of the problems.

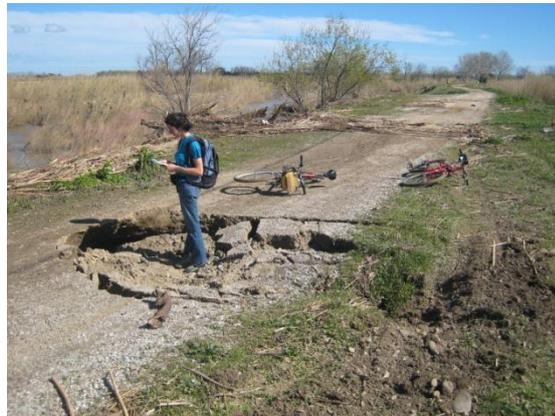
There was internal erosion in some places as well, as shown by some sinkholes and subsidence on the crest or traces of sand boils in the land alongside the levees. These internal erosion problems were mainly in the foundations, but they were also observed in the levees themselves: some seepage through the levee was also observed in areas where there were either intersecting pipes or old structures (rocks, wall) inside the levee.

Figure 3.51 Sinkhole on the levee crest (Photograph by Patrice Mériaux).

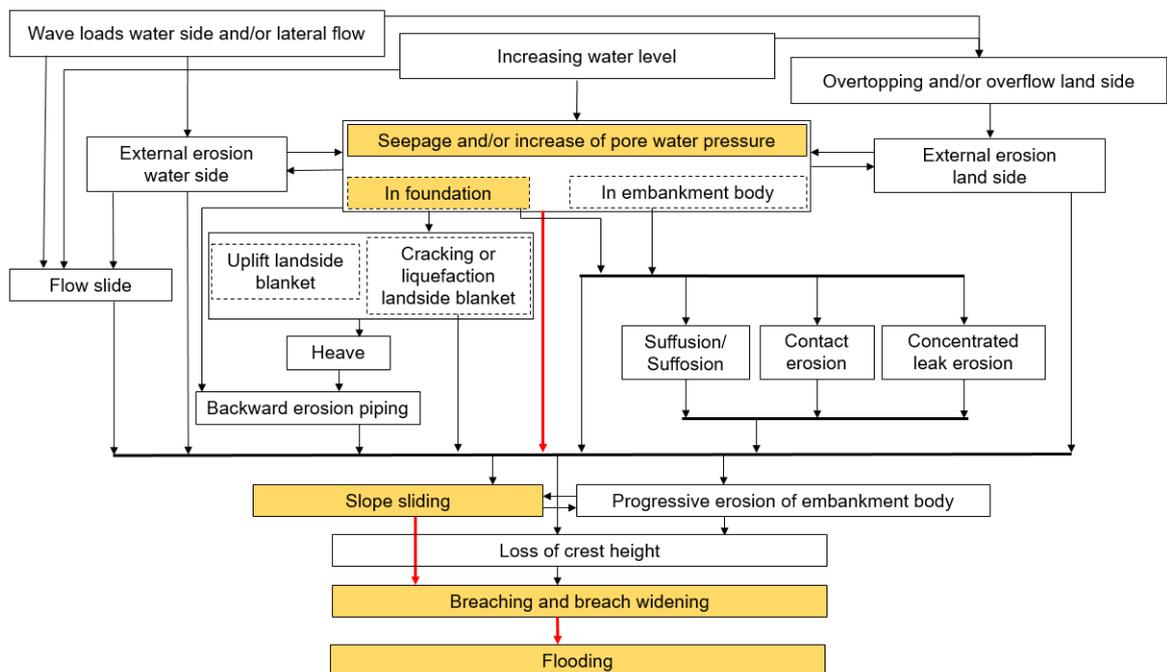
- Increase of water pressures in base:
 - In tensile cracks along sheet pile (cracks affected by shrinkage and pore water pressure);
 - Presence of locally more permeable silt layer in foundation peat layers conducting water along cracks to foundation.
- Slope sliding
 - Extremely dry conditions leading to weight loss and shrinkage of peat embankment;
 - Higher pore water pressure in foundation due to shrinkage at sheet pile and enhanced by presence of local silt layer;
 - Discontinuities present from past land use.

Figure 3.54 Failure tree of Wilnis levee breach, 2003.

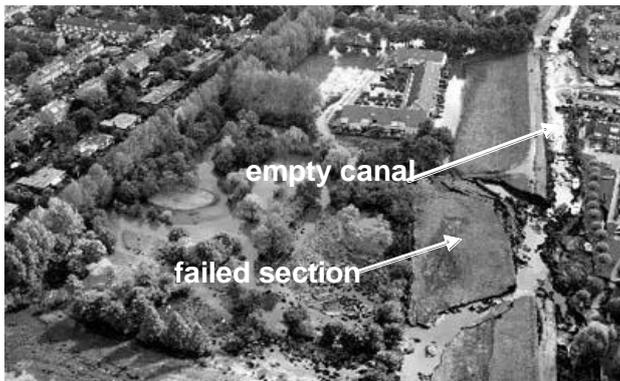
Figure 3.55 Failed canal levee at Wilnis, August 2004.

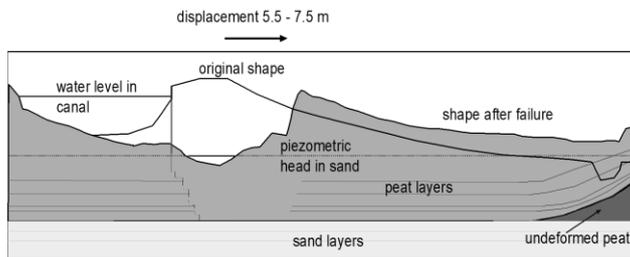
Figure 3.57 Embankment geometry before and after the failure at Wilnis. The various layer boundaries in the subsurface are indicated after failure, as well as the original water level in the canal and the piezometric head in the sand.

The failure consisted of coherent horizontal translation of about 6 m over a 60 m stretch. Vertical displacement was less than a few decimetres. A planar horizontal basal sliding plane was reconstructed from borehole and excavation data and located to have been at the base of the peat, i.e. at the top of the sand. The failed slices were bound laterally by major linear fractures oriented outward at angles smaller than 45° , indicating the wedge to have been pushed by a force from the canal. Displacement of the slice was accommodated in part by filling a ditch and, mainly, in a subsequent upthrust over the existing terrain surface. A tall poplar tree at the toe of the slide had remained in place with its roots firmly anchored in the underlying sand, cutting the about 4 m thick sliding peat and clay mass.

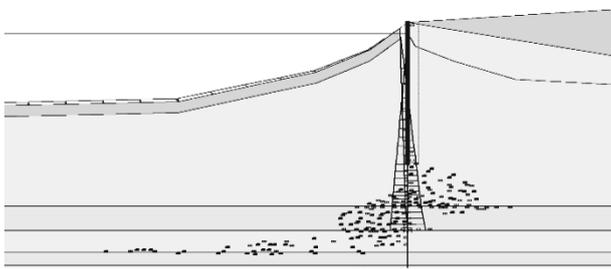
An investigation of the effects of water pressure in vertical cracks in peat showed the cracks to widen substantially upon pressure, due to the very low stiffness of the peat, and despite the peat not being very impervious (see Figure 3.58). The resulting shear stresses at the tip of the water filled cracks in the peat were found sufficient to cause fracture expansion and growth. Thus, penetration of the hydraulic head of the canal a few meters deep along the sheet piles in the peat would result in fracture propagation. Shrinkage of peat due to the dry weather conditions adversely affected stresses and deformation at the sheet pile wall. Increase in evaporation causes negative pore pressure, which induces shrinkage of peat below the already intensely fractured top layer, creating tensional stresses parallel to the levee surface over the depth of the zone experiencing negative pore pressure. The tensional stresses exert a pull on the peat at the sheet pile away from the canal (see Figure 3.58), thus enhancing creation of space along the piles and adding some tensional stress at the tip of shallower cracks. It must be noted that horizontal fracture-like surfaces are widespread in the peat mass. The extent to which the sub horizontal stresses can be transferred across such rough planes was not investigated. These planes are known to be conduits for water in peat, however, enabling high-water pressures to be transferred efficiently through the peat mass. Fracturing of the peat mass by water pressure is therefore not limited to the tip of the initial leak.

Figure 3.58 Cross section of the canal and levee with sheet pile. The dots at the base of the pile indicate occurrence of plastic behaviour in calculations using a Mohr Coulomb model.

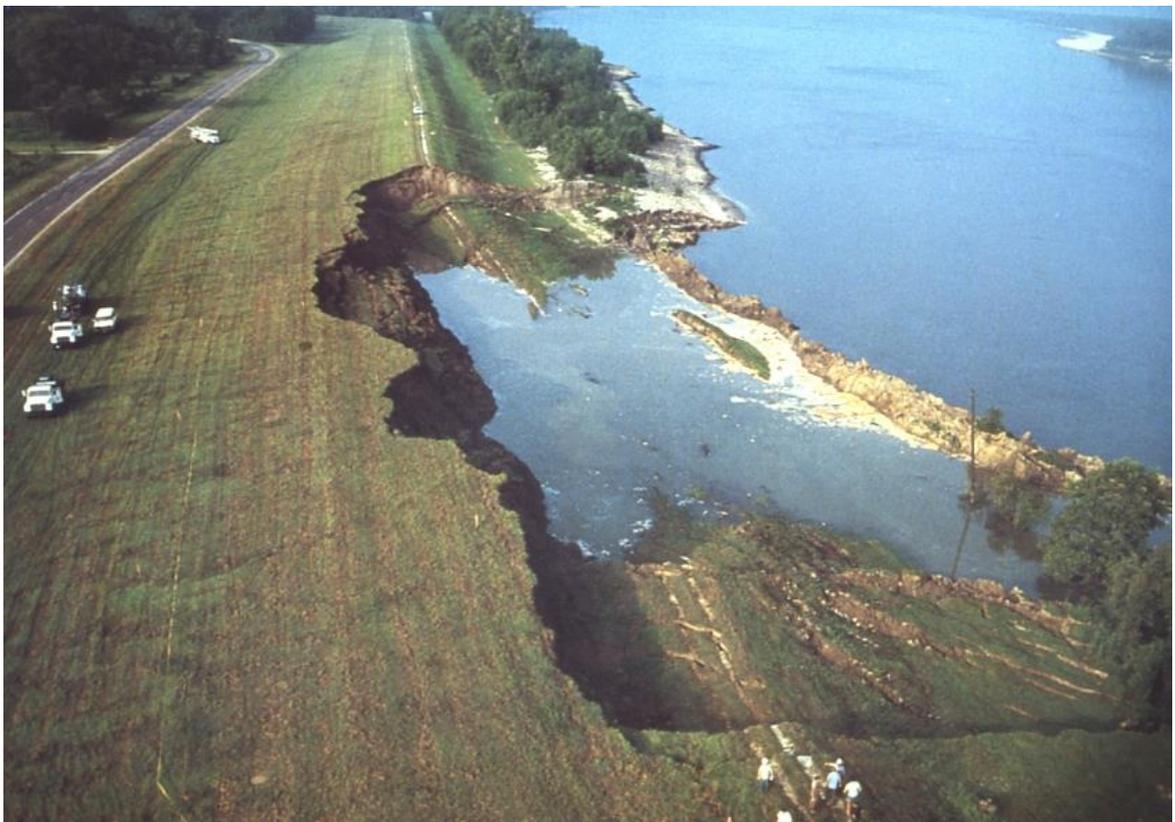
Figure 3.64 Photo: This 210 m section of levee slid into the east side of the Mississippi River on August 23, 1983 at Darrow, in Ascension Parish, Louisiana. The slide occurred shortly after a high-water stage had receded, suggesting that toe undercutting and rapid drawdown likely contributed to the failure. Source: <https://web.mst.edu/~rogersda/levees/Mississippi%20Delta%20Region.htm>.
