## Structural mitigation of a deep-seated slow moving landslide along a major national road in Sri Lanka

**Asiri Karunawardena**

**ABSTRACT:** The government has implemented large-scale landslide mitigation works along the National roads in highland areas to avoid the frequent disturbance of the transport system due to the occurrence of landslides. The stabilization of Kahagolla landslide is one of the largest mitigation works carried out under the “Landslide Disaster Protection Project”. This landslide was first identified in 1957 and creep movements have followed thereafter at different times affecting the road structure. Detailed field and laboratory investigations, instrumentation and monitoring were performed to investigate the characteristics and the possible causes of the landslide. Stability analysis were carried out on the established landslide profile based on the above information and results indicate that some parts of the landslide are in a highly active stage. Also, analysis indicates that the main reason for landslide activation is the increase of ground water level and subsequent loss of slip surface strength. Based on the results of investigations and stability a

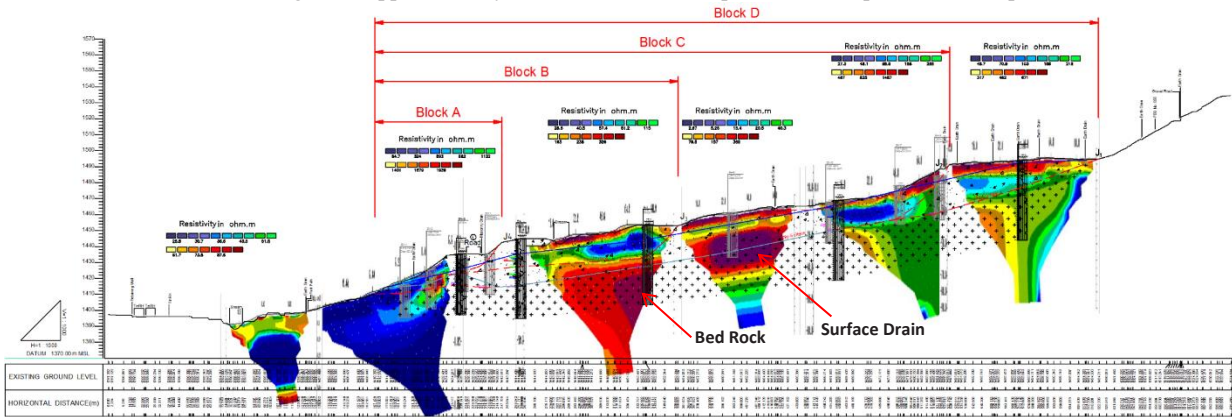
Figure 3. Resistivity profile along the main axis of the landslide

Two types of geophysical explorations, namely seismic and electric explorations (resistivity survey) were carried out at the site. The Two-dimensional electrical resistivity survey was carried out to understand about the weathering state of each layer, depth to the bedrock, aquifers and their continuity, which was very useful in the design of sub-surface drainage. The sub soil profile obtained from the resistivity survey clearly indicated the high water content area inside the landslide. The resistivity profile obtained along the main axis of the landslide is shown in Figure 3.

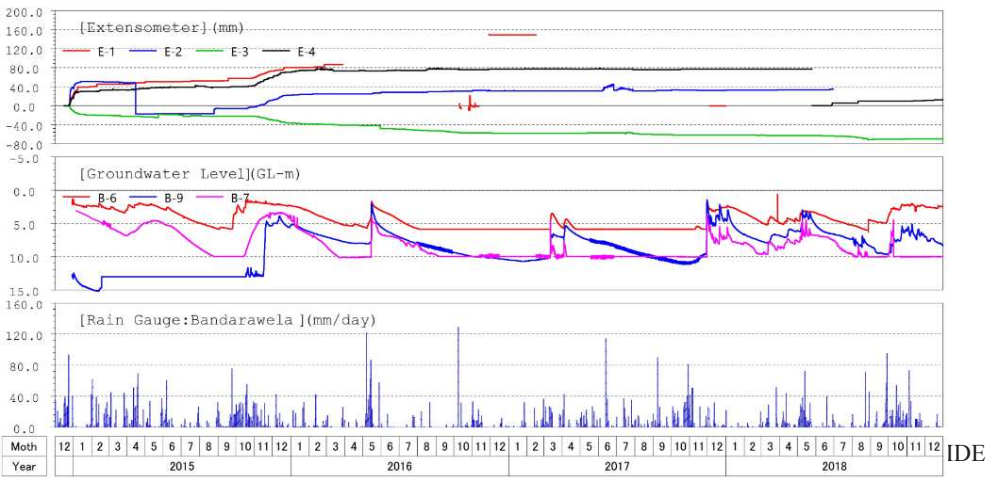
Figure 4. The response of water level meter and extensometer for the rainfall received. Based on the field reconnaissance and the topographic survey result, the landslide of the site area is divided into four blocks as

Field monitoring instrumentation, namely pipe strain gauges, inclinometers, extensometer, water level meters and rain-gauge were installed at identified locations to monitor the behavior of the landslide as indicated in Figure 2. Monitoring was carried out for about a year covering the monsoon periods before the detailed design was carried out and thereafter it was continued during the construction period too. Monitoring was done once a month during the dry period and twice a month during the rainy period. The response of monitoring devices of water level meter and extensometer for the rainfall received is shown in Figure 4. Main observations of the landslide monitoring were made to reveal the relationship with rainfall patterns and slip occurrence.

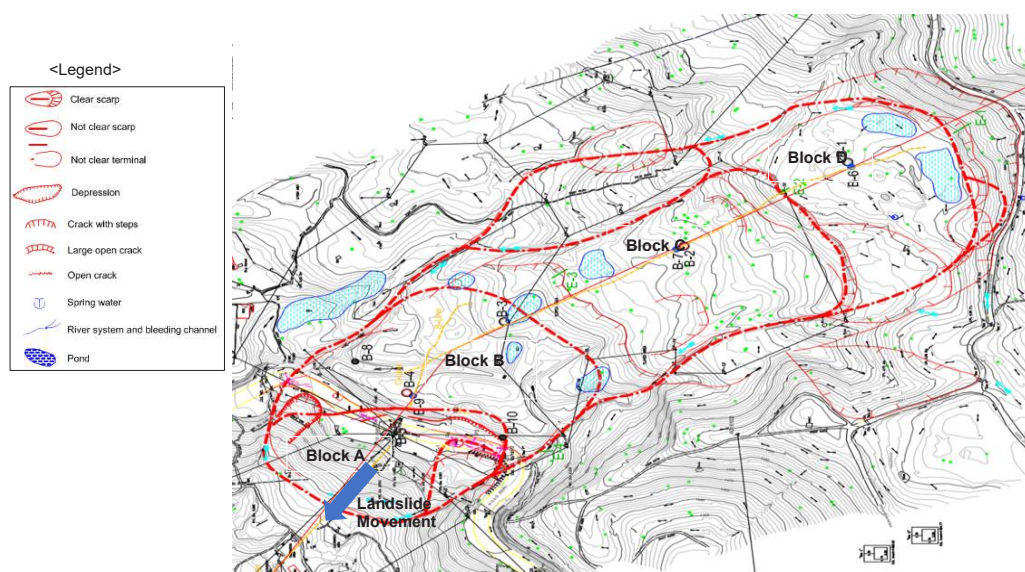
Figure 7. Landslide map showing landslide features

A significant number of tension cracks, minor scarps and bulge have been found on the landslide surface. The boundary, main axis of the landslide and its moving direction together with different land moving blocks were identified through the field survey and accordingly geological maps were prepared.

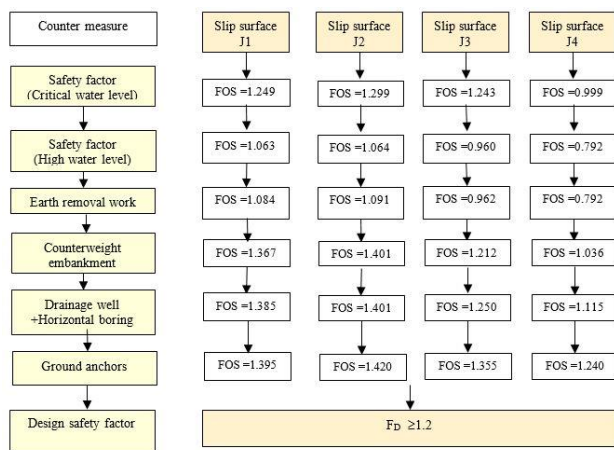
Figure 11. Flow of the safety factor

Counterweight embankment plays a huge role in stabilizing the slip surface J1 and J2 while other most critical slip surfaces are stabilizing with groundwater control works. However, in order to achieve desirable safety margin in slip surface J4, ground anchors are also included in the design.

Based on the results of investigation and stability analysis, several suitable combinations of countermeasures were considered, and examined to decide a couple or more appropriate combinations of countermeasures in terms of both economic efficiency and design requirements. From the more appropriate combinations of countermeasures, an optimum combination of countermeasures was selected by careful examinations and comparison among them. The improvement of safety factor with application of each counter measures are given in Figure 11. The plan and cross section of proposed countermeasures for the landslide mitigation are given in Figure 12.
