## Remedial design of failed embankment founded on clay shale in east kalimantan, Indonesia

**ABSTRACT:** During construction of a 15-meter high embankment in Balikpapan - East Kalimantan, a section of the embankment at STA 2+905 failed following a prolonged rainfall. The failed embankment was subsequently repaired by re-excavating and re-compacting it to its original geometry. One year later, however, extensive cracks re-appeared at this section, leading to the failure of the adjacent box culvert. The second remedial work was carried out by installing mini piles to reinforce the foundation at the failed section. Yet, the cracks and slips still occurred at this section.

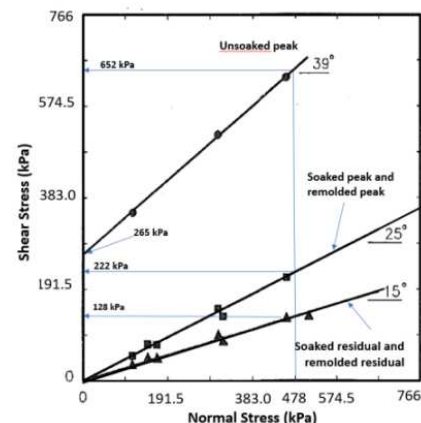
Figure 4. Effect of soaking on the strength parameters of very stiff clay from San Luis Dam downstream foundation (after Stark and Duncan, 1991)

Stark and Duncan (1991) tested stiff-fissured clay obtained from downstream of San Luis Dam, California, which failed during drawdown in 1981. The results of the direct shear tests on dry undisturbed samples indicate that the clay was very strong with  $c=265\text{kPa}$  and friction angle of  $39^\circ$ , as can be seen in Figure 4. However, when the samples were soaked, the strength reduced to  $c=0\text{kPa}$  and friction angle of  $25^\circ$  for peak strength and  $15^\circ$  for residual strength. This is equivalent to over 2/3 strength loss from  $652\text{kPa}$  (peak) to  $222\text{kPa}$  (soaked) and  $128\text{kPa}$  (residual) for normal stress of  $478\text{kPa}$  (blue line in figure 4).

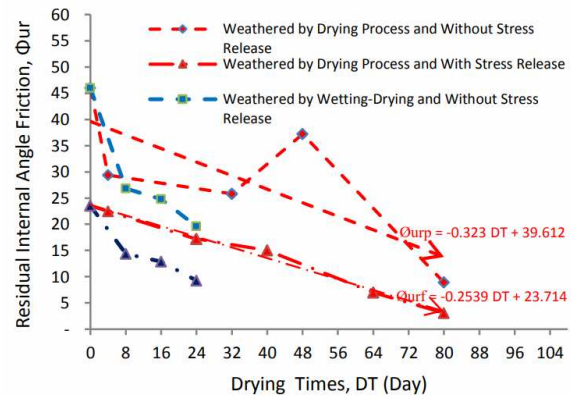
The effect of weathered by wetting-drying process in Indonesian Clay Shale sample on shear strength reduction (residual friction angle and cohesion) was studied by Idrus M. Alatas et al (2016). The study was conducted for clay shale sample in Semarang (Central java) and Hambalang (West Java). The total percentage of its clay minerals (smectite, illite, kaolite, chlorite) content around 56%-62%. The samples were weathered by wetting and drying up to 80 days. Both cohesion and friction angle were decrease as the increased of the frequencies of wetting-drying cycles as shown in Figure 12 and 13.

Figure 12. Residual internal friction angle reduction of unsaturated Semarang-Bawen clay shale due to natural drying and wetting cycles (soaked twice in every 8 days) (Idrus, M. Alatas).

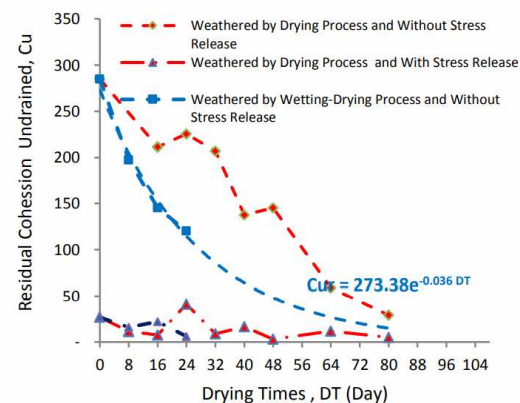
Figure 13. The residual cohesion reduction of unsaturated Semarang-Bawen clay shale due to natural drying and wetting drying cycles (soaked 2 times in every 8 days) (Idrus, M. Alatas).
