## Settlements of an erection bay of the Mavčiče Dam founded on a backfill

**Pavel Žvanut**

*Slovenian National Building and Civil Engineering Institute, Ljubljana, Slovenia, pavel.zvanut@zag.si*

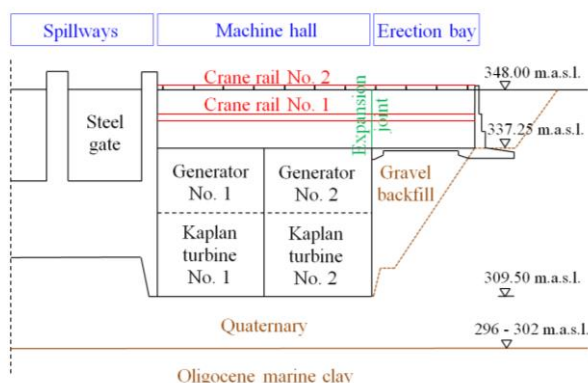
The machine hall is founded on conglomerate bedrock at the altitude of 309.50 m, whereas the erection bay, which is located next to it, is founded on a layer of gravel backfill, up to 25 m thick, which lies on top of the bedrock. The lower courtyard, which is located in front of the erection bay, has an altitude of 337.25 m, whereas the upper courtyard, which lies behind the erection bay, is located 10.75 m higher, i.e. at the altitude of 348.00 m (Brinšek 1989).

Figure 3. Foundation of the right part of the dam.

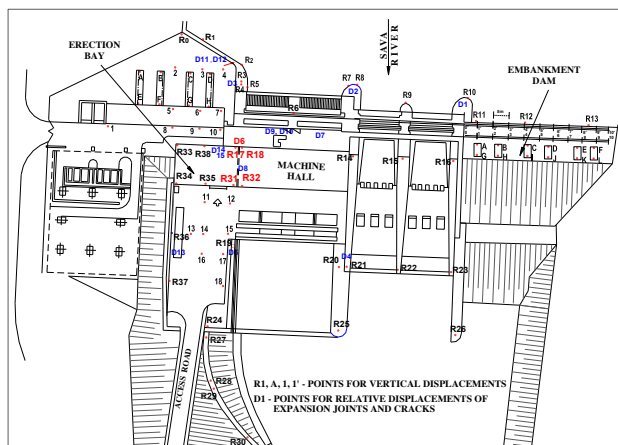
In the years 1999 to 2000, an upgraded system for monitoring the detailed behaviour of the right part of the dam was established, which covered additional twenty-six geodetic points for measurements of vertical displacements (Batagelj 2001). Eighteen of these geodetic points (marked by 1 to 10 and by A to H) are located in the upper courtyard, and the other eight geodetic points (marked by 11 to 18) are located in the lower courtyard (see Figure 4).

Figure 4. Monitoring system for deformation measurements.
