Assessment of soil cracking mechanism in the south-east area of Mexico City based on deep geotechnical exploration

Gabriel Auvinet-Guichard, Moisés Juárez-Camarena, Edgar Méndez-Sánchez, Francisco Hernández-Vizcarra, Sergio A. Martínez-Galván, Marco A. Pérez-Ángeles & Jesús Sánchez-Guzmán
Geotechnics, Instituto de Ingeniería, UNAM, Mexico, gauvinetg@iingen.unam.mx

ABSTRACT: This paper presents an interpretation of the results of a deep geotechnical exploration campaign carried out at several sites, in the south-east area of Mexico City. The purpose was to identify the mechanism of generation of the cracks in the soil that have affected this area during the last decades. The stratigraphic characteristics and the subsoil properties correspond to an abrupt transition zone between lacustrine soft clays and firm soils or volcanic rocks found in this area of Mexico City. Cracks can thus be attributed to the uneven consolidation of the lacustrine clays affected by drawdown of pore pressure due to deep pumping of water in local aquifers. Some remedial and mitigation measures that have been implemented in the area are presented.

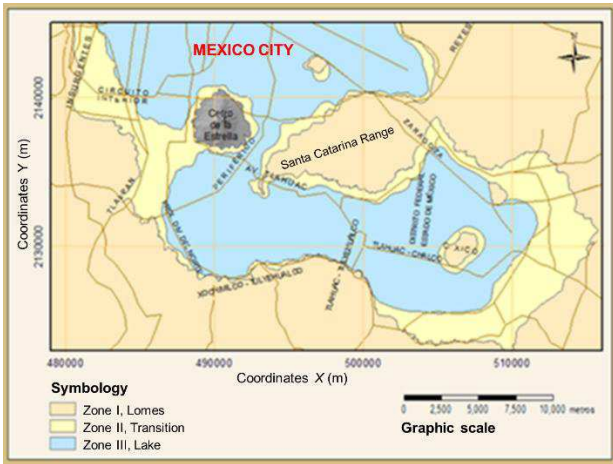
Figure 2. Geotechnical zoning of Mexico City south area (NTCDCC, 2017).

Figure 2 shows the geotechnical zoning of the south area of Mexico City, based on the above information and included in the Complementary Technical Standards for Design and Construction of Foundations for Mexico City (NTCDCC) published in December 2017. The areas corresponding to zones I (Lomas), II (Transition) and III (Lacustrine) are indicated.

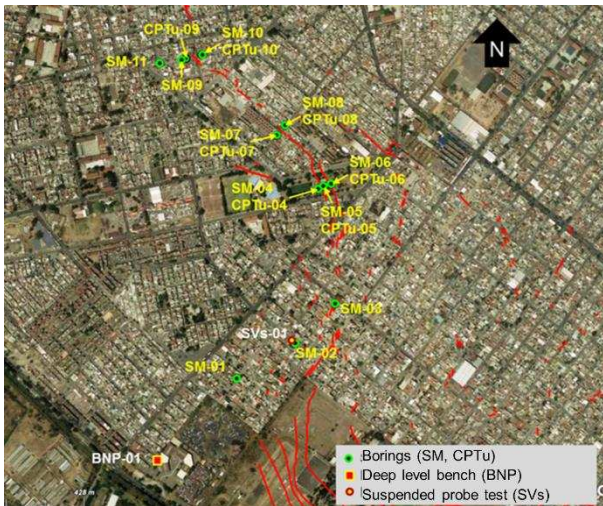
Figure 3. Geotechnical borings and instrumentation location.

In order to advance in the understanding of the large-scale soil cracking phenomenon, as well as to obtain useful data for numerical modeling focused on evaluating its medium and long term evolution, a detailed geotechnical exploration and instrumentation campaign was performed at four sites considered as representative of the affected area.

The deep exploration program included mixed borings (SM) with recovery of disturbed and undisturbed samples to define the local stratigraphy, electric cone tests (CPTu) with pore pressure measurement and pore pressure dissipation tests to determine the piezometric profile, one deep level bench (BNP) down to the deep deposits below the lacustrine clay soils, and one suspended probe test (SVs) to define a profile of the shear wave velocity. The geotechnical exploration and instrumentation were carried out by four different companies. Figure 3 shows the plan location of the borings and instrumentation with respect to the cracks.

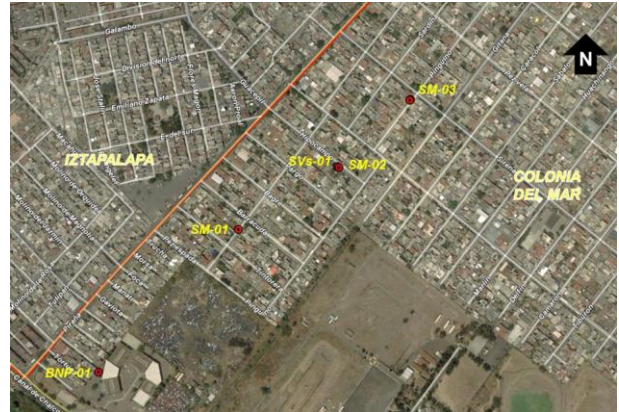
Figure 4. Location of borings, *Colonia Del Mar* site.

At the *Colonia Del Mar* site, borings SM-01, SM-02 y SM-03 with maximum exploration depth 74.8, 83.0 and 83.0m, respectively, were performed, as well as three electric cone tests with pore pressure measurement CPTu-01, CPTu-02 and CPTu-03, with maximum depth 57.78, 63.0 and 39.28 m, respectively. Figure 4 shows the location of borings.

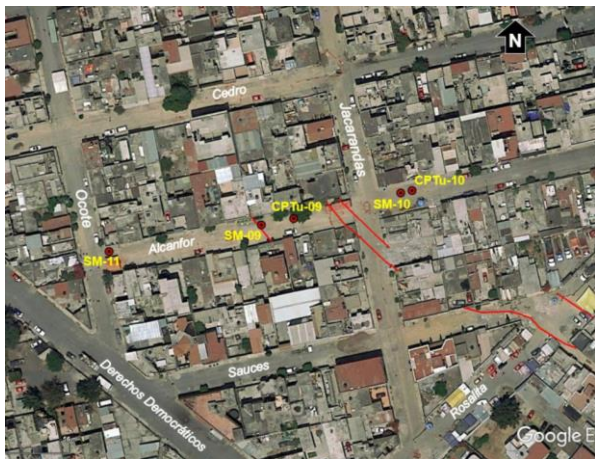
Figure 14. Location of borings, Colonia El Molino Tezonco site.

At the Colonia Del Mar site (Figure 14), borings SM-09, SM-10 and SM-11, with a maximum exploration depth of 68.3, 66.0 and 100.2 m respectively, were performed as well as three electric cone tests with pore pressure measurement CPTu-09 and CPTu-10, with a depth of 58.14 and 55.86 m respectively. The borings are located along a 55 m long axis (GEOVISA, 2019).
