Factorial analysis of lateral flow induced damage in Uchinada Town due to the 2024 Noto Peninsula Earthquake, Japan

ABSTRACT: The 2024 Noto Peninsula Earthquake caused widespread liquefaction and significant ground deformation across Ishikawa Prefecture. Uchinada Town, located approximately 100 km south of the epicenter, experienced particularly severe damage, especially in low-lying coastal and reclaimed areas. This study focuses on the Muro district of Uchinada Town, where intensely localized lateral flow occurred. To investigate the deformation mechanism, field surveys including boring investigations, Standard Penetration Tests (SPT), and Piezo Drive Cone (PDC) tests were conducted. Results revealed that the subsurface primarily consists of fine, loose sand highly susceptible to liquefaction under seismic loading. The area's gentle slope and catchment topography promoted groundwater accumulation, resulting in a shallow groundwater table (~1 m depth) that further contributed to the severity of lateral flow. PDC tests identified a continuous weak soil layer (N-value 0–1) along the reclamation side of Prefectural Route 8, corresponding with the most severe lateral spreading. Lique

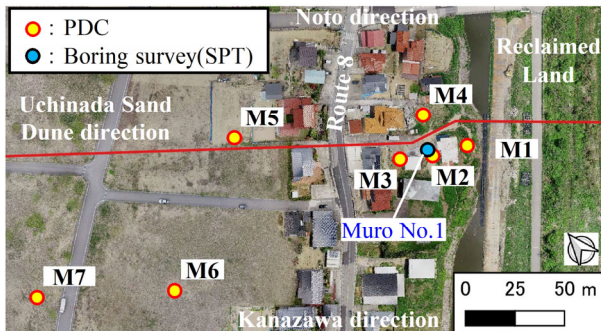
Figure 4. Field Survey Locations in the Muro District

Three different surveys and a test were conducted in the Muro district: Boring Survey, Standard Penetration Test (SPT), Piezo Drive Cone (PDC) Test and Grain size analysis. Figure 4 shows the locations where the field surveys were conducted and Table 1 and Figure 5 and show sampling locations of the grain size test.

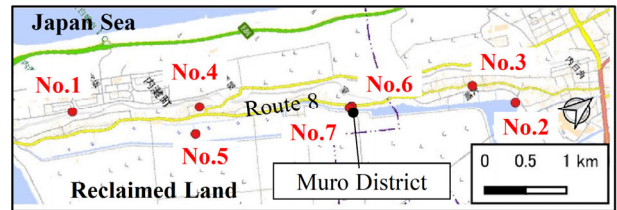
Figure 5. Sampling Locations of the Grain Size Test

No.	Sampling sites
1	Sand dune(no liquefaction damage)
2, 3	Sand boiling location
4	Sand boiling location (Elementary school ground)
5	Sand boiling location
6, 7	Muro district residence

1. Grain Size Analysis: Samples were collected from both the top of a dune where liquefaction did not occur and sand boil locations.
2. Topographic Analysis: The topography and groundwater conditions in the Muro district were analyzed based on elevation data (5m DEM) obtained before the disaster and existing geological survey results.
3. Boring Survey and Standard Penetration Test (SPT): The purpose of the boring survey is to understand the ground composition of the Muro district, where significant lateral flow damage was observed. Additionally, the purpose of the Standard Penetration Test (SPT) is to determine the N-values of the ground.
4. Piezo Drive Cone (PDC) Test: The Piezo Drive Cone (PDC) Test measures pore water pressure through dynamic penetration and estimates the N-value and fine content (Fc) to evaluate the soil's liquefaction resistance.
