# Failure Analysis and Proposed Repair and Retrofit Schemes for a Mechanically Stabilized Earth Wall System in Metro Manila, Philippines

**Francis Jenner Bernales, Marielle Gwen Martinez, Desz Justinne Ocampo, Roy Anthony Luna**  
*AMH Philippines, Inc., Quezon City, Philippines, [francis.bernales@amhphil.com](mailto:francis.bernales@amhphil.com)*

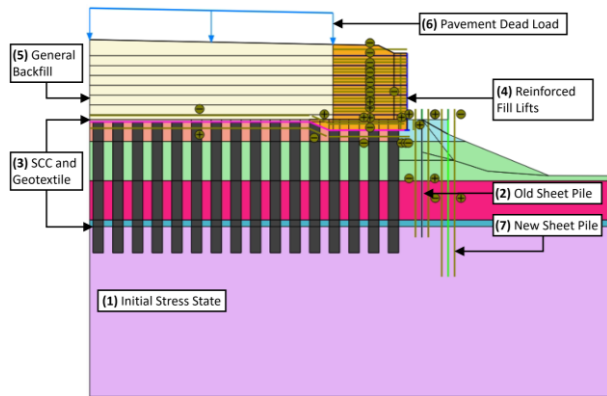
Figure 5. FEA geometry for MSE wall section.

FEM analyses were carried out for the MSE wall section with the adjacent sheet pile (Figure 5). The geometry was based on available design drawings, with the global water table positioned 2.0 m below original ground level in accordance with the borehole data. The construction sequence was modeled in phases to replicate stress and strain history: (1) initial stress state assignment, (2) installation of sheet pile, (3) ground improvement with SCC and geotextile, (4) construction of reinforced fill lifts with geosynthetic strips, (5) placement of general backfill, (6) application of pavement dead load, and (7) installation of new sheet pile.
