Modelling Sand Boiling of a Detention Basin due to Internal Erosion During River Flooding

ABSTRACT: A detention basin was constructed below ground level adjacent to a river bridge abutment in northern NSW, Australia. The basin is located approximately 100 m landward of a levee designed for a 27-year return period flood. The subsurface profile comprises continuous sand and gravel layers up to 25 m thick, creating strong hydraulic connectivity between the river and the basin. During a 1-in-12-year flood, the river level rose to RL 6.5 m. Groundwater ingress and sand boiling were observed at the basin floor when its water level reached RL 1.5 m (i.e. about 0.5m above basin floor level). There was also observation of substantial loss of soil strength at the peripheral of the basin floor at the time of sand boiling. Shortly after sand boiling was detected, tension cracks and slope slippage were observed at the basin batter and the adjoining approach embankment of the highway. This paper presents a detailed numerical modelling study using transient flow analysis to investigate groundwater flow leading to sand boiling at the detention basin. A novel approach using a dummy material was em

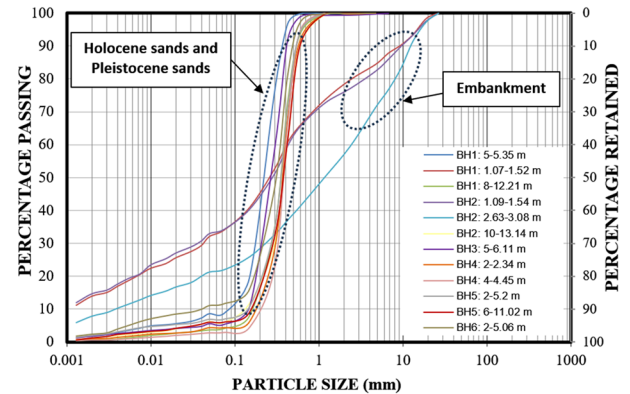
Particle size distribution (PSD) curves for sand samples at different depths are presented in Figure 5. Based on the PSD curves, the Holocene and Pleistocene sand can be classified as uniformly graded sand. Both sand units are similar in grading, i.e. fine to medium grained. Permeability of sands can be estimated using Hazen's formula (Eq. 1) which was developed for uniform sands:

Figure 5. Particle size distribution of samples tested

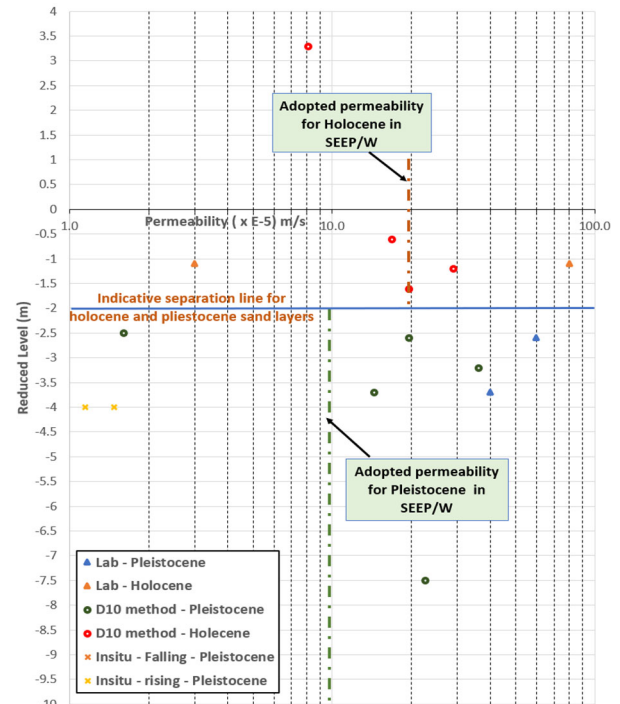
where C is a correlation factor and D_{10} is the 10 per cent particle size in mm taken from the PSD curves. C could vary between about 0.007 and 0.014. By adopting a typical $C=0.01$, the estimated values are shown in Figure 6 together with the in-situ and laboratory permeability test results.

Figure 6. Estimated permeability of the sand layers

The two in-situ permeability (slug) tests were conducted immediately after borehole drilling and standpipes installation. Residual drilling mud within the sub-soil may have impeded water level recovery following slug removal or addition, leading to underestimated permeability values. Consequently, the permeability derived from the slug tests was likely much lower than the actual in-situ permeability. In contrast, laboratory constant-head tests indicate that the Holocene and Pleistocene sand layers possess significantly higher permeabilities than those suggested by the in-situ results. The higher laboratory values likely reflect the absence of drilling mud, reduced influence of in-situ stress, and the use of smaller, more uniform specimens, all of which can increase measured permeability compared with field slug tests.

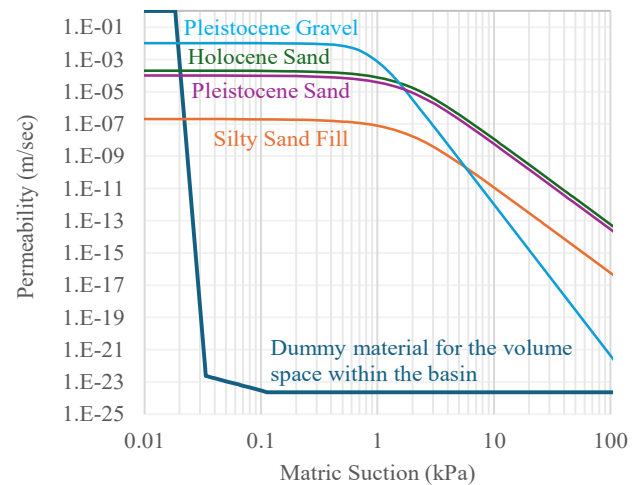
A 2D section shown in Figure 8a capturing the relative distance between the river and the basin was adopted for the flow analysis. Figures 8b and 8c show the soil stratigraphy along the design section. Table 1 summarises the back-analysed hydrogeological properties of the soil layers. Figure 7 provides a comparative plot of hydraulic conductivity curves for the key layers in the model. No site-specific laboratory testing was undertaken to develop the hydraulic conductivity functions for the various soil layers. The hydraulic conductivity functions with matric suction were adopted based on the suggestion provided in SEEP/W for typical soils. However, without extensive testing, the hydraulic conductivity functions of the soils could not be confirmed or refined.

Figure 7. Hydraulic conductivity curves for key layers

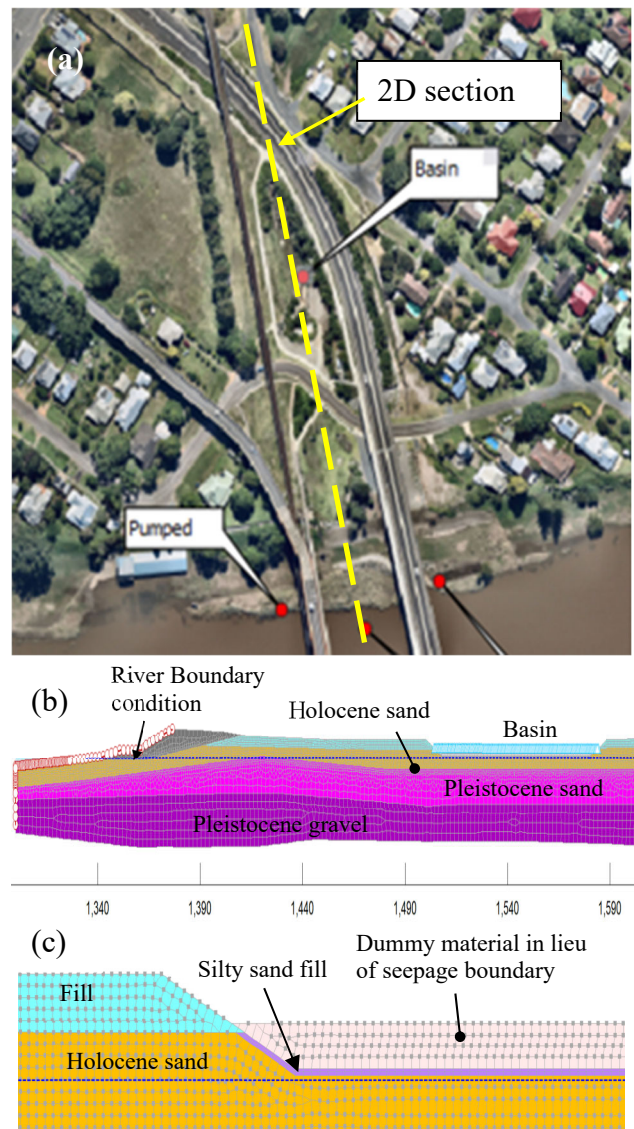
Figure 8. (a) 2D Section; (b) Overall hydrogeological profile; (c) Soil layers near the basin

not be equal to zero after the phreatic surface reaching these boundary nodes. An alternative way to model groundwater entering the basin was the adoption of a dummy material for the volume space within the basin with a hydraulic conductivity function as shown in Figure 8c and Figure 7 that has the following characteristics:

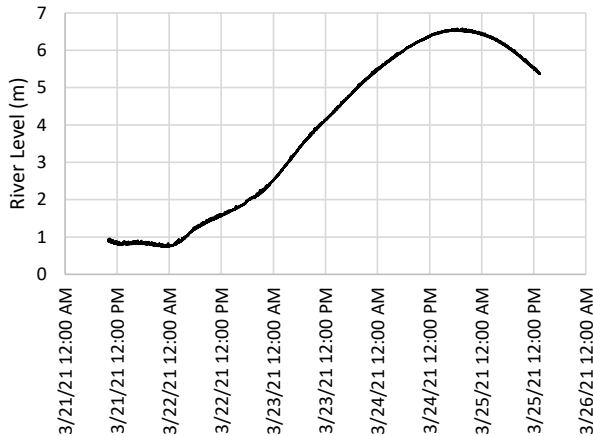
Figure 9 shows the rising of the monitored river water level with time during the 2021 flood event. This was applied as the boundary condition at the riverbed in the transient flow model as shown on the left side in Figure 8b.

Figure 9. Monitored rising river water level with time

The preferential flow path has been assessed in seepage analysis as shown in Figure 10a and has also been shown diagrammatically in Figure 4. As the river water rose to RL 5.6 m (at approximately 5 am on 24 March per Figure 9), the groundwater was assessed to have entered the basin with a basin water level at RL 1.3 m (0.3 m above basin floor). Pore water pressure was assessed to have built up below the sandy loam layer at this point of time as it has a lower permeability than that of the underlying Holocene sand. For example, the assessed total stress at Point A (see Figure 10b) below the sandy loam was 11 kPa, which was lower than the assessed pore water pressure of 16 kPa. The assessed effective stress was -5 kPa, hence indicating the occurrence of sand boiling. As the basin water rose further to RL 2.4 m (1.4m above basin floor, see Figure 10c), it was assessed that sand boiling subsided as indicated by the positive effective stress at Point A (+2 kPa = total stress of 22 kPa – pore water pressure of 20 kPa). The assessed results outlined above are consistent with the observations outlined in Section 4.1.
