The geotechnical analysis corresponding to the high road embankments close to a bridge

Chirica A.

ABSTRACT: The paper presents a complex study case corresponding to a road embankment until 10m height placed at Iassy, Romania. It is about the access embankments at a bridge with total length of about 300m. After one year of service the studied embankments presented the following geotechnical problems: longitudinal cracks parallel and along with road axis, lateral knobs corresponding to each compacted layer, infiltrations through the backfill from the top (faulty pluvial system) and from the bottom (flooded foundation soil without drainage system). Foundation soil is metastable clay. Triaxial tests type CKoD on stress loading paths has shown that this soil is sensitive to moistening at shear stresses. The embankment is made also from a clay unusually used for such type of structures and several geosynthetic layers. At the top there is an elastic pavement. The footwalks over the embankment are from reinforced concrete and are bracket assembled. The finite element model has taken into account various hypothesis: 1. Model with the soils in natural state, 2. Model with foundation soil i

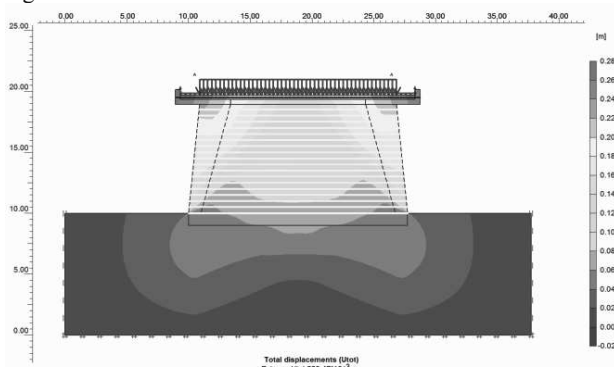
Figure 7 Total displacements.

- a) Model 1: the maximum total displacement is 280mm (at the edge the sidewalks - Fig. 6). As it can be seen in Fig. 10 the plastic points appear at the edges of the embankments and in the central part of soil foundation at a approx. depth of 5m. Also, a very important notice is that the plastic points also appear at the edge of the embankment at maximum 1m around the body of backfill.
