Investigation of Reinforced Earth Structures Following the 2011 Tohoku Earthquake

Otani Y., Takao K.

ABSTRACT: An investigation of mechanically stabilized earth (MSE) structures constructed with Reinforced Earth (Terre Armée) technology¹ was carried out after the 2011 Tohoku Earthquake in Japan. Reinforced Earth walls examined for the survey were ranked according to associated disaster-caused damages. The results of this research indicated high levels of earthquake resistance in the steel-reinforced structures constructed with this technology method.

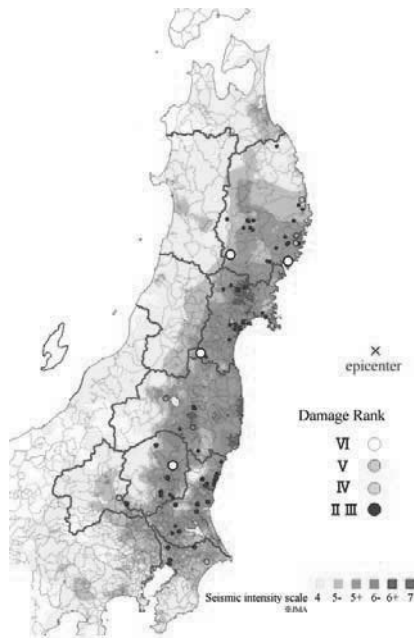
Figure 1. Distribution of walls classified as damage rank II or greater

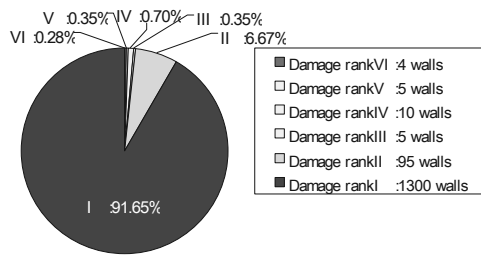
The Tohoku Earthquake that took place on March 11, 2011 was a reverse fault type earthquake with its epicenter in an ocean trench at the boundary of the Pacific Plate and North American Plate. It registered a moment magnitude (M_w) of 9.0 and a seismic intensity of 7.0, the maximum intensity on the JMA scale ($MM \text{ scale} \approx 5.5 \cdot \text{JMA scale} + 0.5$). The earthquake generated tsunami waves that affected not only Japan, but also other Pacific Rim countries, with the height of tsunami waves travelling upstream and over land reaching as high as 40.1 meters. In addition, the earthquake caused landslides, liquefaction and subsidence. During the one-month period after the earthquake, over 100 aftershocks registering intensity of 4.0 or greater on the Japanese scale occurred. Figure 1 shows the distribution of Reinforced Earth walls that were classified as Damage Rank II or higher. In Figure 2, a pie chart of the Reinforced Earth wall numbers by Damage Rank is provided for 1,419 of the structures. The walls in the figure represent 55% of the 2,540 such walls subjected to upper intensity 5 or higher tremors. It is noted that a total of 4,127 Reinforced Earth walls were located in what was considered the overall disaster stricken area³. Of the 1,419 walls surveyed, 1,400

(approximately 98.4%) had non-existent to light damage (Damage Rank I or II). Only 4 walls (0.28%) rated Damage

Figure 2. Percentages of each Damage Rank

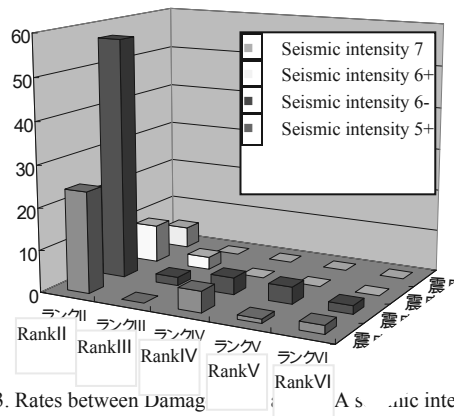
Figure 3. Rates between Damage Rank and Seismic intensity

As shown in Figures 3 and 4, the Damage Rank VI walls were at sites that were hit by upper intensity 5 to lower intensity 6 tremors, and in terms of their damage occurrence rates by wall height ($5 \text{ m} \leq H < 10 \text{ m}$, $10 \text{ m} \leq H < 15 \text{ m}$). They represent the same 0.4% rate in each seismic intensity and wall height. Therefore, the high degree of damage was not necessarily as a result of the strongest tremors or tallest wall heights.

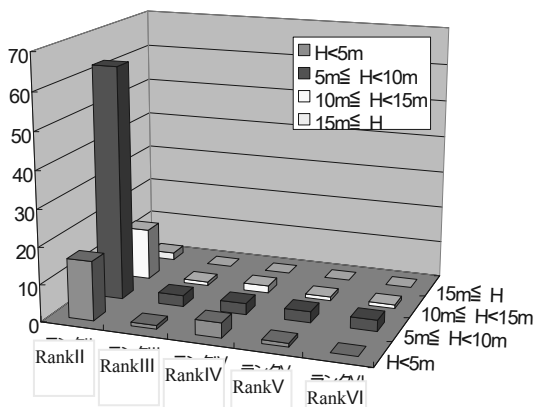
Figure 4. Relationship between Damage Rank and Wall height

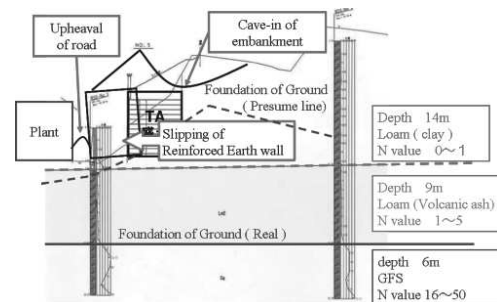
Along the boundary of a manufacturing site located in an area hit by lower intensity 6 tremors, a wall slipped forward by up to 7.0 m, accompanied by the uplift of the ground in front (by 3.0 m) and the subsidence of the embankment at its back (Photo 4). The structural integrity of the wall itself was confirmed through a strength test on the steel reinforcements and panels, an in-situ pull-out test on the reinforcing strips and laboratory tests on the embankment fill. The presence of very soft foundation ground was confirmed as a result of the in-situ boring and SPT tests carried out after the earthquake (Figure 5); the entirety of the reinforced earth fill seems to have slipped forward due to general movement at depth with soil characteristics lower than assumed during the design stage. This mechanism of general sliding was confirmed by an analysis of safety rating carried out considering soil characteristics assumed to have been present at the time of the earthquake.

Figure 5. Result of boring survey
