Stabilisation of a soft fill slope by compacted rockfill – an example of good practice

Slobodan B. Mickovski

Martyn J. Smith

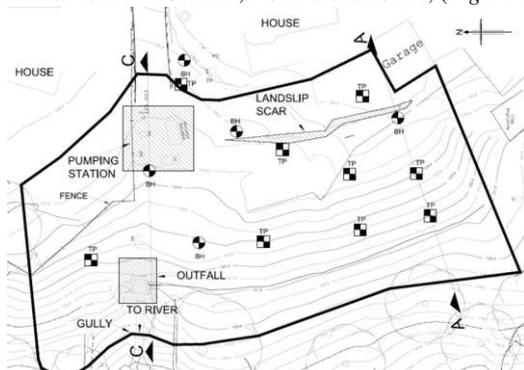
Figure 1. Site plan with marked areas of excessive settlement (shaded regions) and GI locations (BH-borehole, TP-trial pit)

In absence of any historical GI records and to obtain information relevant for the design of the remedial works, a topographic survey and intrusive ground investigations comprising 5 terrier boreholes and 9 trial pits were carried out on the site (Figure 1).

Slope stability was assessed for the designed rockfill slope using strength parameters for the rockfill of $c'=0$ kPa and $\phi'=40^\circ$ which are on the lower bound of the typical ranges reported (Barton 1981, GEO 1984) for this type of material (grading 100-150mm, $\gamma=20$ kN/m³). LEM analysis showed that the FS for the rockfill slope ranged between 1.43 (section through the existing landslide scar, A-A on Figure 1) and 1.49 (section through the PS, C-C on Figure 1).
