# Engineering assessment of jet-grouted structures

M. Arroyo & A. Gens

*Department of Geotechnical Engineering & Geosciences, UPC, Barcelona, Spain*

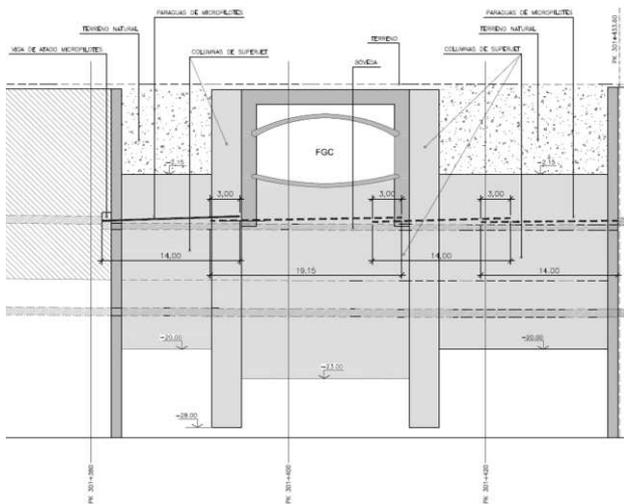
Site B was located at less than 2 km from site A, but the geotechnical setting was very different. A tunnel linking two cut and cover excavations had to cross underneath an existing railway tunnel. The new tunnel countervault was at about 23 m below ground (Figure 3). The soil profile at site B comprised 2 m of made ground, 3 m of medium clay, 8 m of medium sand,

15 m of fine sand and silts and 1 m of gravels, overbearing the same stiff clays treated at site A. The water table was at the countervault level of the existing tunnel. The newer tunnel had to be excavated through the water bearing fine sands and silts.

Figure 3. Designed treatment at site B: section

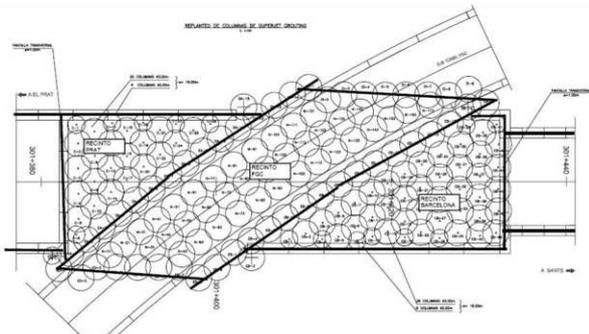
Apart from other protective measures the new tunnel design was heavily reliant on a jet-grouted treatment. The treatment was organized according to two main ideas: a sealing barrier around the excavation, and a generalized reinforcement inside the excavated area. The sealing barrier was partly formed by long jet-grout columns and, outside the older tunnel shadow, partly by diaphragm walls. Thus three independent enclosures were theoretically formed, one at each side of the older tunnel, and another just below it (Figure 4). Sealing was to be achieved by reaching into the clay substrate.

Figure 4. Designed treatment at site B: plan view. Black lines indicate sealing barriers: either diaphragm walls or long jet-grout columns

To materialize the soil treatment a bi-fluid jet-grout technique, commercialized under the name “superjet” was proposed by the specialist contractor. Two different types of columns were proposed, with 2 and 3 m estimated diameter. The plan arrangement of the columns is shown in Figure 4. The known basic treatment parameters are collected in Table 1. As indicated, some of these parameters were verified by monitoring of the injection process.
