Ground improvement under historical buildings: a case history

R. Passalacqua

Dep.t of Civil, Environmental & Architectural Eng.g (DICAT) – University of Genoa -Italy

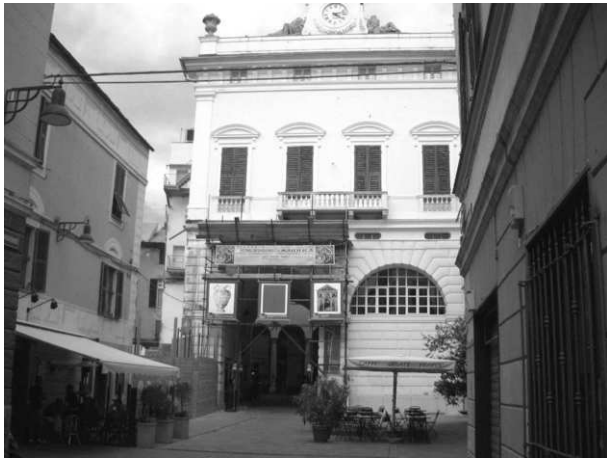
But, as the piles' execution approached the Gavotti Palace's masonry wall, this begun to settle markedly, rousing up safety issues.

Figure 1. Main façade of the Gavotti Palace, with the exit of its arcaded walkway and, at left, the neighboring erecting yard.

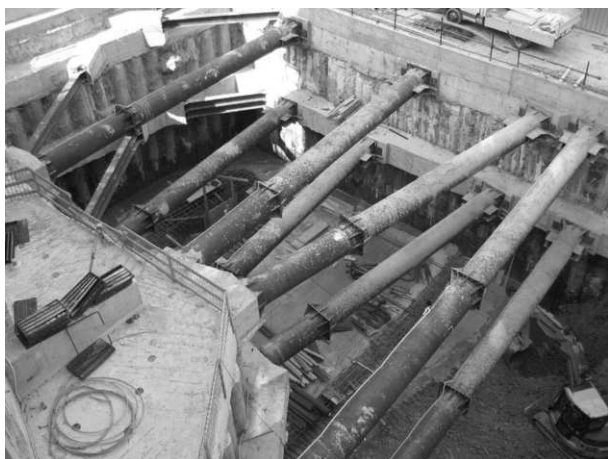
FEM analyses allowed to identify and correct some issues, among whose the most relevant had been: the depth at which the first stage of excavation must stop and the struts' pre-stressing values, to be applied at both the planned levels, before of the deepening restarts.

Figure 4. The two levels of struts and the excavation at full depth.
