Re-use of existing piles, Belgrave House, London

Mohsen Vaziri

Geotechnical Department, Whitbybird Engineers, London, UK

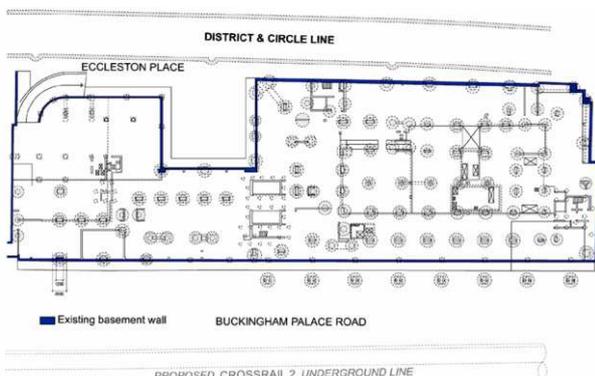
Figure 3: Existing Basement Plan

The presence of existing piled foundations at Belgrave House imposed restrictions on the design of the new building. The existing piles which were constructed in the early 1970's are generally under-ream piles up to 2800mm in diameter with a corresponding 1200mm shaft diameter. The piles supporting the original lift cores are 600 and 900mm in diameter. The existing pile layout plan is shown in Figure 3.

The drawings showed the piles used for the existing building were of four types, three of which were under-reamed (Figure 3). The pile sizes ranged from 600mm diameter straight-shafted piles up to 1200mm diameter piles with 2800mm under-reams. Piles were generally shown to be 20m in length. The pile toe levels were shown at -19m O.D with requirements that the piles are founded a minimum depth of 16m into London clay, a minimum concrete strength of 25N/mm² and a total reinforced length of 10m. A safe working load factor of 2.5 was used in the design of the piles. The Ove Arup & Partners drawings dated May 1976 and it was assumed that construction followed soon after this date.

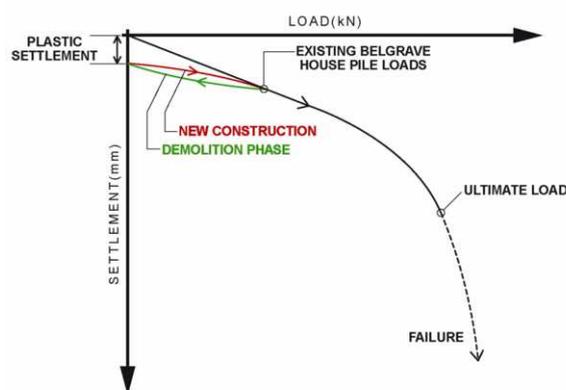
Figure 4: Load settlement response of a pile

The effect of the construction processes arising from the building redevelopment on the existing piles can be compared to a loading test on an under-reamed pile. The demolition stage is comparable to an unloading cycle of a pile in a maintained load test and the construction of the new structure is analogous to the second load cycle of a pile load test. Figure 4 shows an idealised load-settlement response of a pile in London Clay.

If the new loads exceeded the original Belgrave House pile loads then there would be a net permanent settlement, and a reduc-

tion in pile stiffness. This would become progressively worse as the pile ultimate load is approached whereupon, the stiffness of the pile reduces rapidly and excessive settlement will be observed which would subsequently lead to pile failure. To overcome potential problems with excessive settlement the piles were linked by a new transfer slab which redistributed loads avoiding the risk of failure of the piles and where there was a risk of over-loading the piles new ones would be installed.

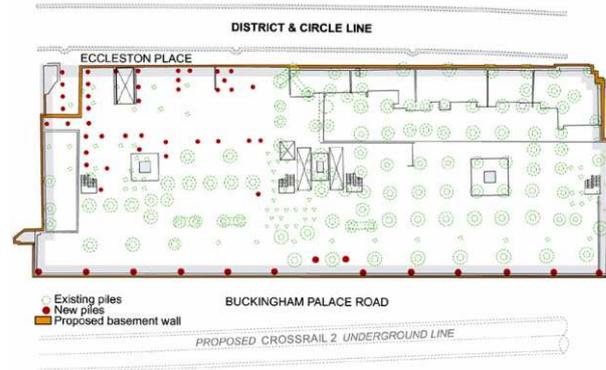
Figure 8: Proposed Foundation Layout

The load transfer from the new column grids to the existing piles was achieved by a new transfer slab and ground beams. Figure 8 shows the foundation layout for the Belgrave House. The centre bay of columns is supported on a 1 metre deep transfer slab which is supported on the existing piles. Few 750mm new diameter friction piles were constructed to the south sector of the site to compliment the existing piles where their load capacities have been exceeded. Similarly adjacent to Eccleston place, where a new area of basement was created, new piles were installed to support the row of column on the rear façade of the building. The new columns on the Buckingham Palace Road elevation are supported on a new line of 1200mm diameter, 40 metre long friction piles. A finite element software package was used to design the 1 metre deep basement transfer slab.

In the analyses the existing piles were modelled into two distinct groups, one straight shafted with a load capacity of 1170kN, the other under-reamed piles with load bearing capacities ranging from 3850-5600 kN respectively. Due to the different type of piles different stiffness properties were assigned and hence predicted how each group of piles attracted a portion of the column loads.
