Behaviour of foundations over surface fault rupture: Analysis of case histories from the Izmit (1999) earthquake

Ioannis Anastasopoulos
Candidate, National Technical University, Athens

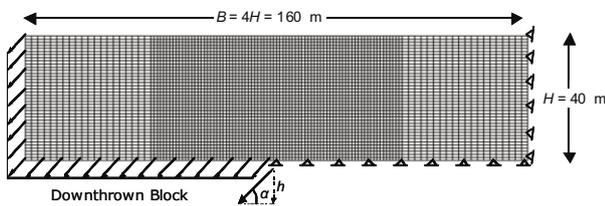
Figure 4. Problem geometry and finite element discretization

The developed FE model is displayed in Fig. 4, referring to an $H = 40$ m soil layer at the base of which a normal fault, dipping at an angle α , ruptures and produces downward movement of vertical amplitude h . Our model is $B = 4H = 160$ m in width, following Bray's recommendation (1994) that a $B : H = 4 : 1$ ratio is sufficient to minimize boundary effects. The discretisation is finer at the medium, being sparser at the two edges. The differential displacement is applied to the left part of the model in small consecutive steps.
