Analyses of historical buildings condition with respect to soil-structure interaction

V.M. Ulitsky

A.G. Shashkin & M.B. Lisyuk

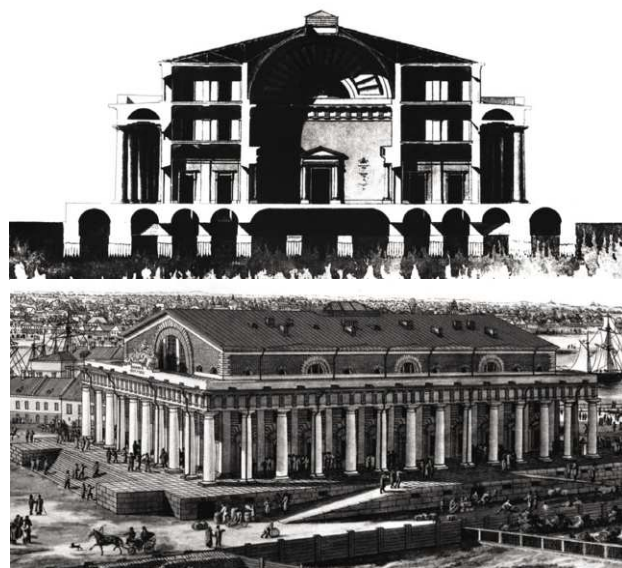
Figure 1. Former Stock Exchange on Vasilievsky island spit:
a) cross section; b) the building by the construction completion

In 2002 a large scope of works on the building's elevations was carried out. The cracks developed over two centuries of the building's life were revealed. The restorers expressed their concern regarding the renewed cracks appearing in the new superficial finishes on the gable ends and splitting the building along its longitudinal axis.

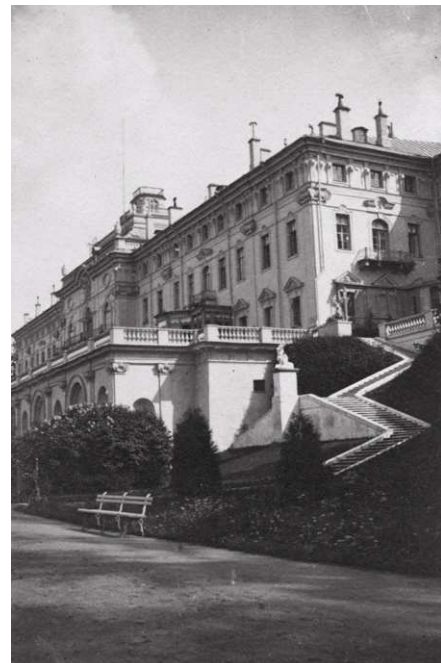
Figure 6. Constantinovsky Palace in the suburb of Strelna. Photo taken in 1910

Its dilapidation over past few decades was brought about by a group of contributing factors. The condition survey identified the following features. Foundations of the exterior elevation wall of the loggias as well as foundations of the retaining walls were constructed of brickwork. The brickwork was dilapidated and therefore could suffer squeezing with formation of local bulges, quite similar to the subsoil material bulging under pressure from the superstructure.
